N242479760 Electric Vehicle Sound Levels

Release Date: December 2024 Revision: 00

General Motors has decided that certain 2025 model year Chevrolet Equinox EV vehicles potentially fail to conform to Section S5.4 of Federal Motor Vehicle Safety Standard (FMVSS) No. 141, and Section (1)(b) of Canada Motor Vehicle Safety Standard (CMVSS) No. 141, "Minimum Sound Requirements for Hybrid and Electric Vehicles." The pedestrian alert sound system in these vehicles may have an incorrect software calibration and may not produce exterior sound at the required relative volume when the vehicle is travelling between 20 km/h (12.4 mph) and 30 km/h (18.6 mph). Under some conditions pedestrians may not be able to determine by sound whether an approaching vehicle is speeding up or slowing down, increasing the risk of injury to pedestrians.
Dealers will update the software calibration in the vehicles' body control module (BCM) to correct the condition. Some unsold vehicles may receive this update via wireless over-the-air (OTA) technology.

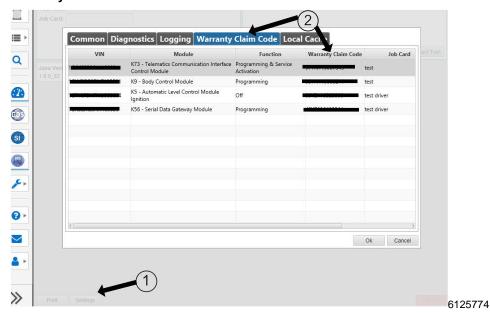
Warranty Claim Code Information Retrieval

If the Warranty Claim Code was not recorded on the Job Card, the code can be retrieved in the SPS2 system as follows:

- 1. Open TLC on the computer used to program the vehicle.
- 2. Select and start SPS2.
- 3. Select Settings (1).
- 4. Select the Warranty Claim Code tab (2).

The VIN, Warranty Claim Code and Date/Time will be listed on a roster of recent programming events. If the code is retrievable, dealers should resubmit the transaction making sure to include the code in the SPS Warranty Claim Code field.

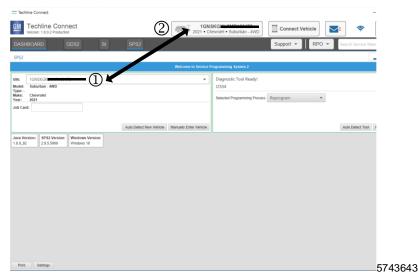
Caution: Be sure the VIN selected in the drop down menu (1) is the same as the vehicle connected (2) before beginning programming.

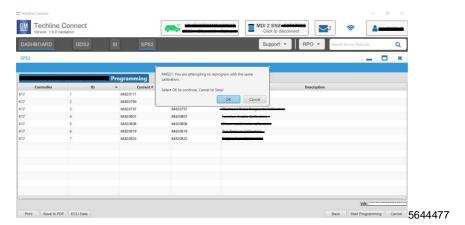
Important: If the vehicle VIN DOES NOT match, the message below will be shown.

Important: Techline Connect screens shown above.
