Safety Recall Launch Notification

Campaign #	NHTSA ID	Description	Update Battery Management System Software
2025040005	25V050	25P5496507

Total Recall Population	7,358	Model(s)/ Platform(s)	EQB SUV (243 platform)
Vehicles in Dealer Inventory	3		
Model Year(s)	2022-2024		
Issue	Mercedes-Benz AG, the manufacturer of Mercedes-Benz vehicles, has determined that on certain subject vehicles, the high voltage battery might not be sufficiently robust at a high state of charge (above 80%). Due to a combination of battery production and vehicle use conditions, an internal short circuit of a battery cell in the high-voltage battery could occur. Therefore, the risk of a fire cannot be ruled out.		
What We're Doing	MBUSA will conduct a voluntary recall. An authorized Mercedes-Benz dealer will update the battery management system software on the affected vehicles. Customers are being advised not to charge the battery to a State of Charge above 80% until the remedy is performed. Once the software update is performed on the vehicle, the customer can once again charge the vehicle's battery to greater than 80% State of Charge.

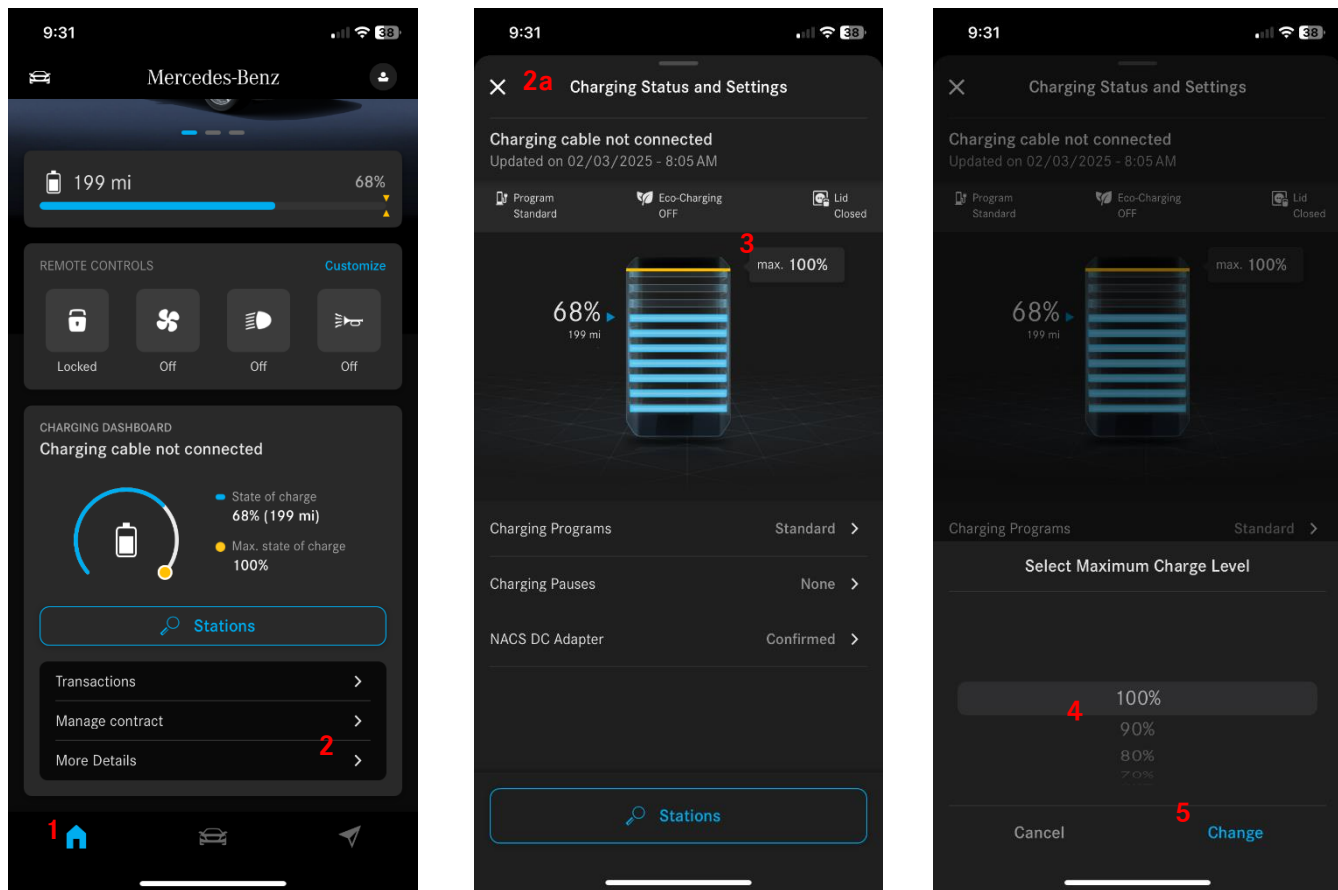
HOW TO CHANGE STATE OF CHARGE (MERCEDES APP):

- 1) Select the “Home” icon at the bottom of the home screen of your Mercedes App
- 2) Select “More Details”
 - a. The “Charging Status and Settings” submenu should open automatically.
- 3) Press the “max. charge percentage” seen on the battery charge level indicator image.
- 4) Scroll down and select the Maximum Charge Level 80%
 - a. NOTE: After software update, the Maximum Charge Level can be set to 100%
- 5) Select “Change”
 - a. The message “Updating – Request Sent” and a loading circle should appear at the top, when complete, the state of charge should now read “max 80%.”
 - b. NOTE: After software update, the Maximum Charge Level can be set to “max. 100%”

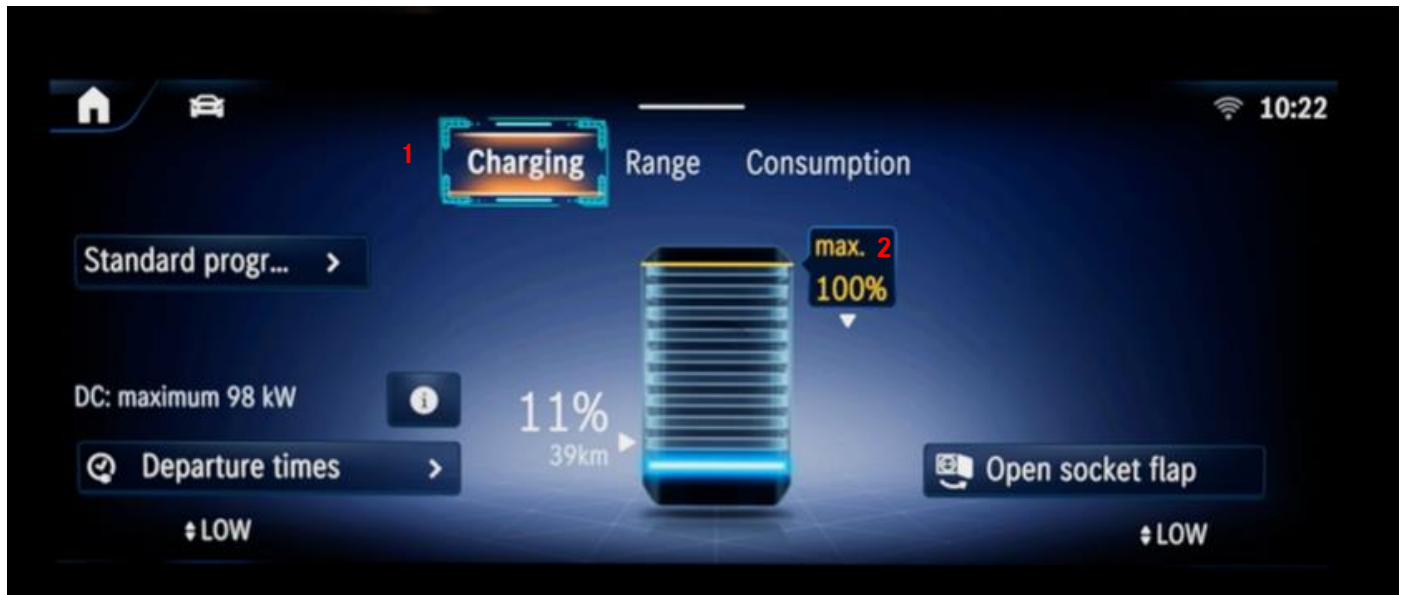
HOW TO CHANGE STATE OF CHARGE (MBUX):

- 1) On the multimedia system, select the “Home” icon, then “EQ”, to navigate to the “Charging” screen.
- 2) Tap and drag the “max. percentage” icon to the right of the battery state of charge display to read “max. 80%.”
 - a. NOTE: After software update, the Maximum Charge Level can be set to “max.100%”
