Service Engineering Operations
Customer Service Division

**SUBJECT: NEW VEHICLE DEMONSTRATION / DELIVERY HOLD -
Safety Recall 25S28**
Certain 2021-2022 Model Year Edge Vehicles with SYNC 4
APIM Module Reprogramming Due to Distorted Screen

REASON FOR THIS SAFETY RECALL

SERVICE ACTION

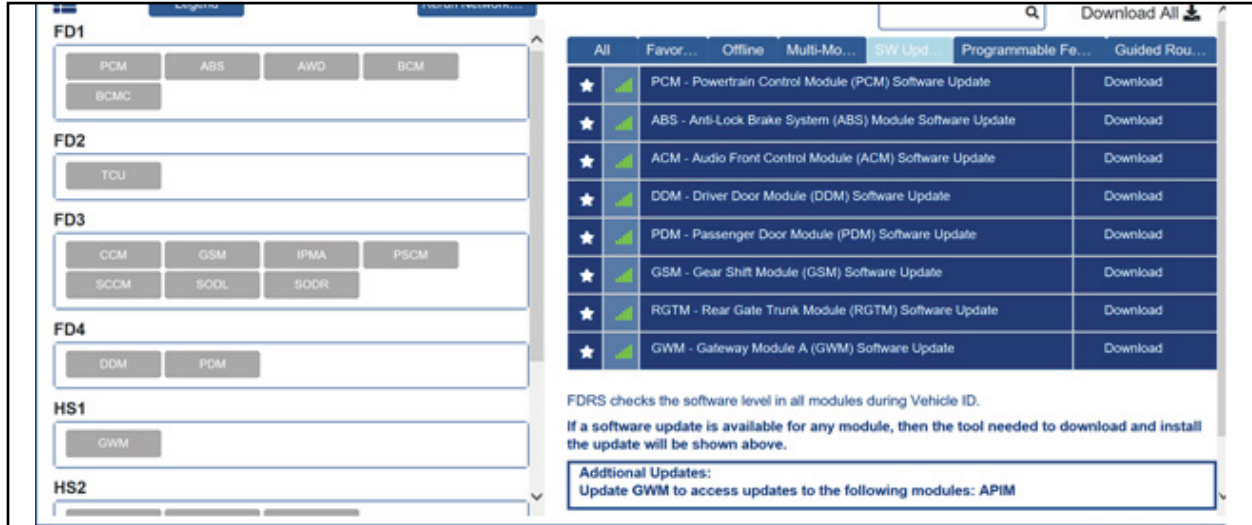
FIGURE 3

NOTE: Module dependencies may require that you update other modules before the APIM software update is available. This may include GWM, TCU, IPC, etc. See Figures 3 and 4.
