R25DL

IMPORTANT SAFETY RECALL

NHTSA Number: 25V-249 (School Bus)

SUBJECT: R25DL: Secondary Brake System Failure in Electric Vehicles with Hydraulic Brakes

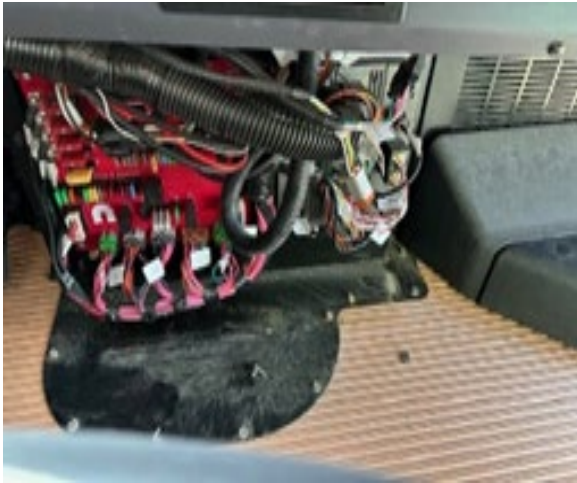
Figure 1

1. Turn off battery disconnect or remove negative battery cable from terminal and secure
2. Inside the bus, remove the plastic doghouse cover exposing the A MUX module and wiring harness (Figure 1)
3. Remove the six (6) RH switch panel screws and panel (Figure 2)
4. Using the upper dash panel opening, locate the white wire labeled “BRAKE WARN GND”. The wire will be connected at the firewall to the C703 bulkhead connector immediately above and to the driver’s side of the body PCB. (Figure 3)
5. Cut the white wire labeled “BRAKE WARN GND”. Be certain to leave adequate length on the side leading to the firewall to allow you to strip and attach a new lead in a later step. (Figure 4)

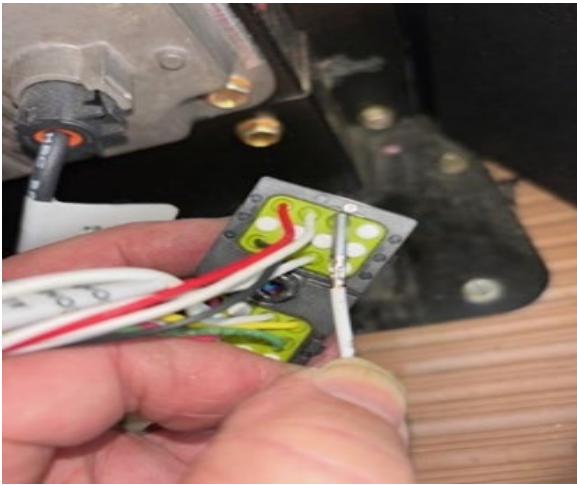
Figure 9

11. Verify the new wire you've run from the "BRAKE WARN GND" wire is routed correctly and secure with zip ties
12. Insert the Deutsch socket at the end of the new wire into the back side of the pin 18 cavity on plug E8 until you feel a click. (Figure 9)
13. Verify the socket is locked in the plug by gently tugging on the wire. If the socket pulls out, it must be reinserted
14. Reinstall plug E8 into the cavity on the A module and torque the retaining bolt to 25 inch pounds. (Figure 10)
15. Replace doghouse cover

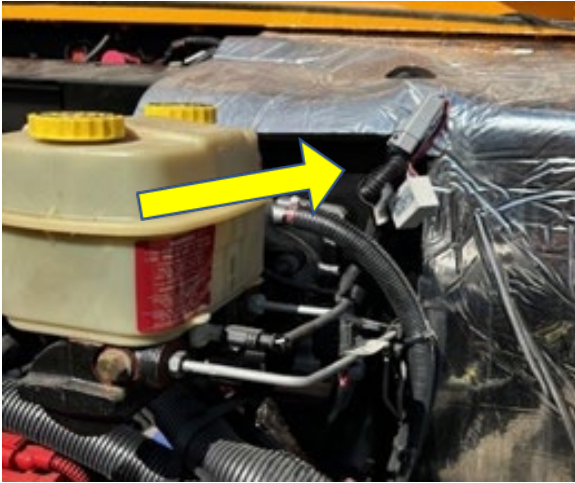
Figure 11

16. Open the hood and locate the gray brake module harness connection on the driver's side of the brake master cylinder (Figure 11)
17. Cut the zip tie securing the gray plug to the harness (Figure 12)
18. Disconnect the brake module from the harness by depressing the locking tab (Figure 13)
19. Remove the brake module for modification

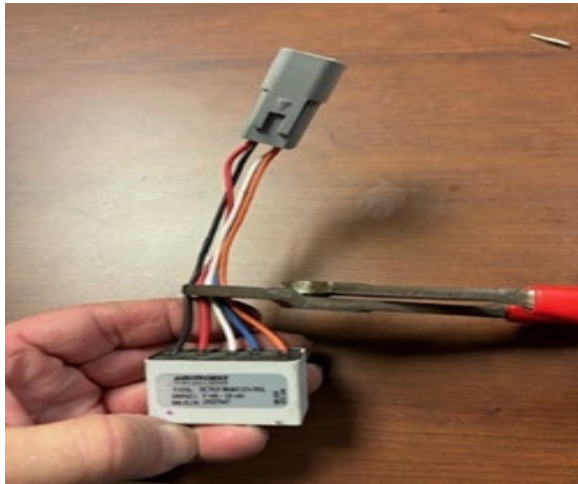
Figure 14

20. Cut the brake module from the plug approximately 1" from the module (Figure 14). Discard module.
21. Remove the retaining clip from inside the plug (Figure 15)
22. With a small flat blade screwdriver, carefully pry back the retaining lock on pin 4 (red wire) to release the pin (Figure 16)
23. Slide the wire and pin out of the plug (Figure 17)
24. Repeat for the white wire on pin 1

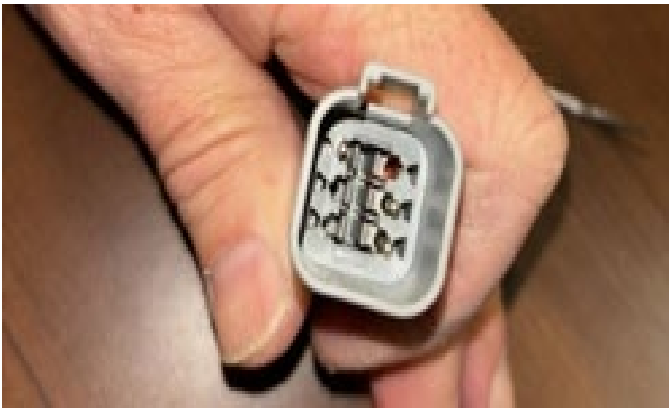
Figure 18

25. The modified plug cavity should look like (Figure 18)
26. Reinstall the retaining clip
27. Place sealing pins in cavity 1 and 4 (cavity 5 is unused and already sealed) (Figure 19)
28. Strip the blue wire (pin 2) and orange wire (pin 3)
29. Connect the blue wire (pin 2) to the orange wire (pin 3) using an insulated butt connector (Figure 20)
30. Strip the black wire (pin 6) and crimp a 5/16 insulated ring terminal (Figure 20)

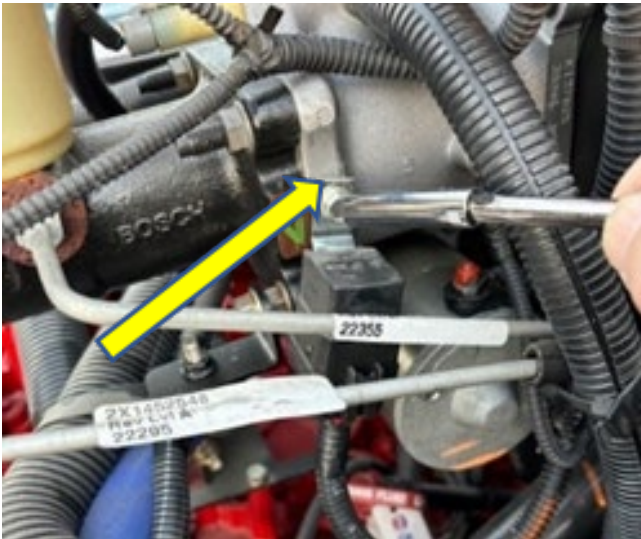
Figure 21

31. Under hood, locate the relay mounted on the master cylinder hydroboost power brake booster and remove the bolt securing the relay. (Figure 21)
32. Put the relay mounting both through the eyelet of the black wire on the modified module harness and relay mount
33. Tighten bolt
34. Snap modified module harness back into harness plug. (Figure 22)
35. Secure with zip ties
