TECHNICAL INSTRUCTIONS
FOR
25LA05
REPROGRAMMING FOR COMBINATION METER ASSEMBLY

CERTAIN
2024 -2025 LS500 vehicles
2024 – 2025 LS500h vehicles
2024 - 2025 TX350 vehicles
2024 TX500h vehicles
2024 TX 550h+ vehicles
2025 RX350
2025 RX350H
2025 500H

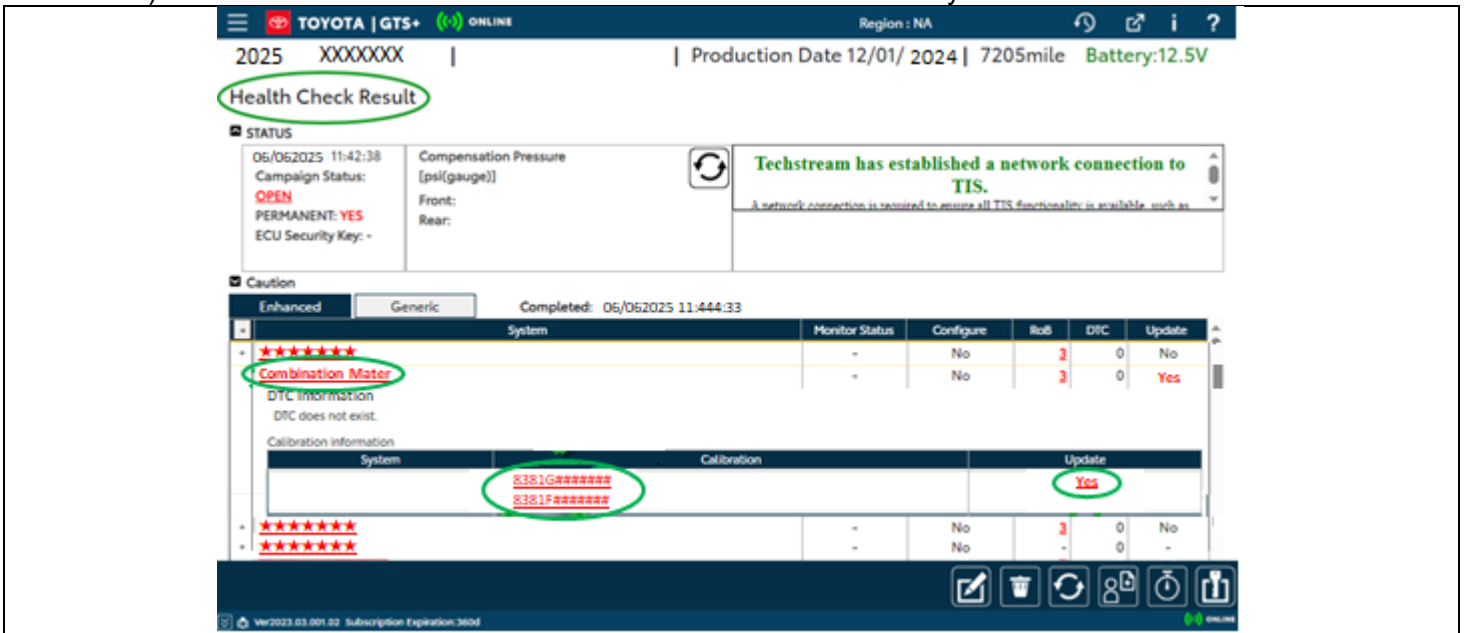
1. CONFIRM THE CALIBRATION ID FOR THE COMBINATION METER SYSTEM

a) Confirm the current calibration ID in the Combination Meter System.
