R25DL

**NHTSA Number: 25V-249 (School Bus)**

**SUBJECT:** R25DL: Secondary Brake System Failure in Electric Vehicles with Hydraulic Brakes

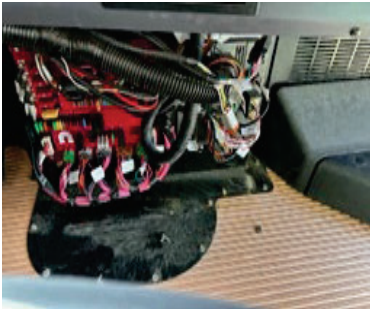
Figure 1

1. Turn off battery disconnect or remove negative battery cable from terminal and secure
2. Inside the bus, remove the plastic doghouse cover exposing the A MUX module and wiring harness (Figure 1)
3. Remove the six (6) RH switch panel screws and panel (Figure 2)
4. Using the upper dash panel opening, locate the white wire labeled “BRAKE WARN GND”. The wire will be connected at the firewall to the C703 bulkhead connector immediately above and to the driver’s side of the body PCB. (Figure 3)
5. Cut the white wire labeled “BRAKE WARN GND”. Be certain to leave adequate length on the side leading to the firewall to allow you to strip and attach a new lead in a later step. (Figure 4)

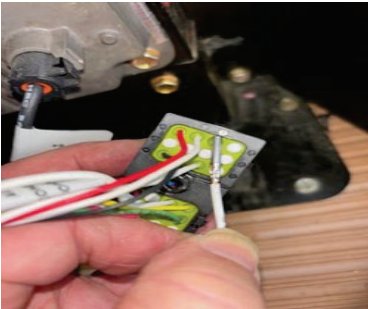
Figure 9

11. Verify the new wire you've run from the "BRAKE WARN GND" wire is routed correctly and secure with zip ties
12. Insert the Deutsch socket at the end of the new wire into the back side of the pin 18 cavity on plug E8 until you feel a click. (Figure 9)
13. Verify the socket is locked in the plug by gently tugging on the wire. If the socket pulls out, it must be reinserted
14. Reinstall plug E8 into the cavity on the A module and torque the retaining bolt to 25 inch pounds. (Figure 10)
15. Replace doghouse cover

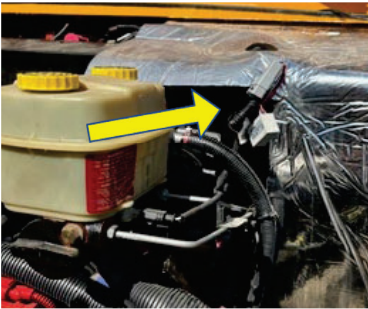
Figure 11

16. Open the hood and locate the gray brake module harness connection on the driver's side of the brake master cylinder (Figure 11)
17. Cut the zip tie securing the gray plug to the harness (Figure 12)
18. Disconnect the brake module from the harness by depressing the locking tab (Figure 13)
19. Remove the brake module for modification

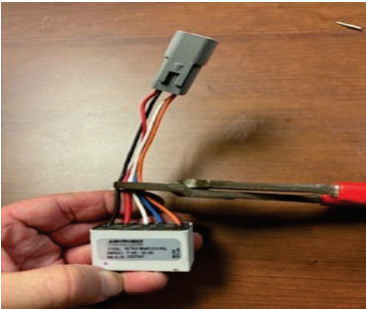
Figure 14

20. Cut the brake module from the plug approximately 1" from the module (Figure 14). Discard module.
21. Remove the retaining clip from inside the plug (Figure 15)
22. With a small flat blade screwdriver, carefully pry back the retaining lock on pin 4 (red wire) to release the pin (Figure 16)
23. Slide the wire and pin out of the plug (Figure 17)
24. Repeat for the white wire on pin 1

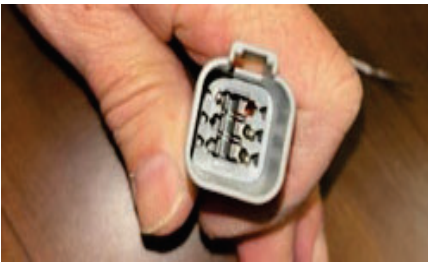
Figure 18

25. The modified plug cavity should look like (Figure 18)
26. Reinstall the retaining clip
27. Place sealing pins in cavity 1 and 4 (cavity 5 is unused and already sealed) (Figure 19)
28. Strip the blue wire (pin 2) and orange wire (pin 3)
29. Connect the blue wire (pin 2) to the orange wire (pin 3) using an insulated butt connector (Figure 20)
30. Strip the black wire (pin 6) and crimp a 5/16 insulated ring terminal (Figure 20)

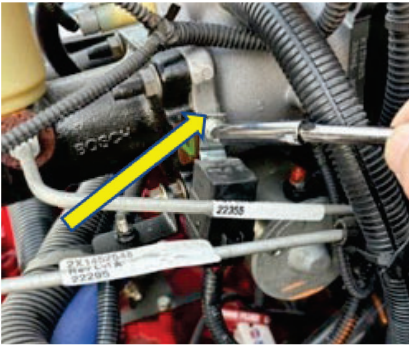
Figure 21

31. Under hood, locate the relay mounted on the master cylinder hydroboost power brake booster and remove the bolt securing the relay. (Figure 21)
32. Put the relay mounting both through the eyelet of the black wire on the modified module harness and relay mount
33. Tighten bolt
34. Snap modified module harness back into harness plug. (Figure 22)
35. Secure with zip ties
