## RECALL ACTION

Reference number:	RA-30-2015	Issued: 3 January 2025
Subject:	Head Unit Software Update (Reverse Camera Display)	
Model(s):	DB12, DBX, Vantage	
VIN range:	Refer to the separately published list of affected Vehicle Identification Numbers (VINs)	
Applicable to:	All US Dealers	
Distribute to:	After Sales Manager Executive Manager Service Manager Sales Manager	Warranty Staff Technician(s) Parts Staff

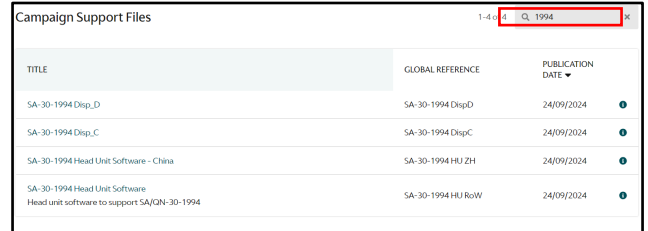
Figure 1

1. Log in to Technical Hub.
2. Navigate to Campaign support Files and search "Camera Patch Head Unit Software" in the search box (refer to Figure 1).
3. Download the following campaign support files:
  - Camera Patch Head Unit Software

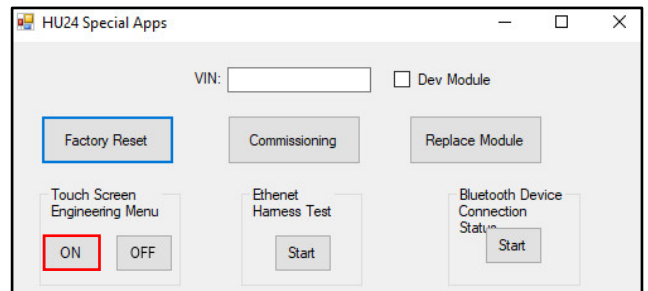
Figure 4

8. Select "ON" to unlock the Touch Screen Engineering Menu (refer to Figure 4).

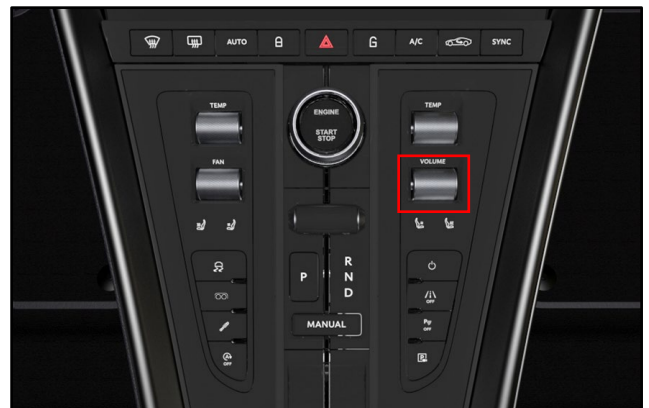
Figure 5

12. Once the update is complete, the Head Unit must do a power reset. Press the "Home" icon to return to the engineering menu.
13. Select "Power".
14. Select "Shutdown" and tap "Shutdown" again to confirm.
15. Select "Shutdown".
16. The Head Unit will then reset. This can take several minutes to complete.
17. On the main menu, swipe from left to right to open the menu and select "Settings".
18. Press "Software".
19. Make sure the vehicle is at the correct software level shown in step 6.
20. Press and hold the volume dial button until the screen goes black to reset the head unit (refer to Figure 5).

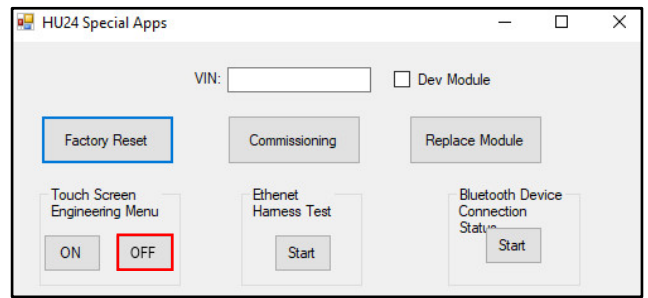
Figure 8

5. Select "OFF" to lock the Touch Screen Engineering Menu (refer to Figure 8).
