GROUP	MODEL
<b>Noncompliance Safety Recall Campaign</b>	<b>2024-2025MY Sorento (MQ4a) and 2025MY Sorento P/HEV (MQ4 P/HEV)</b>
NUMBER	DATE
<b>SC331 (Rev 1, 3/19/2025)</b>	<b>January 2025</b>

### BODY DOMAIN CONTROL UNIT LOGIC IMPROVEMENT (SC331)

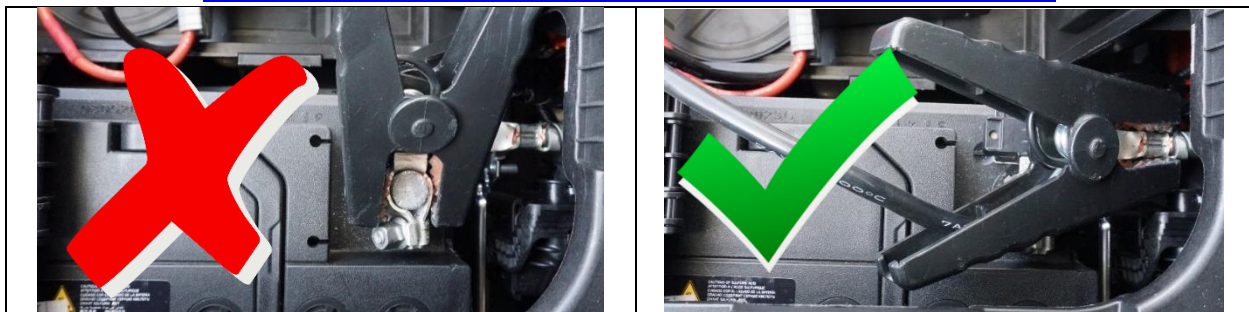
[Connect the negative \(-\) terminal to the battery as shown below.](#)

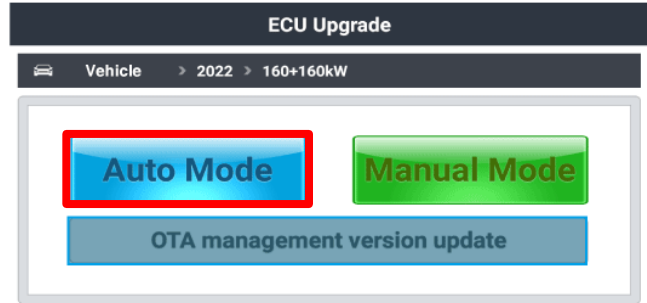
The required software must be installed by selecting the **'Auto Mode'** ECU Upgrade option.

**Note:** In some cases, the 'Manual Mode' installation option may be required **ONLY** if the 'Auto Mode' function fails or is otherwise noted above.

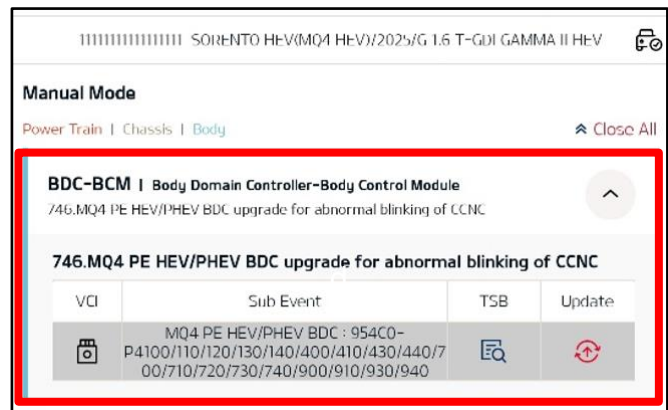
Select the applicable **'BDC-BCM'** 'system' module and **'Event Group'** number in the ECU Upgrade.

- **2025MY Sorento P/HEV (MQ4 P/HEV) - Korea Built**  
746.MQ4 PE HEV/PHEV BDC Upgrade for Abnormal Blinking of CCNC

- **2025MY Sorento (MQ4a) - US Built**  
799.MQ4a PE BDC Upgrade for Abnormal Blinking of CCNC

Verify the affected vehicle Calibration Identification of the applicable ECU ROM ID and reference the Information Table on page 3 as necessary.
