RAM Remedy available for

- 2016 and 2018-2019 (D2) Ram 3500 Pickup
- 2016 and 2018-2020 (DJ) Ram 2500 Pickup
- 2016 and 2018-2019 (DS) Ram 1500 Pickup
- 2016 (DF) Ram 3500 GVWR less than 10,000 lbs Cab Chassis

SAFETY RECALL
NORTH AMERICA
Curtain Airbag Inflator

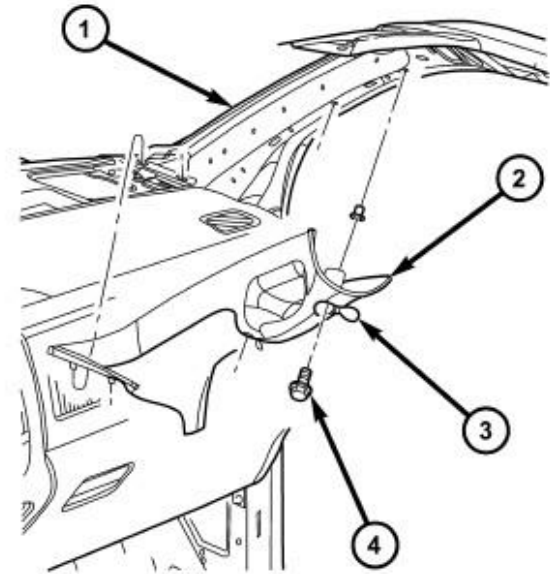
Figure 1 – A-Pillar

1. Using a small flat-bladed tool, carefully open the two fastener covers (3) located in the A-pillar trim panel (2) (Figure 1).

65. Position the locating tab of the A-pillar trim panel (2) into the slot located in the top of the instrument panel (Figure 1).
66. Install the A-pillar trim panel onto the A-pillar (1) and install the two bolts (4). Tighten the bolts to 5 N·m (44 in. lbs.) (Figure 1).

-
67. Close the two fastener covers (3) located in the A-pillar trim panel (Figure 1).
 68. Install the door seals around the door openings.
 69. Return the vehicle to the customer or inventory.

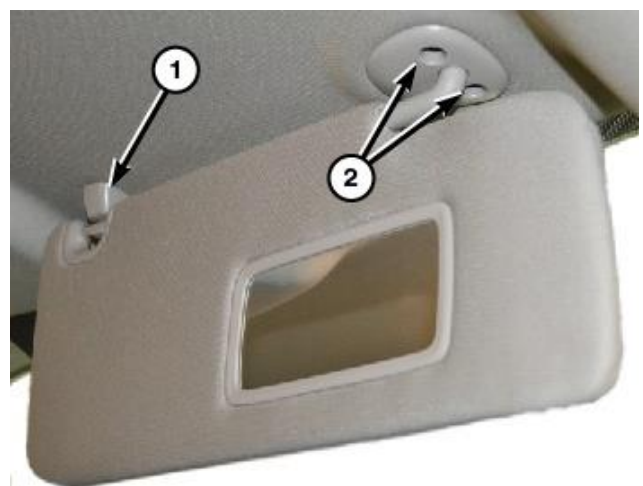
Figure 2 – Visors

3. Separate the visor from the support (1) then remove the screw and remove the visor support (Figure 2).

4. Remove the visor screws (2) then remove the visor (Figure 2).

61. Install the front seat headrests (Figure 4).
62. Position the visor supports (1) onto the headliner and install the screws into the mounting clips (Figure 2).

63. If equipped with illuminated vanity mirror, connect the wire harness connector.
64. Position the visor to the headliner and install the screws (2) that secure the visor to the roof panel. Tighten the screws to 6 N·m (53 in. lbs.) (Figure 2).

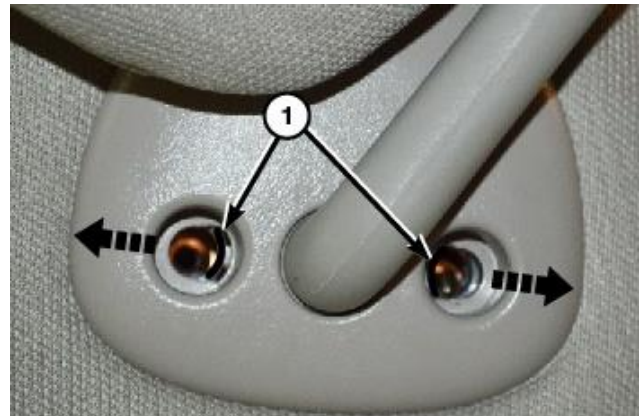
Figure 3 – Visors

- Using a small flat bladed tool or equivalent, release the retaining tabs (1) and separate the visor from the headliner (Figure 3).

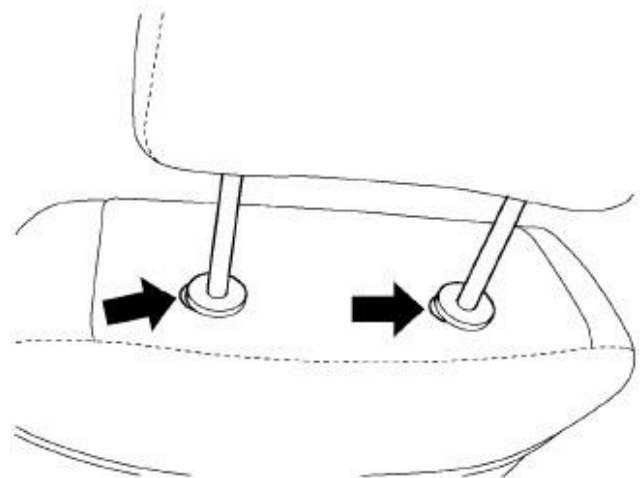
Figure 4 – Head Rest

- Push in the buttons on front seat headrest sleeves then pull the headrest up and remove (Figure 4).

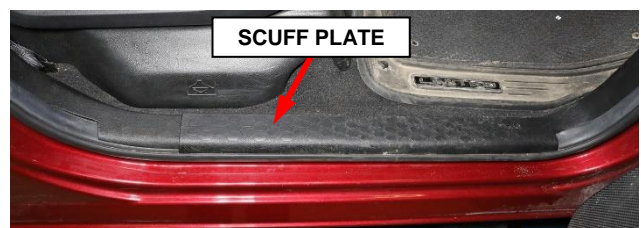
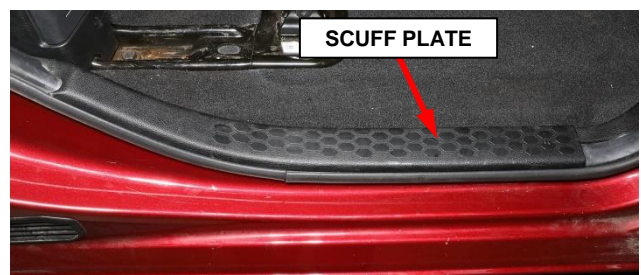
Figure 5 – Door Sill Scuff Plates

10. Release the front and rear door sill scuff plates on either side of the B pillar lower trim panel to allow for removal of the B-pillar lower trim panel (Figure 5).

49. Install the seat belt turning loop cover (Figure 7).
50. Position the B-pillar lower trim panel and engage the retaining clips fully (Figure 6).
51. Position the front and rear door sill scuff plates and engage the retainers (Figure 5).

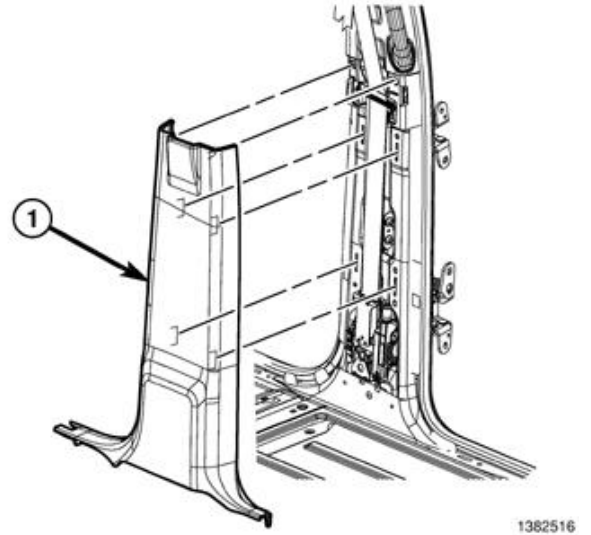
Figure 6 – B-Pillar Lower Trim Panel

11. Release the retaining clips and remove the B-pillar lower trim panel to allow for removal of the B-pillar upper trim panel (Figure 6).

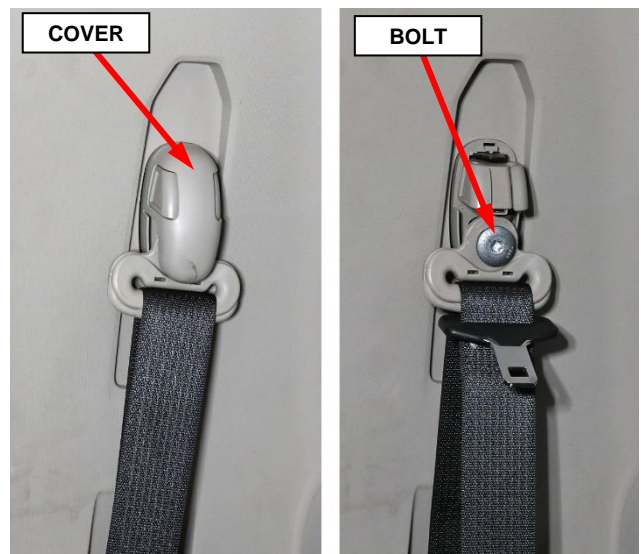
Figure 7 – Seat Belt Turning Loop

12. On the B-pillar, separate the seatbelt turning loop cover then remove the turning loop bolt (Figure 7).

47. Remove and **DISCARD** the bolt retainer and the bolt from the seat belt turning loop, save the spacer washer for reuse (Figure 19).
48. Using a **NEW** bolt and reusing the spacer washer, install the turning loop then tighten the bolt to 40 N·m (30 ft. lbs.) (Figure 7).

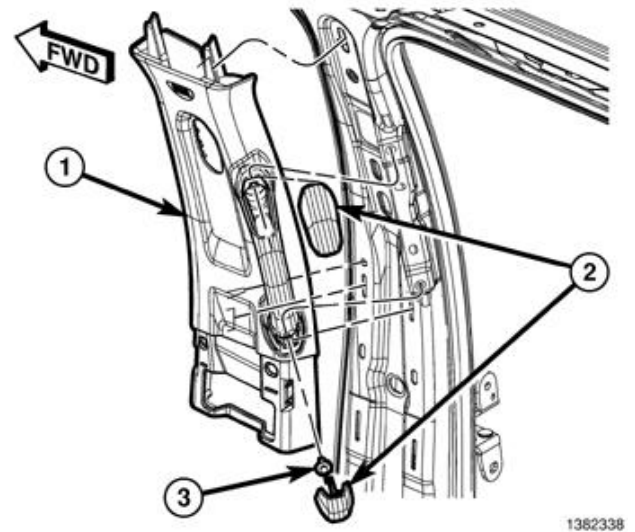
Figure 8 – B-Pillar Upper Trim Panel

13. On the B-pillar, use a small flat-bladed tool to carefully open the two fastener covers (2) located on the grab handle (Figure 8).
14. Remove the two bolts (3) that secure the grab handle to the B pillar (Figure 8).
15. Using a trim stick C-4755 or equivalent, release the retaining clips that secure the B pillar upper trim panel (1) then position the trim panel out of the way. It is not necessary to remove the seat belt from the trim panel (Figure 8).

45. Install the B-pillar upper trim panel (1) and engage the retaining clips fully (Figure 8).
46. Install the grab handle bolts (3) and tighten to 5 N·m (44 in. lbs.). Close the fastener covers (2) (Figure 8).

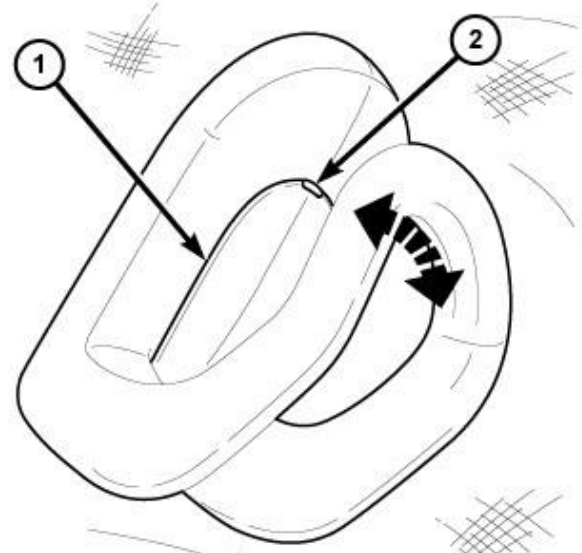
Figure 9 – Coat Hook

16. Using a small flat bladed tool, open the coat hook screw cover (2) then remove the screw and coat hook (Figure 9).

44. Position the coat hooks (5) onto the headliner and install the screws tightening securely into the mounting clips then close the screw cap fully (Figure 9).

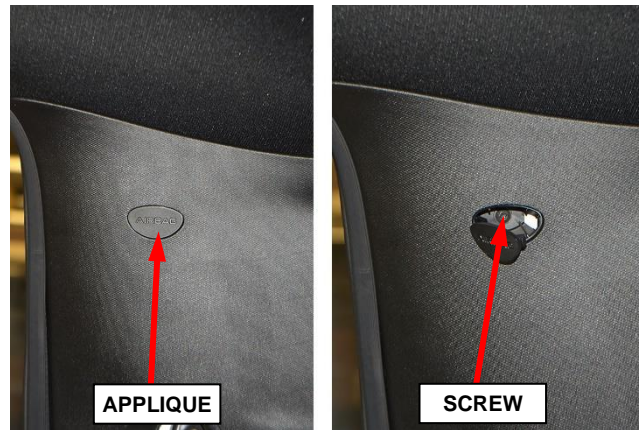
Figure 10 – C-Pillar Upper Trim Panel

- Using a trim stick or equivalent, release the C-pillar airbag applique then remove the screw that secures the upper trim panel (Figure 10).

42. Position the upper trim panel to the C-pillar then engage the retaining clips (Figure 11).
43. Install and tighten the screw that secures the C-pillar upper trim panel. Then install the airbag applique (Figure 10).

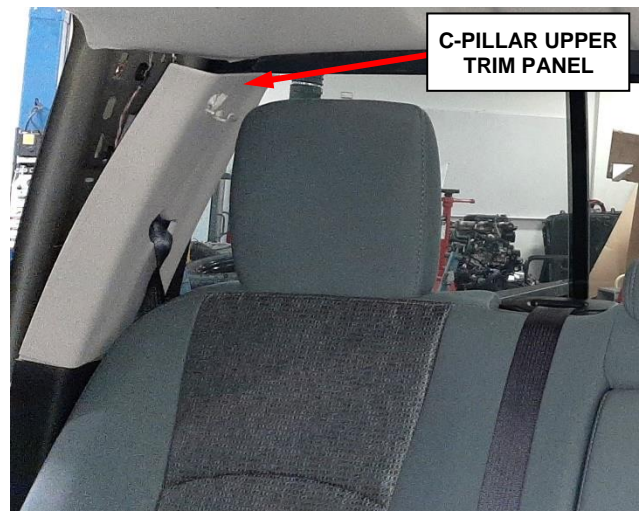
Figure 11 – C-Pillar Trim Panels

- Release the retaining clips and tilt the top of the C-pillar upper trim panel inward (Figure 11).

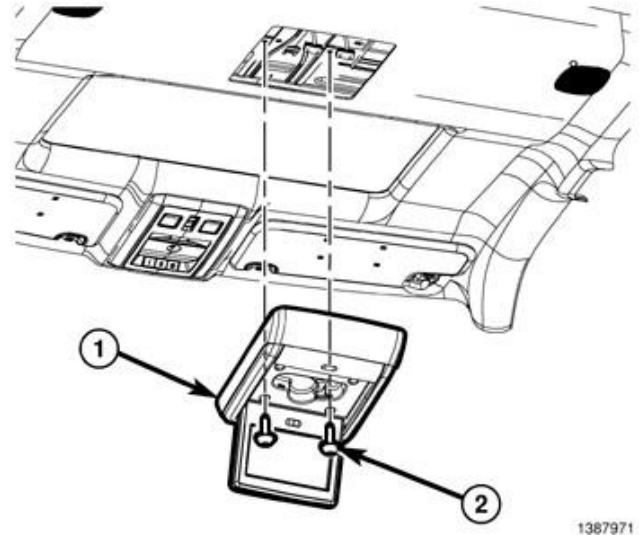
Figure 12 – Rear Seat DVD Monitor

19. If equipped with DVD monitor, remove the screws (2) and separate the monitor (1) from the roof (Figure 12).

39. Tilt the rear view mirror down to allow it to support the headliner (Figure 15).
40. Reattach any headliner wiring harness clips (3) removed from the A-pillar to allow slack while lowering headliner (Figure 14).
41. If equipped with DVD monitor, connect the DVD monitor electrical connectors (1) (Figure 13). Position the DVD monitor to the roof then install and tighten the screws (2) (Figure 12).

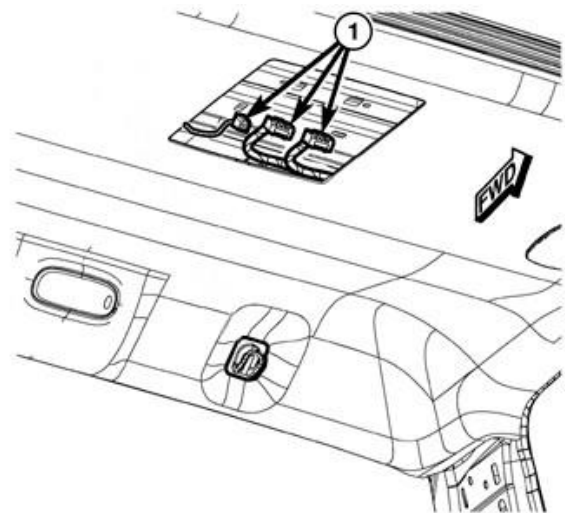
Figure 13 – DVD Monitor Electrical Connectors

20. If equipped with DVD monitor, disconnect the electrical connectors (1) (Figure 13).

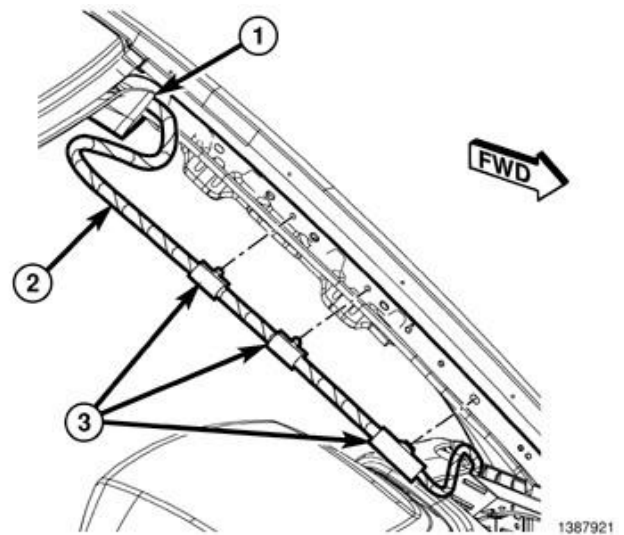
Figure 14 – Headliner Harness

21. As necessary, release the headliner wiring harness clips (3) from the A-pillar to allow enough wiring harness slack for lowering the headliner (Figure 14).

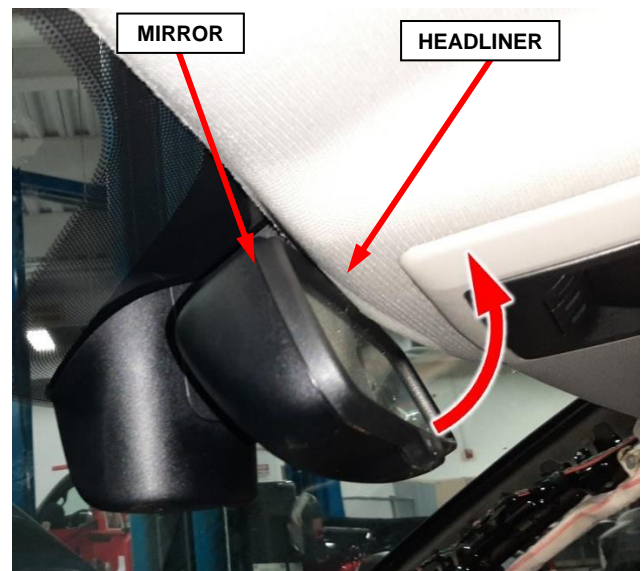
Figure 15 – Rearview Mirror

22. Release the door seals from the door openings to allow for lowering of the headliner.
23. Tilt the rear view mirror up to allow clearance for lowering the headliner (Figure 15).

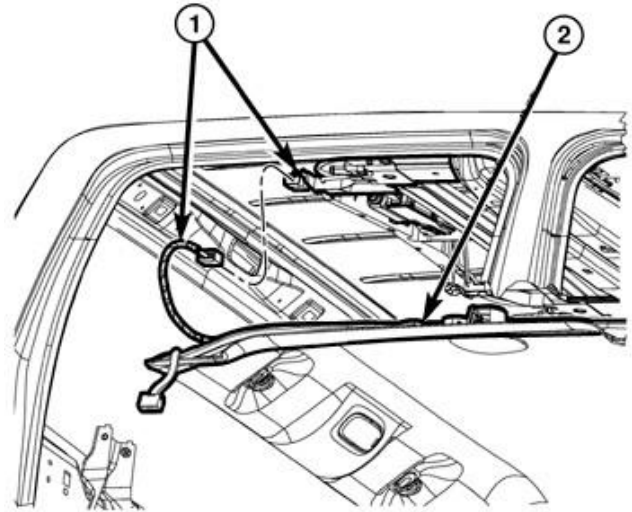
Figure 16 – Headliner Harness

24. Carefully tilt the front of the headliner (2) down to clear the rear view mirror then slide the headliner forward to clear the C pillar trim while disconnecting any wiring harness electrical connectors (1) as necessary to allow enough wiring harness slack to lower the headliner (Figure 16).
25. lower the headliner (2) allowing it to rest on the seat backs and instrument panel (Figure 16).

38. Raise the headliner into proper vehicle position and connect any electrical connectors previously disconnected from the headliner (Figure 16).

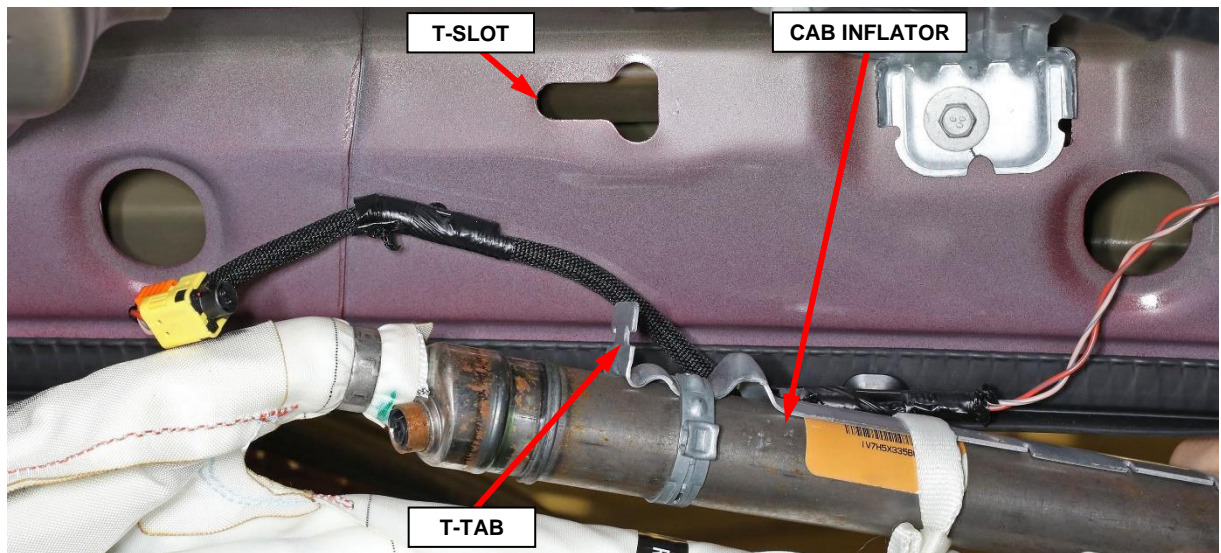
Figure 18 – CAB Inflator T-Tab and Inner Roof Rail T-Slot

30. Slide the inflator rearward far enough to disengage the T-tab at the front of the inflator bracket from the keyed T-slot in the inner roof rail over the rear door opening (Figure 18).

34. Insert the T-tab at the front of the inflator bracket into the keyed T-slot in the inner roof rail over the rear door opening and slide the inflator forward to engage it (Figure 18).

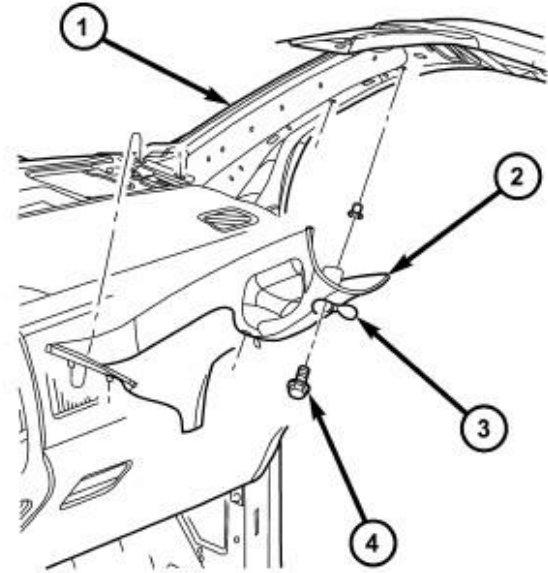
Figure 20 – A-Pillar

1. Using a small flat-bladed tool, carefully open the two fastener covers (3) located in the A-pillar trim panel (2) (Figure 20).
2. Remove the two bolts (4) that secure the A-pillar trim panel to the A-pillar (1) and remove the trim panel (Figure 20).

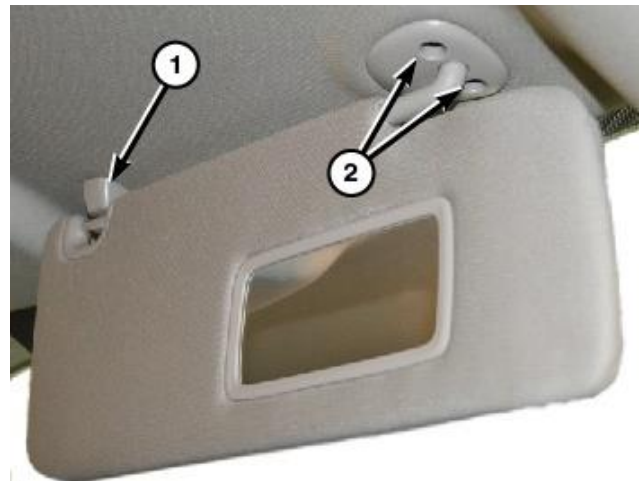
Figure 21 – Visors

3. Separate the visor from the support (1) then remove the screw and remove the visor support (Figure 21).
4. Remove the visor screws (2) then remove the visor (Figure 21).

67. Install the front seat headrests (Figure 23).
68. Position the visor supports (1) onto the headliner and install the screws into the mounting clips (Figure 21).
69. If equipped with illuminated vanity mirror, connect the wire harness connector.
70. Position the visor to the headliner and install the screws (2) that secure the visor to the roof panel. Tighten the screws to 6 N·m (53 in. lbs.) (Figure 21).
71. Position the locating tab of the A-pillar trim panel (2) into the slot located in the top of the instrument panel (Figure 20).
72. Install the A-pillar trim panel onto the A-pillar (1) and install the two bolts (4). Tighten the bolts to 5 N·m (44 in. lbs.) (Figure 20).
73. Close the two fastener covers (3) located in the A-pillar trim panel (Figure 20).
74. Install the door seals around the door openings.
75. Return the vehicle to the customer or inventory.

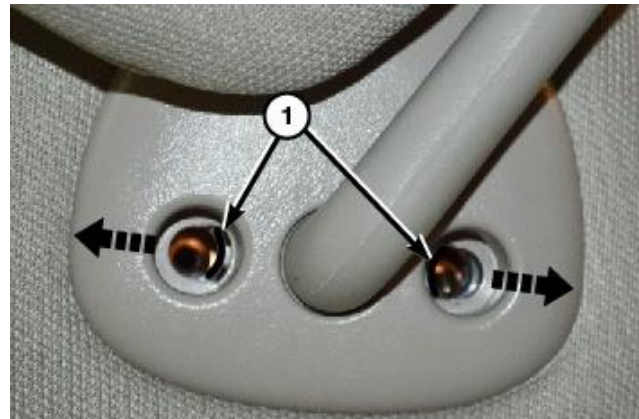
Figure 22 – Visors

5. Using a small flat bladed tool or equivalent, release the retaining tabs (1) and separate the visor from the headliner (Figure 22).

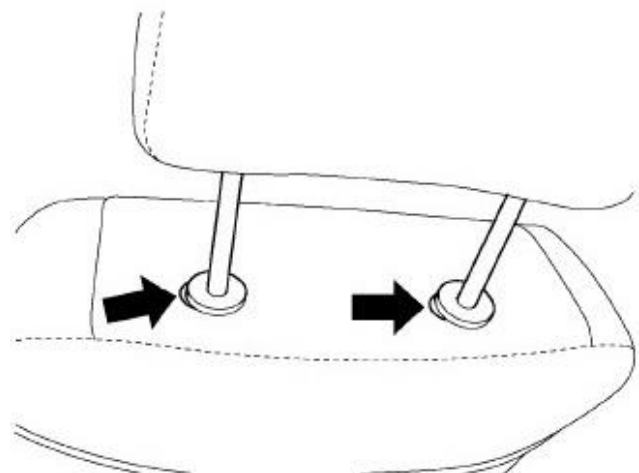
Figure 23 – Head Rest

7. Tilt seat backs all the way back. Push in the buttons on front seat headrest sleeves then pull the headrest up and remove (Figure 23).

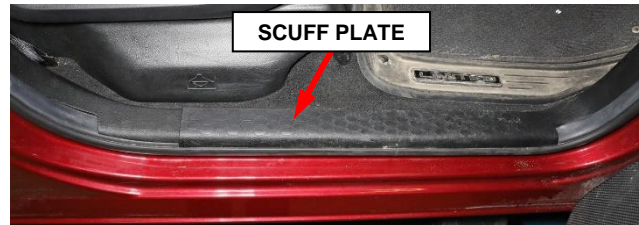
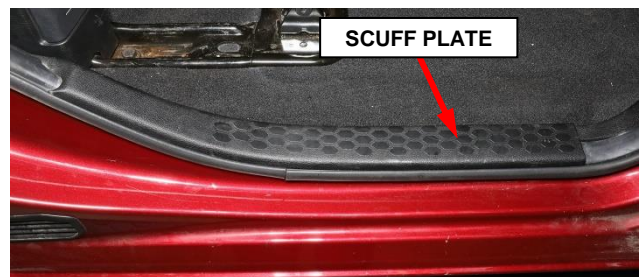
Figure 24 – Door Sill Scuff Plates

9. Release the front and rear door sill scuff plates on either side of the B pillar lower trim panel to allow for removal of the B-pillar lower trim panel (Figure 24).

NOTE: Ensure that all C-pillar fasteners are installed/engaged properly.
60. Install the B-pillar upper trim panel (1) and engage the retaining clips fully (Figure 27).
61. Install the grab handle bolts and tighten to 5 N·m (44 in. lbs.). Close the fastener covers (2) (Figure 27).
62. Remove and **DISCARD** the bolt retainer and the bolt from the seat belt turning loop, save the spacer washer for reuse (Figure 40).
63. Using a **NEW** bolt and reusing the spacer washer, install the turning loop then tighten the bolt to 40 N·m (30 ft. lbs.) (Figure 26).
64. Install the seat belt turning loop cover (Figure 26).
65. Position the B-pillar lower trim panel and engage the retaining clips fully (Figure 25).
66. Position the front and rear door sill scuff plates and engage the retainers (Figure 24).

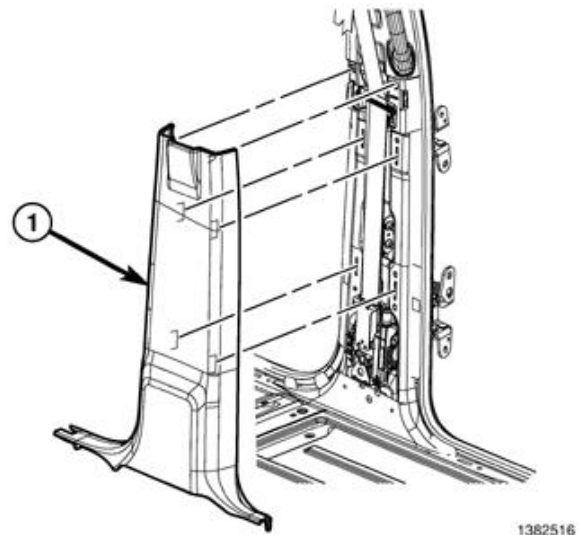
Figure 25 – B-Pillar Lower Trim Panel

10. Release the retaining clips and remove the B-pillar lower trim panel to allow for removal of the B-pillar upper trim panel (Figure 25).

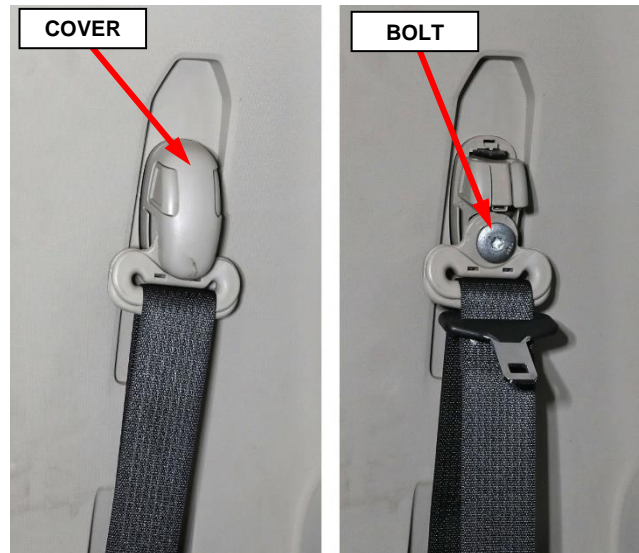
Figure 26 – Seat Belt Turning Loop

11. On the B-pillar, separate the seatbelt turning loop cover then remove the turning loop bolt (Figure 26).

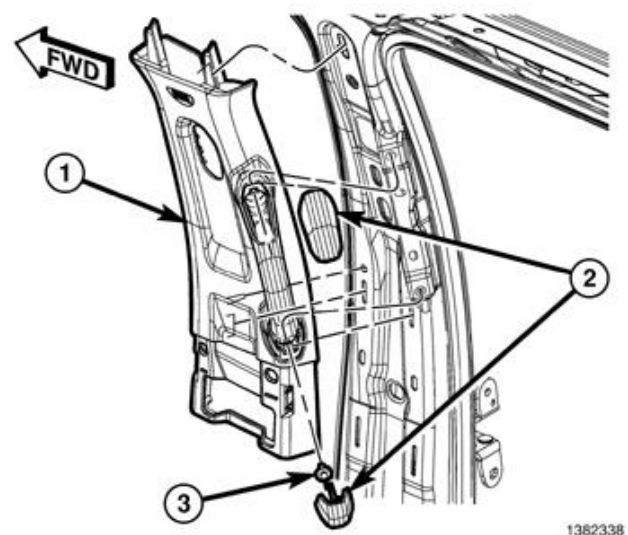
Figure 27 – B-Pillar Upper Trim Panel

12. On the B-pillar, use a small flat-bladed tool to carefully open the two fastener covers (2) located on the grab handle (Figure 27).

13. Remove the two bolts (3) that secure the grab handle to the B pillar (Figure 27).

14. Using a trim stick C-4755 or equivalent, release the retaining clips that secure the B pillar upper trim panel (1) then position the trim panel out of the way. It is not necessary to remove the seat belt from the trim panel (Figure 27).

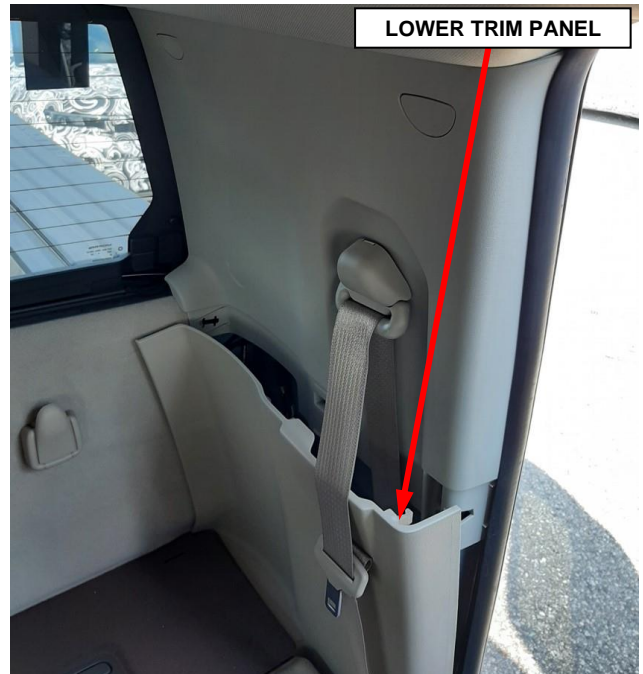
Figure 28 – C-Pillar Lower Trim Panel

- 16. Release the upper retaining clips of the lower C-pillar trim panel to allow for removal of the upper C pillar trim panel (Figure 28).

53. Raise the front seat backs and position the seats forward.
54. Install the C-pillar upper trim panel (1) and engage the retaining clips fully (Figure 31).
55. Install and tighten the screws that secure the C-pillar upper trim panel then install the airbag applique covers (Figure 30).
56. Remove and **DISCARD** the bolt retainer and the bolt from the seat belt turning loop, save the spacer for reuse (Figure 39).
57. Using a **NEW** bolt and reusing the spacer washer, install the turning loop then tighten the bolt to 40 N·m (30 ft. lbs.) (Figure 29).
58. Install the seat belt turning loop cover (Figure 29).
59. Position the lower C-pillar trim panel and engage the retaining clips fully (Figure 28).

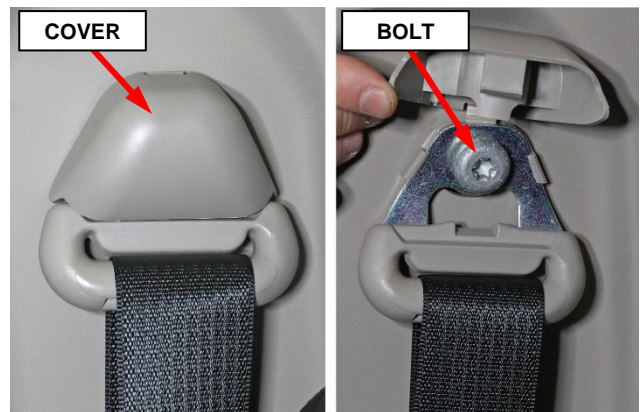
Figure 29 – Seat Belt Turning Loop

- 17. On the C-pillar, lift the seat belt turning loop cover then remove the turning loop bolt (Figure 29).

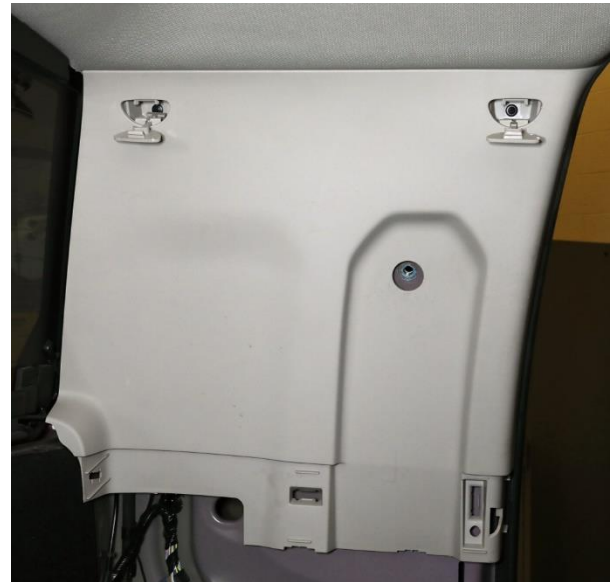
Figure 30 – C-Pillar Upper Trim Panel Fasteners

- Using a trim stick or equivalent, release the B-pillar airbag applique then remove the screw that secures the upper trim panel (Figure 30).

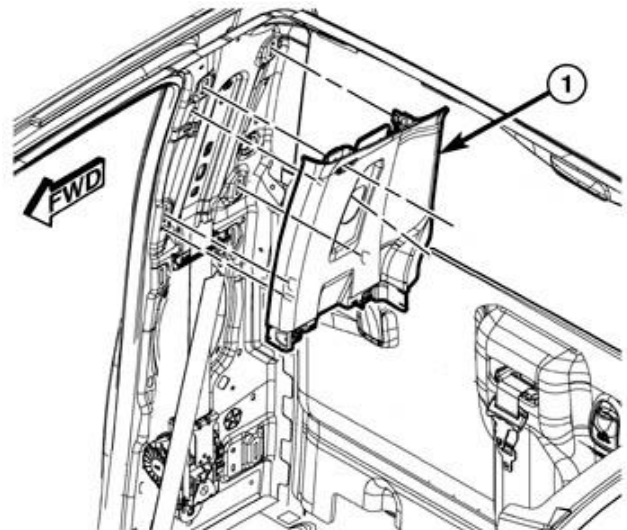
Figure 31 – C-Pillar Upper Trim Panel

- Release the retaining clips and remove the C-pillar upper trim panel (1) (Figure 31).

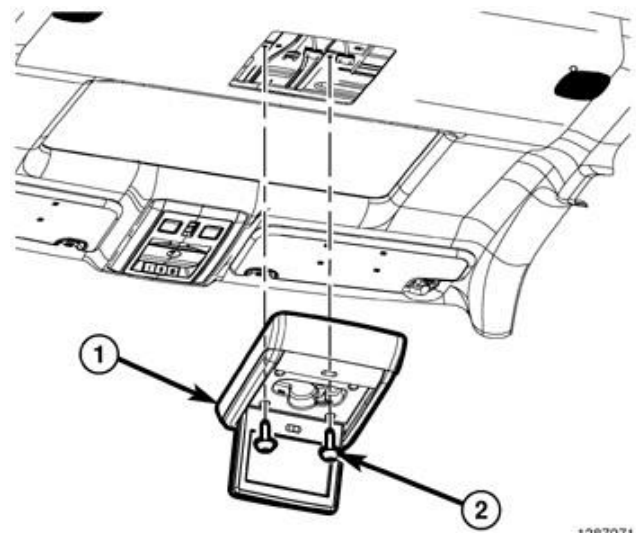
Figure 32 – Rear Seat DVD Monitor

22. If equipped with DVD monitor, remove the screws (2) and separate the monitor (1) from the roof (Figure 32).

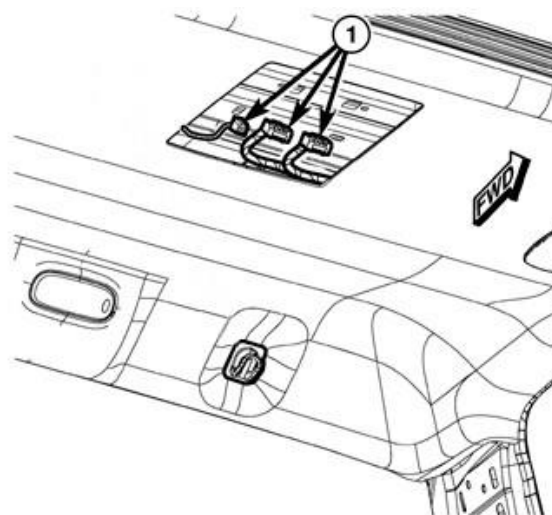
Figure 33 – DVD Monitor Electrical Connectors

23. If equipped with DVD monitor, disconnect the electrical connectors (1) (Figure 33).

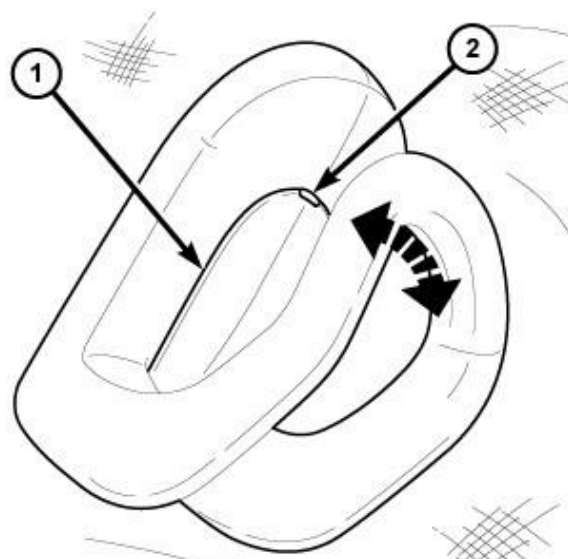
Figure 34 – Coat Hook

24. Using a small flat bladed tool, open the coat hook screw cover (2) then remove the screw and coat hook (Figure 34).

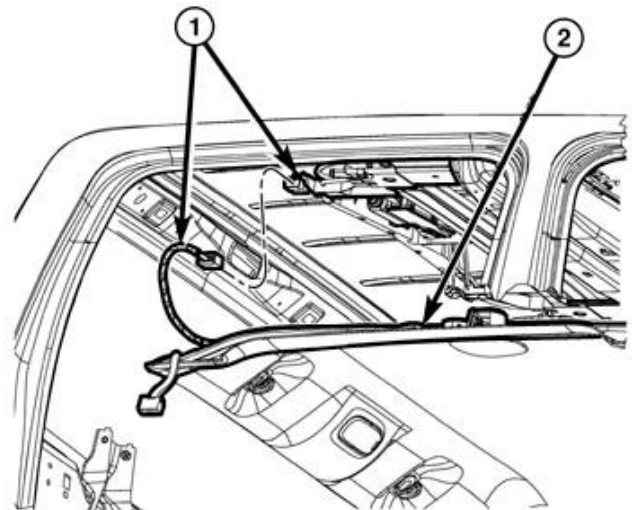
Figure 36 – Headliner Harness

- 27. Carefully lower the headliner (2) allowing it to rest on the seat backs and instrument panel (Figure 36).

CAUTION: Disconnect any wiring harness electrical connectors (1) as necessary to allow enough wiring harness slack while lowering headliner. It will not be necessary to remove the headliner from the vehicle (Figure 36).

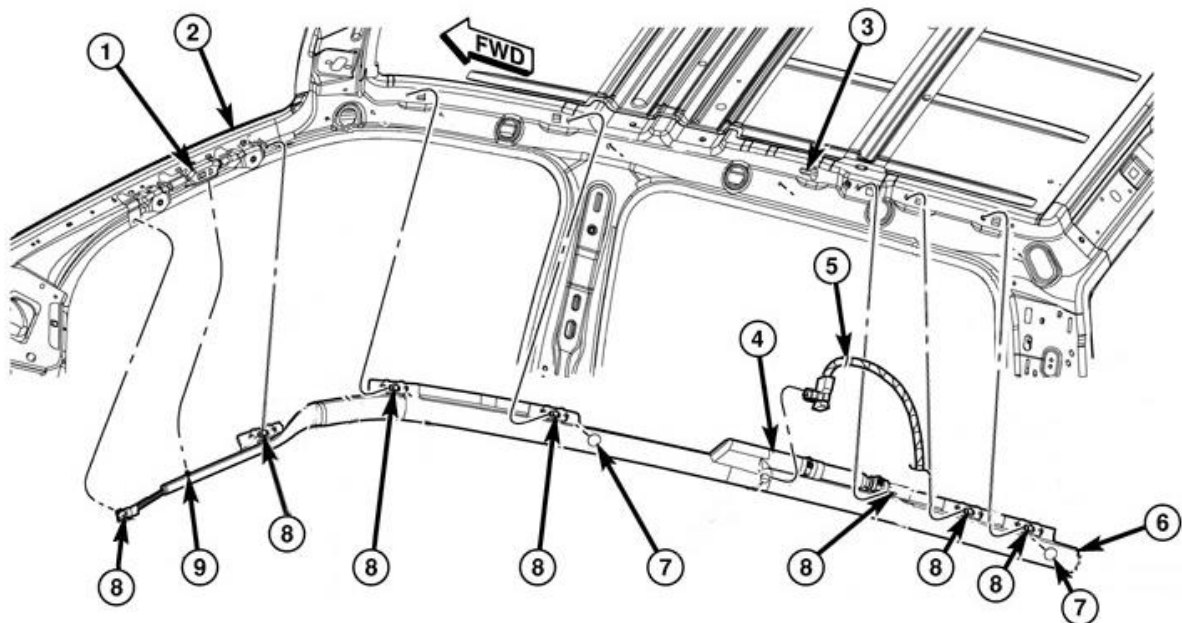
Figure 37 – Side Curtain Airbag

29. The body wire harness connector (5) is secured by integral latches to the connector receptacle on the inflator (4). Pinch both latches firmly, then pull the connector straight out from the airbag inflator to disconnect it from the connector receptacle (Figure 37).

30. Remove the seven bolts (8) that secure the side curtain airbag (6) to the inner roof rail and A-pillar (Figure 37).
31. Disengage the push-in retainer (9) that secures the side curtain airbag tether to the inner A-pillar (1) and the two push-in retainers (7) that secure the side curtain airbag to the inner roof rail (Figure 37).

33. Remove the CAB (6) from the vehicle as a unit and **DISCARD** following local ordinances and recommended procedures for handling and disposal of Non-Deployed Supplemental Restraints (Figure 37). Provided packaging is not authorized for the transport of the recalled CAB Module. Parts will need to be either deployed on-site or transported in alternative approved containers.

34. Check to be certain that the spring nuts are properly installed in the inner roof rail and that they are in good condition.
35. Position the **NEW** CAB (6) into the vehicle as a unit (Figure 37).

38. Working from rear to front, install and tighten the seven bolts (8) that secure the side curtain airbag (6) to the inner roof rail and A-pillar. Tighten the bolts to 7 N·m (62 in. lbs.) (Figure 37).

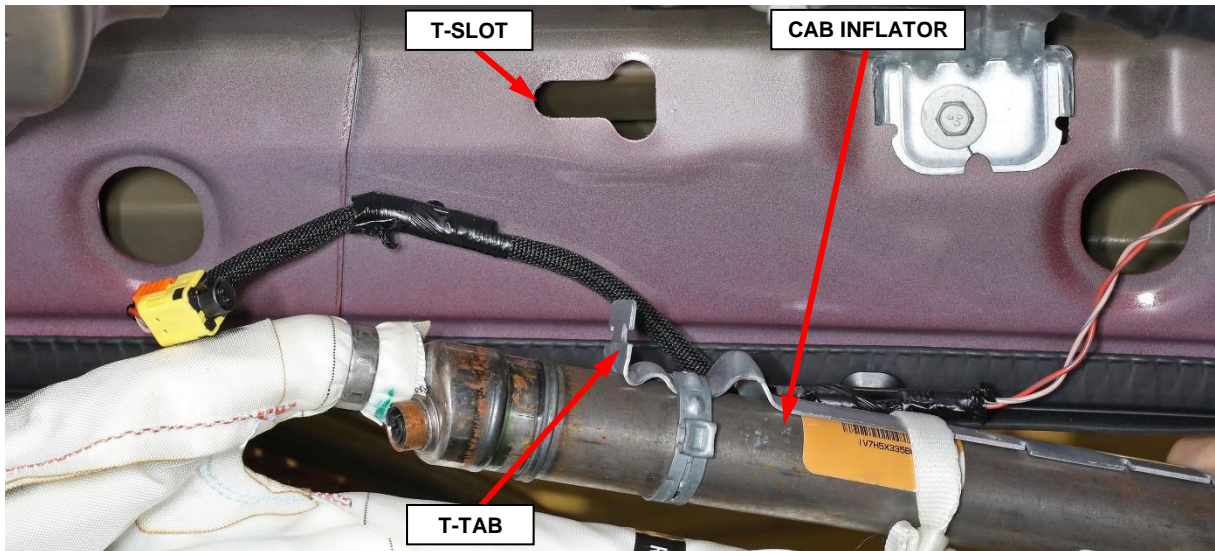
Figure 38 – CAB Inflator T-Tab and Inner Roof Rail T-Slot

32. Slide the inflator rearward far enough to disengage the T-tab at the front of the inflator bracket from the keyed T-slot in the inner roof rail over the rear door opening (Figure 38).

36. Insert the T-tab at the front of the inflator bracket into the keyed T-slot in the inner roof rail over the rear door opening and slide the inflator forward to engage it (Figure 38).
