N242481530 Adaptive Cruise Control May Not Stop Vehicle

Release Date: January 2025 Revision: 00

Condition	General Motors has decided that a defect which relates to motor vehicle safety exists in certain 2025 model year Chevrolet Equinox EV all-wheel drive vehicles. An incorrect software calibration in the brake control module prevents the vehicle's adaptive cruise control feature from braking the vehicle as designed. When adaptive cruise control is engaged and senses a need for deceleration, the vehicle may not brake to sufficiently slow or stop the vehicle. If adaptive cruise control is engaged and does not slow or stop the vehicle as expected, drivers might not timely or sufficiently brake the vehicle, increasing the risk of a crash.
Correction	Dealers will update the software calibration in the vehicles' brake system control module (BSCM) to correct the condition. Some unsold vehicles may receive this update via wireless over-the-air (OTA) technology.

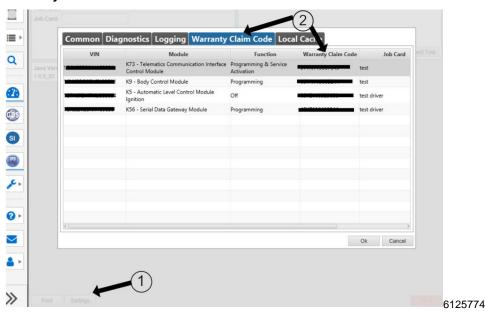
Warranty Claim Code Information Retrieval

If the Warranty Claim Code was not recorded on the Job Card, the code can be retrieved in the SPS2 system as follows:

- 1. Open TLC on the computer used to program the vehicle.
- 2. Select and start SPS2.
- 3. Select Settings (1).
- 4. Select the Warranty Claim Code tab (2).

The VIN, Warranty Claim Code and Date/Time will be listed on a roster of recent programming events. If the code is retrievable, dealers should resubmit the transaction making sure to include the code in the SPS Warranty Claim Code field.

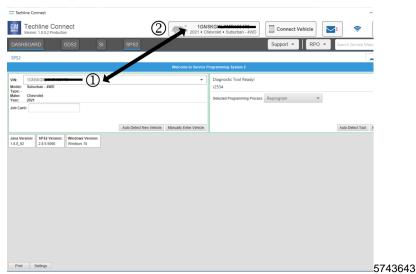
Caution: Be sure the VIN selected in the drop down menu (1) is the same as the vehicle connected (2) before beginning programming.

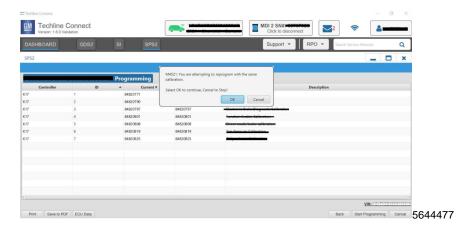
Important: If the vehicle VIN DOES NOT match, the message below will be shown.

Important: Techline Connect screens shown above.
