**ATTENTION:** Mercedes-Benz Dealer Principals, General Managers, Sales Managers, Service Managers & Parts Managers**Safety Recall Launch Notification**

**Update Battery Management  
System Software –  
Additional VINs****Campaign Details**

EQB SUV (243 platform)

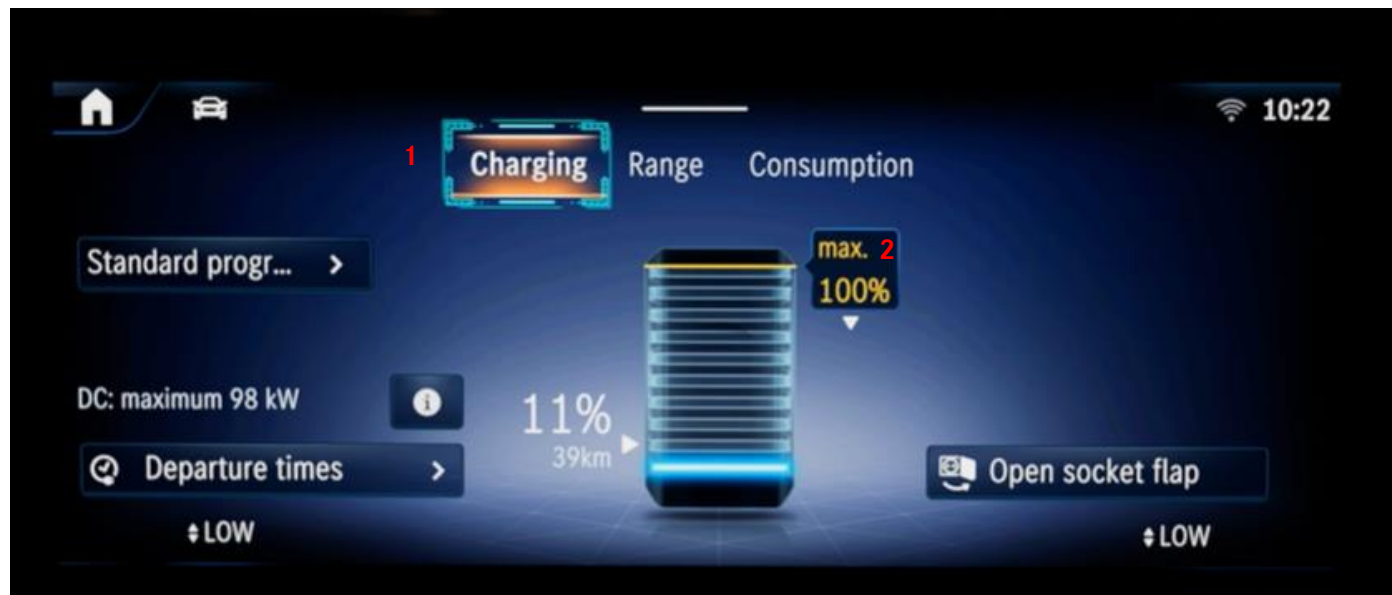
**HOW TO CHANGE STATE OF CHARGE (MBUX):**

- 1) On the multimedia system, select the “Home” icon, then “EQ”, to navigate to the “Charging” screen.
- 2) Tap and drag the “max. percentage” icon to the right of the battery state of charge display to read “max. 80%.”
  - a. NOTE: After software update, the Maximum Charge Level can be set to “max.100%”
