## Customer Legal Recall

### MAS004603 (CLR 25-01)

## Customer Legal Recall # 740 – U.S. MY21 - MY25 Ghibli, Quattroporte , Levante, Grecale, GT/GC, MC20 and MC20 Cielo – ETM SW UPDATE

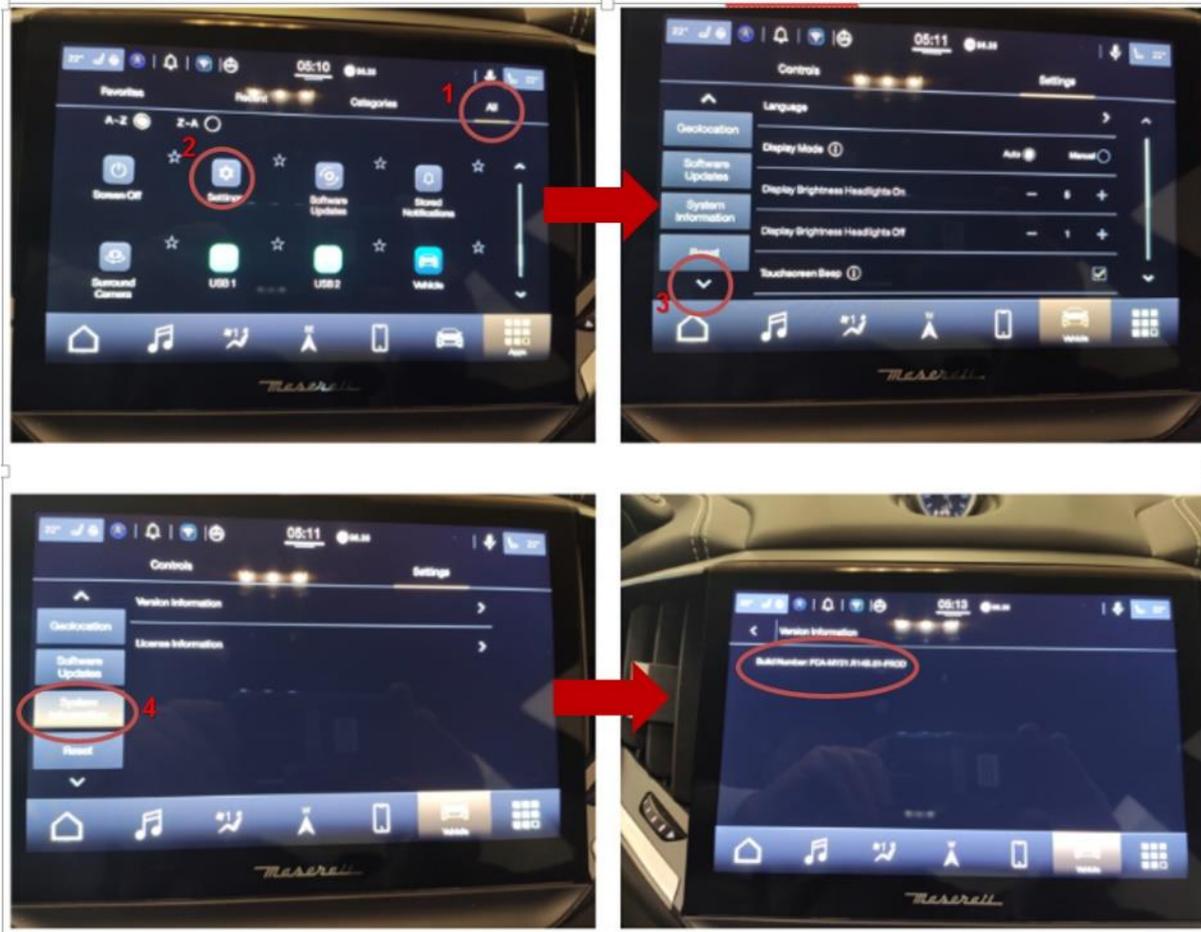
1. Check the actual software version on the vehicle:

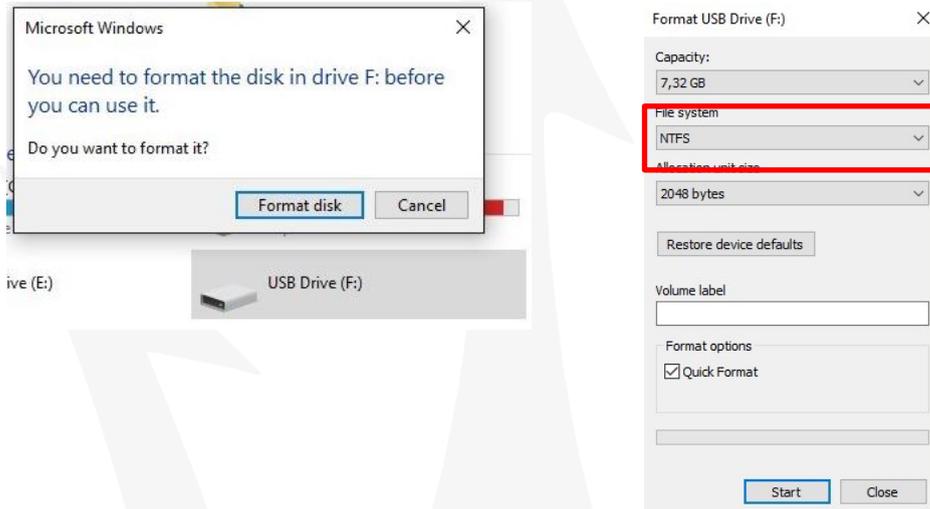
**STEP 1:** Take a fresh new USB FLASH DRIVE and format it to NTFS file system.

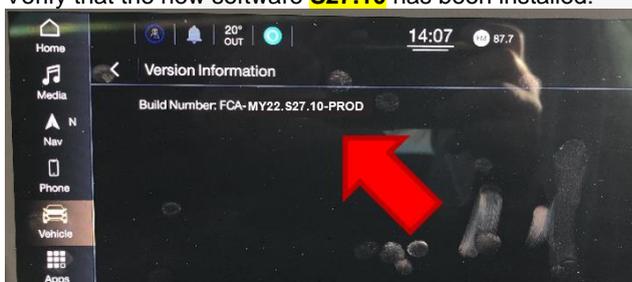
8. Verify that the new software **S27.10** has been installed:

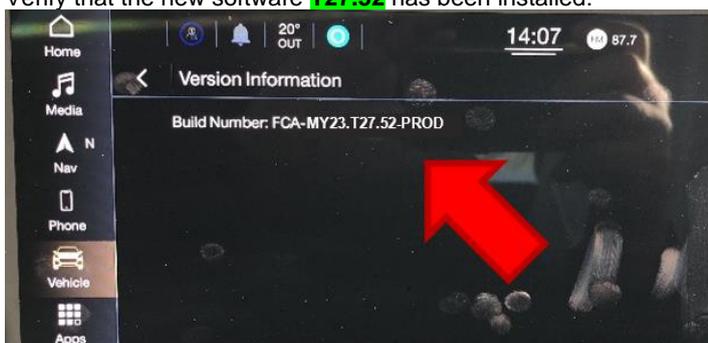
11. Use another USB FLASH DRIVE and format it to NTFS.
12. Copy the zip file to the USB FLASH DRIVE. (DO NOT UNZIP THE FILE!)
13. With the engine running, insert the USB FLASH DRIVE into the vehicle’s USB port.
14. A pop-up will appear on the radio display, press “Update Now” and “Continue”.
15. This step will take approx. 1 hour and 30 minutes without any action being carried out by the operator.
16. After the system reboots automatically, press “Accept” and remove the USB FLASH DRIVE from the vehicle.
17. Verify that the new software **T27.52** has been installed:

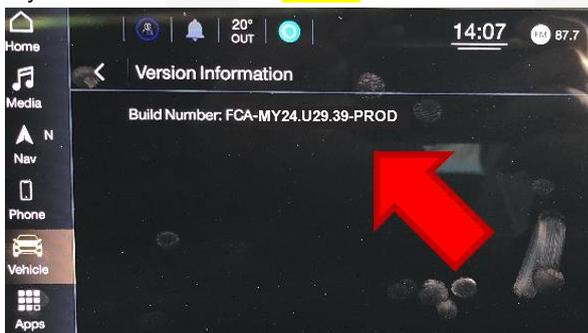
1. Download “R1\_U29.39\_M18X\_NAFTA\_NO\_NAV” from MODIS.
2. Format the USB FLASH DRIVE to NTFS file system.
3. Copy the zip file to the USB FLASH DRIVE. (DO NOT UNZIP THE FILE!)
4. With the engine running, insert the USB FLASH DRIVE into the vehicle’s USB port.
5. A pop-up will appear on the radio display, press “Update Now” and “Continue”.
6. This step will take approx. 30 minutes without any action being carried out by the operator.
7. After the reboot of the system, press “Accept” and remove the PEN Drive.
8. Verify that the new software **U29.39** has been installed:

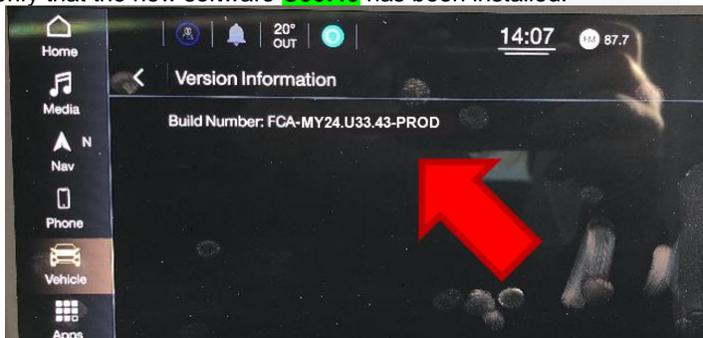
11. Use another USB FLASH DRIVE and format it to NTFS.
12. Copy the zip file to the USB FLASH DRIVE. (DO NOT UNZIP THE FILE!)
13. With the engine running, insert the USB FLASH DRIVE into the vehicle’s USB port.
14. A pop-up will appear on the radio display, press “Update Now” and “Continue”.
15. This step will take approx. 1 hour and 30 minutes without any action being carried out by the operator.
16. After the system reboots automatically, press “Accept” and remove the USB FLASH DRIVE from the vehicle.
17. Verify that the new software **U33.43** has been installed:

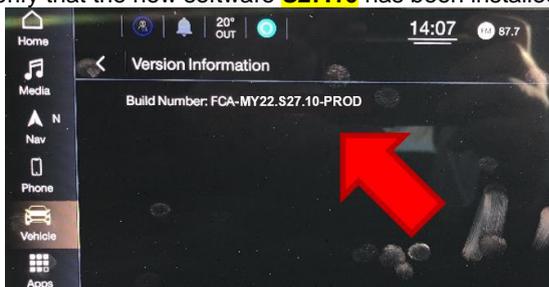
1. Download “R1\_S27.10\_M240\_NAFTA\_NO\_NAV” from MODIS.
2. Format the USB FLASH DRIVE to NTFS file system.
3. Copy the zip file to the USB FLASH DRIVE. (DO NOT UNZIP THE FILE!)
4. With the engine running, insert the USB FLASH DRIVE into the vehicle’s USB port.
5. A pop-up will appear on the radio display, press “Update Now” and “Continue”.
6. This step will take approx. 30 minutes without any action being carried out by the operator.
7. After the reboot of the system, press “Accept” and remove the PEN Drive.
8. Verify that the new software **S27.10** has been installed:

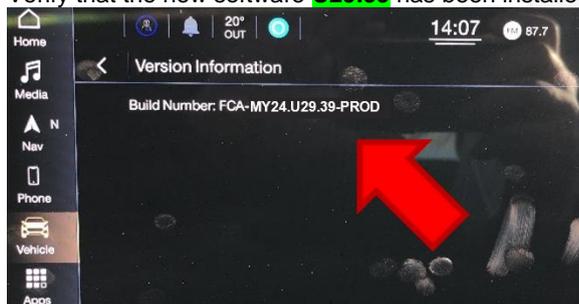
11. Use another USB FLASH DRIVE and format it to NTFS.
12. Copy the zip file to the USB FLASH DRIVE. (DO NOT UNZIP THE FILE!)
13. With the engine running, insert the USB FLASH DRIVE into the vehicle’s USB port.
14. A pop-up will appear on the radio display, press “Update Now” and “Continue”.
15. This step will take approx. 30 minutes without any action being carried out by the operator.
16. After the system reboots automatically, press “Accept” and remove the USB FLASH DRIVE from the vehicle.
17. Verify that the new software **U29.39** has been installed:

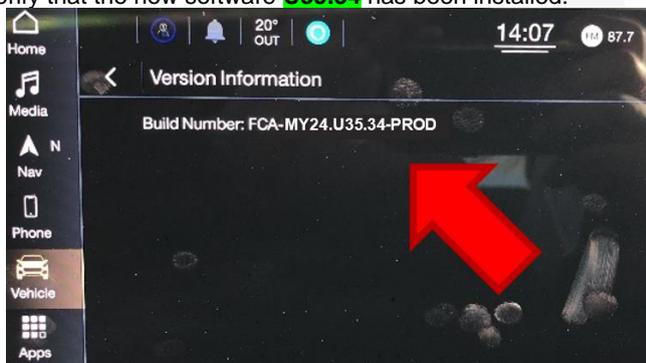
26. Verify that the new software **U35.34** has been installed:

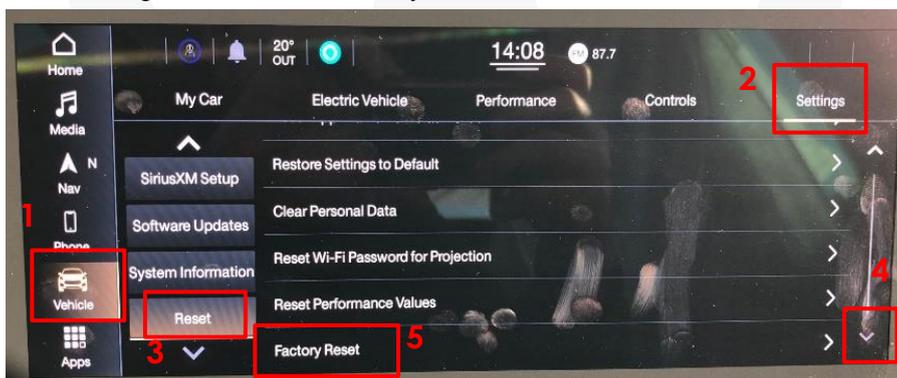
1. Select “Vehicle” > “Settings” > “Reset” > “Factory Reset”:

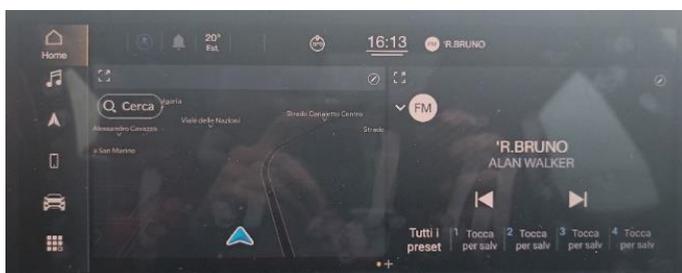
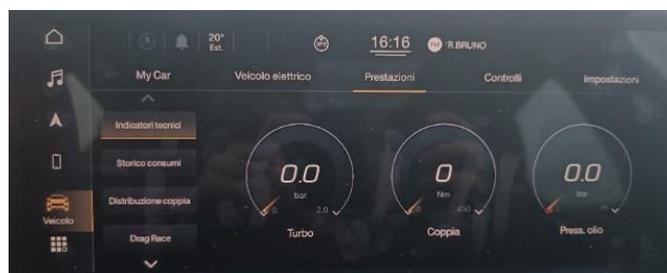
5. Check configuration and ensure that all widgets and screens have the correct theme according to the following slides (No Blue theming should be visible).
