GROUP	MODEL
Safety Recall Campaign	2021-2023MY Soul (SK3) <u>and</u> Seltos (SP2) w/2.0L Nu MPI Engine
NUMBER	DATE
SC336 (Rev 3, 05/07/2025)	April 2025

ENGINE INSPECTION/REPLACEMENT AND ECM LOGIC IMPROVEMENT (SC336)

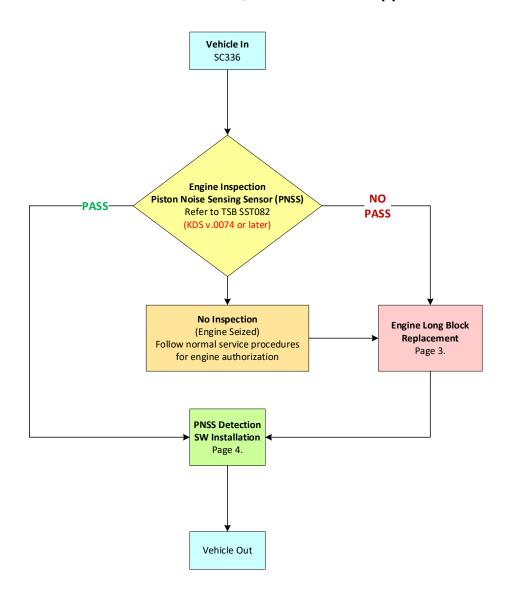
Flowchart:

Ensure that the latest KDS Tablet Software Version is NNK-02-0074 or later. If the software version is not the latest, contact GITA Support at: 888-542-4371.

DO NOT install the PNSS Detection Software <u>BEFORE</u> performing the Engine Inspection (Piston Noise Sensing Sensor)

Depending on the PNSS test result, an engine long block replacement may be required. <u>Be</u> sure to follow the flowchart outlined on page 2.

- Pass: PNSS Inspection complete + Install the PNSS SW (page 4).
- No Pass: PNSS Inspection complete + Engine R&R (see instructions below) + Install the PNSS SW (page 4) after engine replacement is completed.
