GROUP	MODEL
Safety Recall Campaign	2021-2023MY Soul (SK3) and Seltos (SP2) w/2.0L Nu MPI Engine
NUMBER	DATE
SC336 (Rev 1, 04/11/2025)	April 2025

### ENGINE INSPECTION/REPLACEMENT AND ECM LOGIC IMPROVEMENT (SC336)

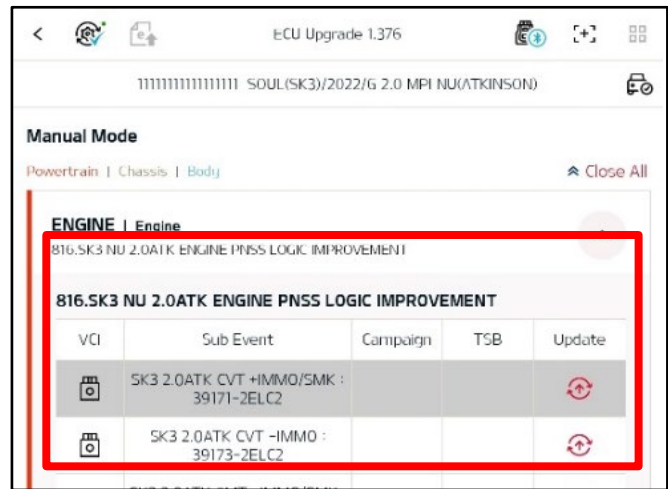
Verify the affected vehicle Calibration Identification of the applicable ECU ROM ID and reference the Information Table on page 5 as necessary.
