GROUP	MODEL
Safety Recall Campaign	2021-2023MY Soul (SK3) <u>and</u> Seltos (SP2) w/2.0L Nu MPI Engine
NUMBER	DATE
SC336 (Rev 5, 09/04/2025)	April 2025

SAFETY RECALL CAMPAIGN

ENGINE INSPECTION/REPLACEMENT AND ECM LOGIC IMPROVEMENT (SC336)

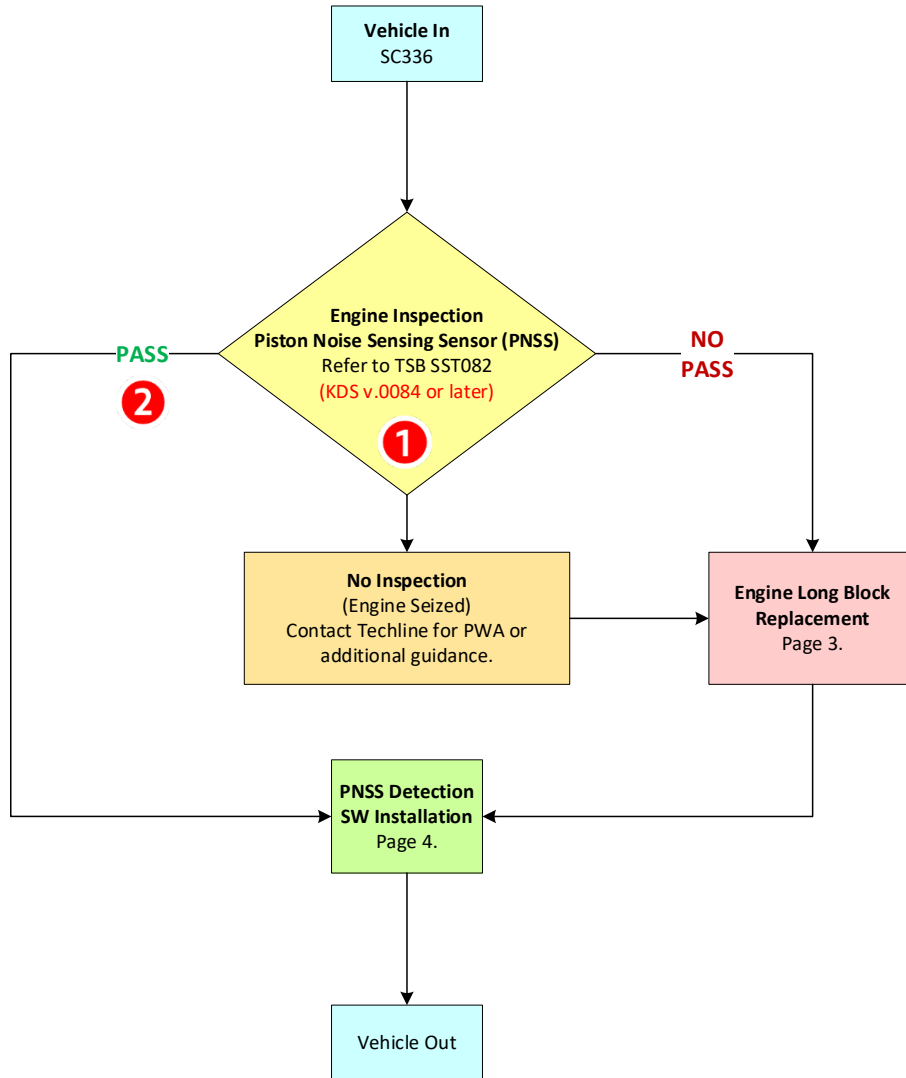
Flowchart:

Ensure that the latest KDS Tablet Software Version is NNK-02-0084 or later.

DO NOT install the PNSS Detection Software BEFORE performing the Engine Inspection (Piston Noise Sensing Sensor)

Depending on the PNSS test result, an engine long block replacement may be required. [Be sure to follow the flowchart outlined on page 2.](#)

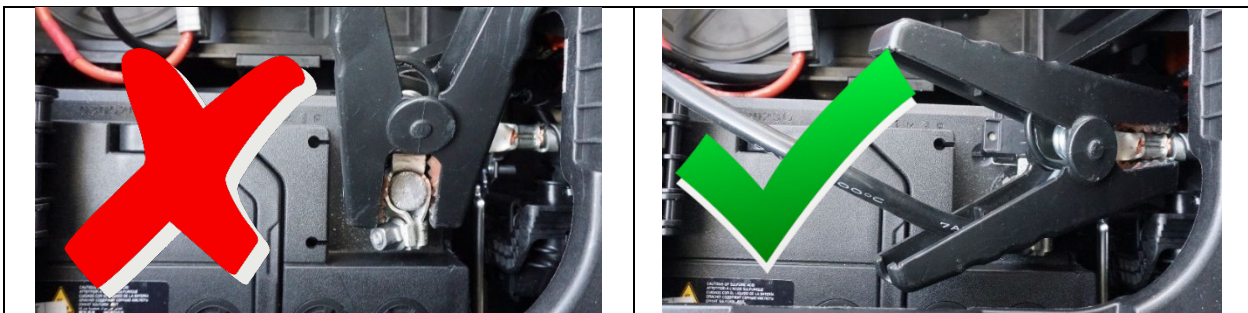
[Connect the negative \(-\) terminal to the battery as shown below.](#)

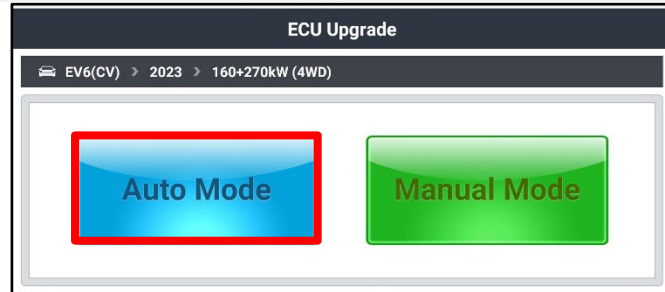
The required software must be installed by selecting the **'Auto Mode'** ECU Upgrade option.

Note: In some case, the 'Manual Mode' installation option may be required **ONLY** if the 'Auto Mode' function fails or is otherwise noted above.
