GROUP	MODEL
Safety Recall Campaign	2021-2023MY Soul (SK3) and Seltos (SP2) w/2.0L Nu MPI Engine
NUMBER	DATE
SC336 (Rev 2, 04/29/2025)	April 2025

### ENGINE INSPECTION/REPLACEMENT AND ECM LOGIC IMPROVEMENT (SC336)

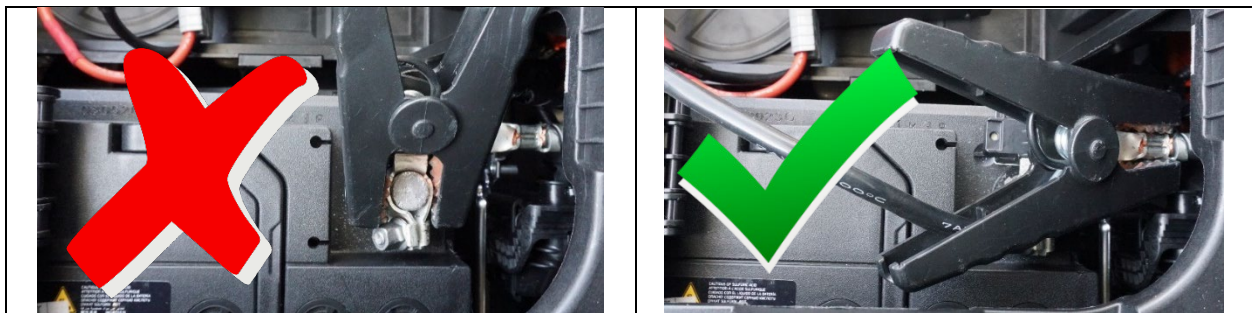
[Connect the negative \(-\) terminal to the battery as shown below.](#)

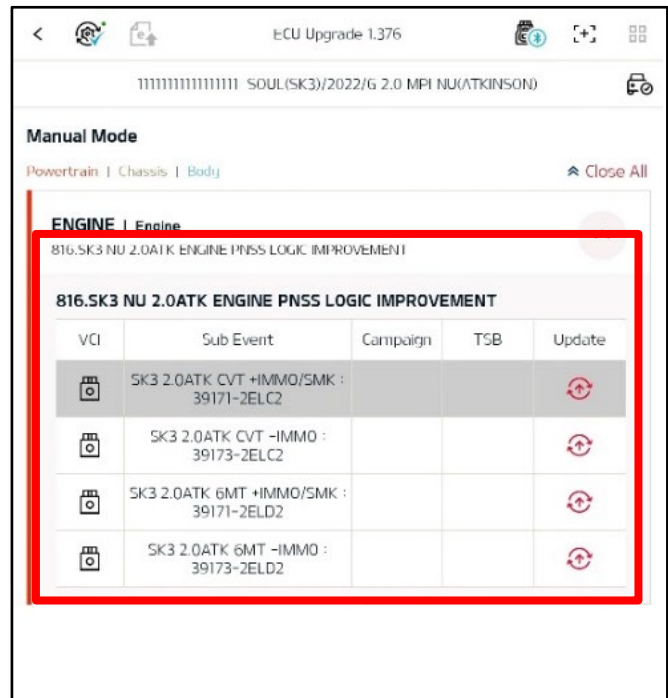
Verify the affected vehicle Calibration Identification of the applicable ECU ROM ID and reference the Information Table on page 5 as necessary.
