| GROUP | MODEL |
|---|---|
| Safety Recall Campaign | 2021-2023MY Soul (SK3) <u>and</u> Seltos (SP2) w/2.0L Nu MPI Engine |
| SC336 | April 2025 |

### ENGINE INSPECTION/REPLACEMENT AND ECM LOGIC IMPROVEMENT (SC336)

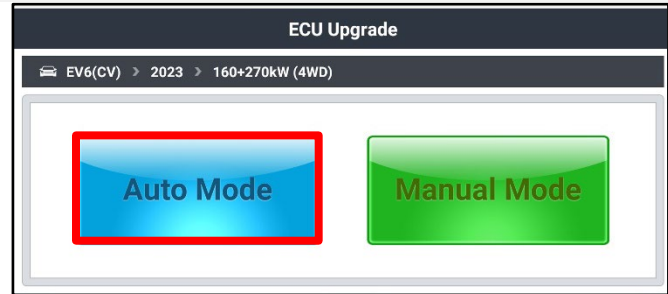
The required software must be installed by selecting the **'Auto Mode'** ECU Upgrade option.

**Note:** In some case, the 'Manual Mode' installation option may be required **ONLY** if the 'Auto Mode' function fails or is otherwise noted above.
