## Technical Service Bulletin

<b>GROUP</b>	<b>NUMBER</b>
<b>RECALL</b>	<b>25-01-007G-4</b>
<b>DATE</b>	<b>MODEL(S)</b>
<b>AUGUST 2025</b>	<b>SEE BELOW</b>

**SUBJECT:** INSTRUMENT CLUSTER LOGIC UNIT (CLU) SOFTWARE INSPECTION & UPDATE (RECALL 026G)

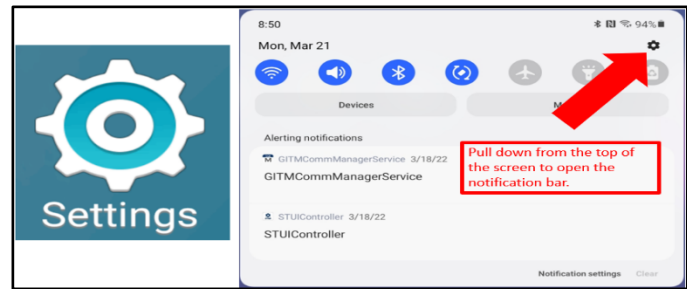
- 1. Swipe down from the top of the tablet screen to open the notification panel, then select the **Settings** icon.

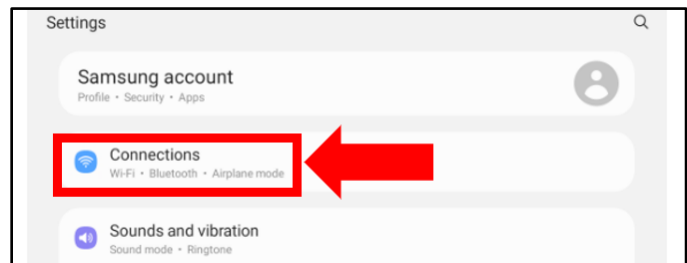
- 2. Select **Connections**.

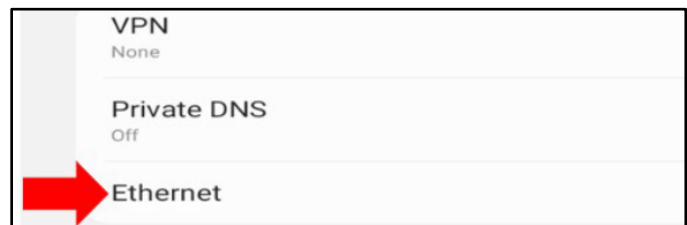
- 4. Select **Ethernet**.

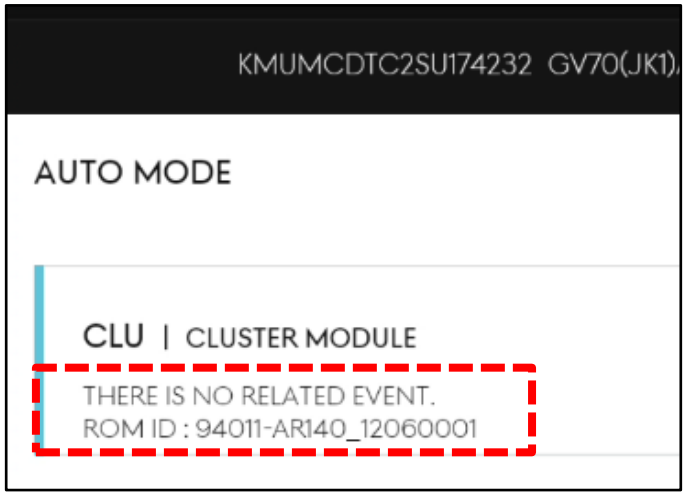
1. Check the Instrument Cluster ROM ID:
  - If the screen states **THERE IS NO RELATED EVENT** and the ROM ID is **NOT** listed on **page 4**, then do **NOT** perform a software update and proceed to **step 2**.
  - If Auto Update is available, then proceed to the **ECU Update Procedure**.

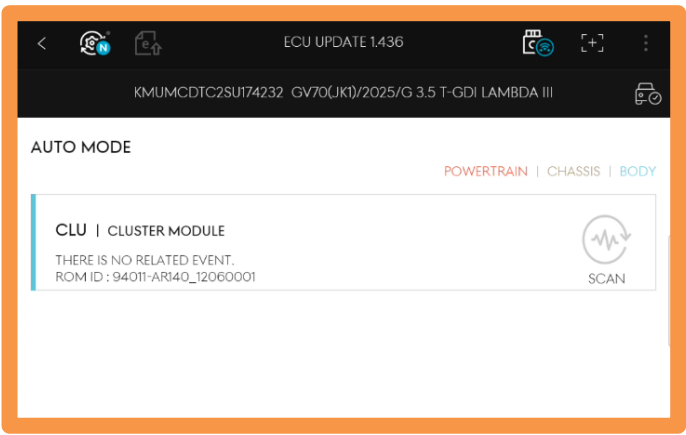
**Take a screenshot of the ROM ID with the message “THERE IS NO RELATED EVENT” using your tablet and upload to STUI.**

This TSB includes Repair validation photos. A photo capture of the ECU Update "Success" screen as outlined in the Digital Documentation Policy must be provided if the cluster requires an update. In the case that the ROM ID is not applicable for an update, a photo of the vehicle's existing ROM ID must be captured.

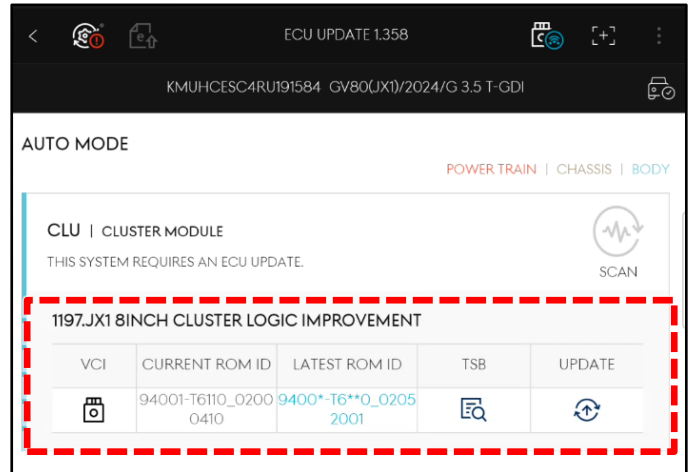
- Select the **CLU** system to scan the vehicle's current ROM ID.

Check the current ROM ID version and compare it to the ROM ID Information table before attempting to perform the software update.

If the update fails, remove the power connector from the in-cabin fuse box for at least **5 seconds**. Alternatively, disconnect the negative (-) **12V** battery terminal, wait at least **5 seconds**. Reassemble and retry the update.
