Technical Service Bulletin

GROUP	NUMBER
RECALL	25-01-007G-2
DATE	MODEL(S)
FEBRUARY 2025	SEE BELOW

SUBJECT: INSTRUMENT CLUSTER LOGIC UNIT (CLU) SOFTWARE UPDATE
(RECALL 026G)

This bulletin provides instructions to update the instrument panel (IP) cluster display software.

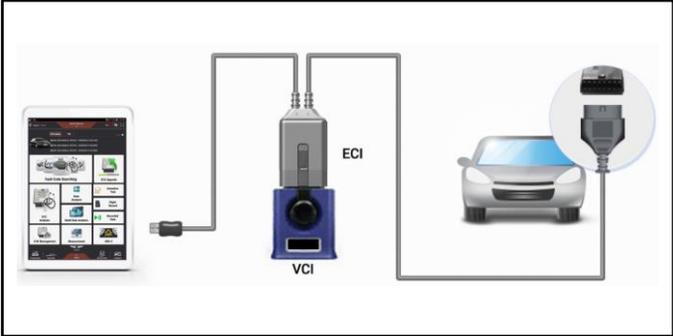
1. Connect the Ethernet Communication Interface (ECI) DLC cable to the OBD connector of the vehicle.
2. Connect the VCI 2 DLC cable to the ECI.
3. Select the appropriate tablet cable (type C, 5-pin) to the ECI.
4. Connect the cable to the tablet PC.

The connection between the VCI 2 and tablet PC is wireless, whereas the tablet PC is connected to the vehicle through the ECI (Ethernet Adapter).

If using the VCI 3, the ECI is **NOT** needed. Connect the tablet directly to the VCI 3 using the USB-C to 19 Pin Cable supplied in the VCI 3 Kit.

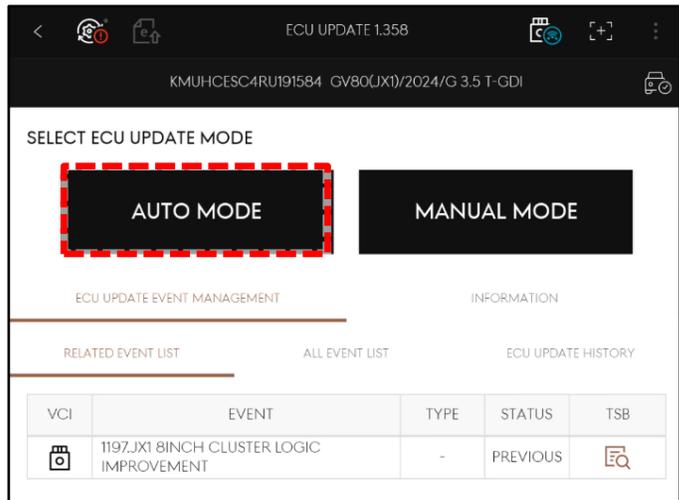
2. Perform the ECU update in **Auto Mode**.

Use the **ID Check** to verify the ROM ID before updating the software.

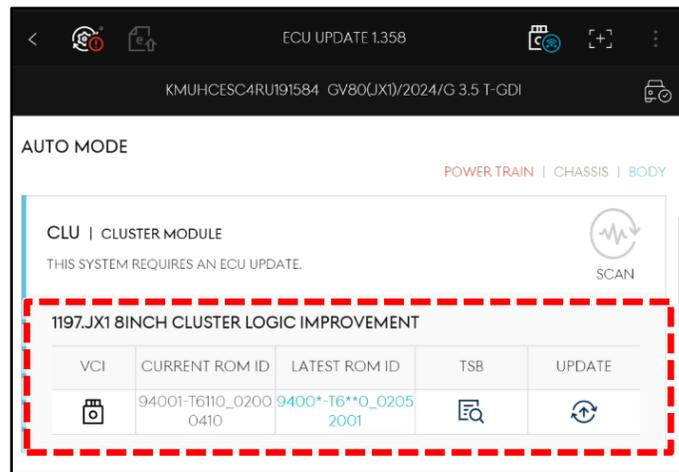
3. Select the **CLU** system to scan the vehicle’s current ROM ID.

Check the current ROM ID version and compare it to the ROM ID Information table before attempting to perform the software update.

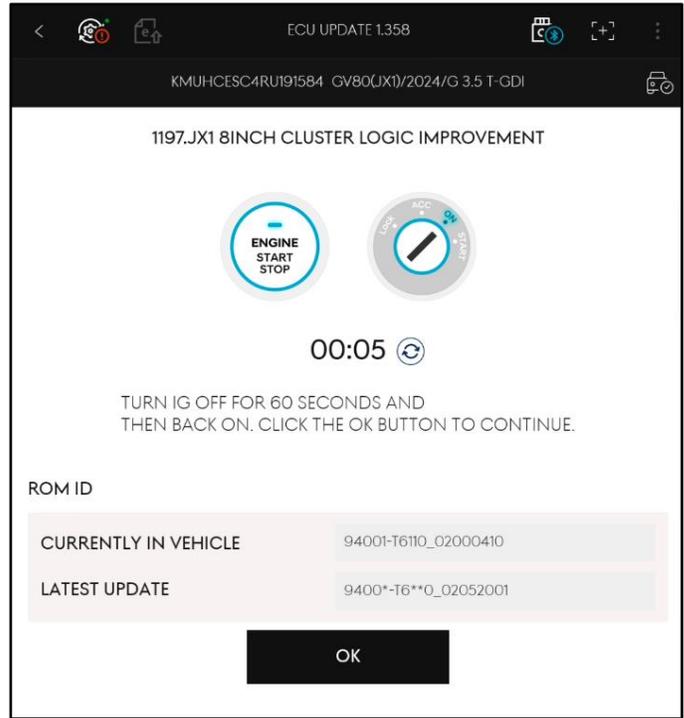
- After the ECU update process shows **100%** complete, follow the prompts on the screen to cycle the ignition **OFF** for **60 seconds**.

Use the **Refresh** button to reset the timer.

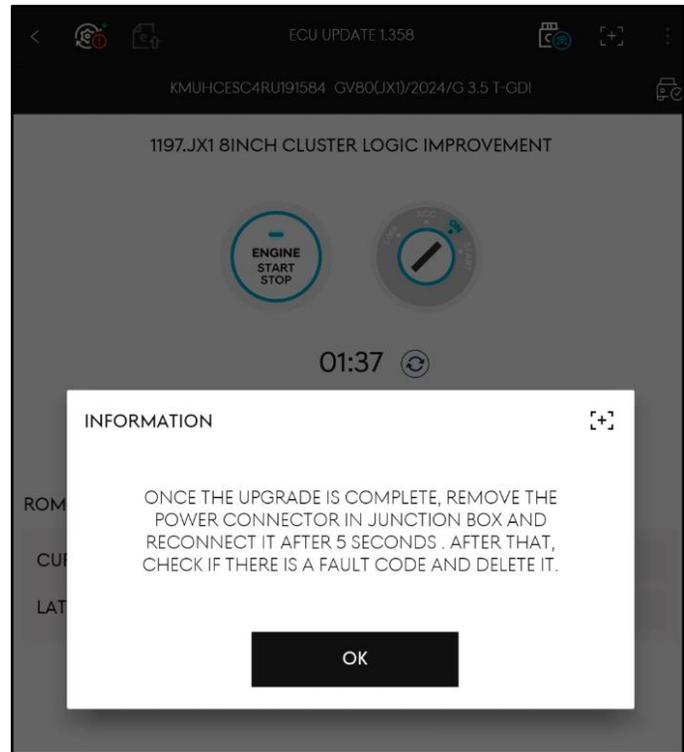
- Perform the prompted procedure after the software update is completed.

Software update is completed when the **“SUCCESS”** screen is displayed on the GDS.

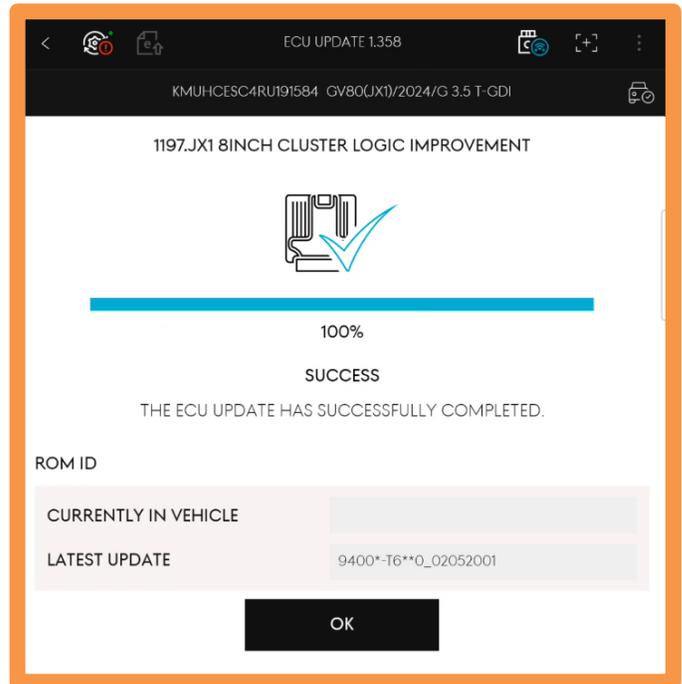
Take a screenshot of the ECU update complete screen using your tablet and upload to STUI.

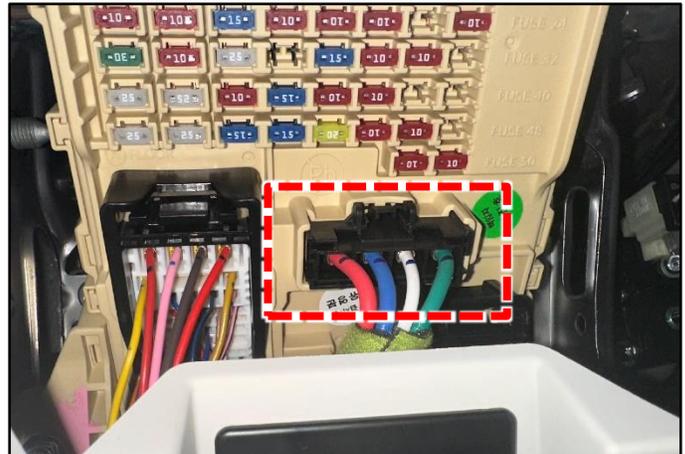
7. Remove the power connector of the indoor fuse box and reconnect after **5 seconds**.

If the update fails, please remove the power connector or the battery (–) connector from the indoor fuse box for at least **5 seconds** and reassemble it to retry the update.
