## Technical Service Bulletin

<b>GROUP</b>	<b>NUMBER</b>
<b>RECALL</b>	<b>25-01-007G-3</b>
<b>DATE</b>	<b>MODEL(S)</b>
<b>APRIL 2025</b>	<b>SEE BELOW</b>

**SUBJECT:** INSTRUMENT CLUSTER LOGIC UNIT (CLU) SOFTWARE UPDATE  
(RECALL 026G)

This bulletin provides instructions to update the instrument panel (IP) cluster display software.

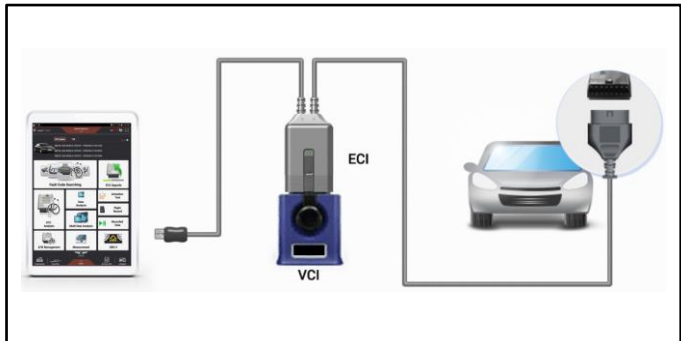
1. Connect the Ethernet Communication Interface (ECI) DLC cable to the OBD connector of the vehicle.
2. Connect the VCI 2 DLC cable to the ECI.
3. Select the appropriate tablet cable (type C, 5-pin) to the ECI.
4. Connect the cable to the tablet PC.

The connection between the VCI 2 and tablet PC is wireless, whereas the tablet PC is connected to the vehicle through the ECI (Ethernet Adapter).

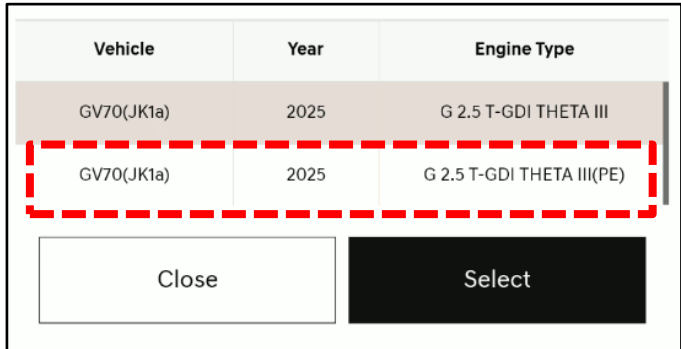
- 1.

The 2025 GV 70 (JK1/JK1A) may have an engine choice option. Select the (PE) engine option. Otherwise, a message “There Is No Related Event” will appear.

If the wrong engine was selected, then return to the Menu to select the PE engine.

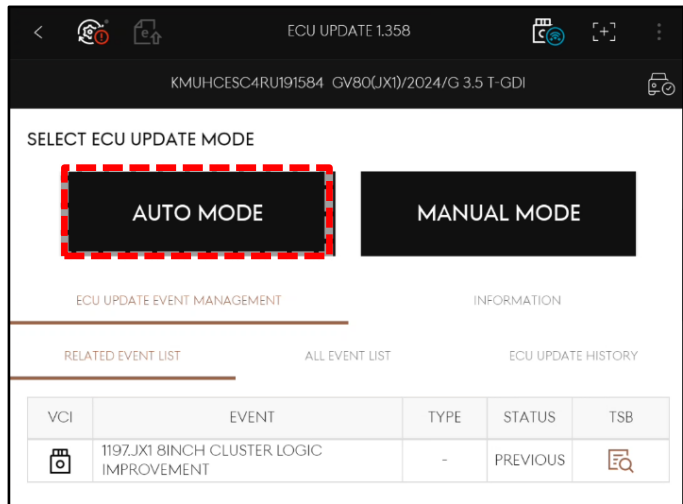
2. Perform the ECU update in **Auto Mode**.

Use the **ID Check** to verify the ROM ID before updating the software.

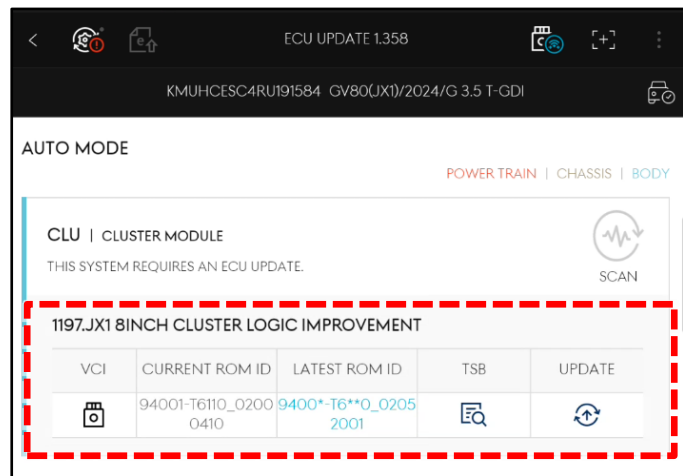
3. Select the **CLU** system to scan the vehicle’s current ROM ID.

Check the current ROM ID version and compare it to the ROM ID Information table before attempting to perform the software update.

If the update fails, please remove the power connector or the battery (–) connector from the indoor fuse box for at least **5 seconds** and reassemble it to retry the update.

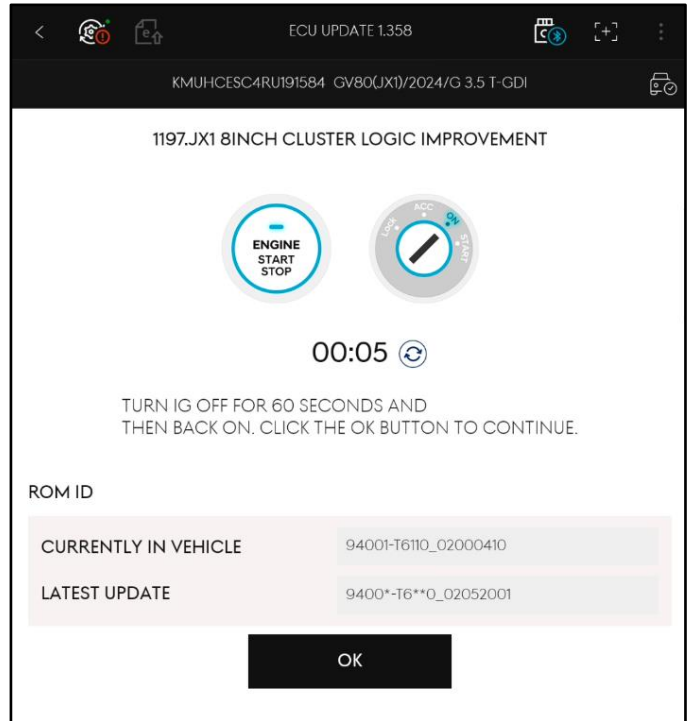
- After the ECU update process shows **100%** complete, follow the prompts on the screen to cycle the ignition **OFF** for **60 seconds**.

Use the **Refresh** button to reset the timer.

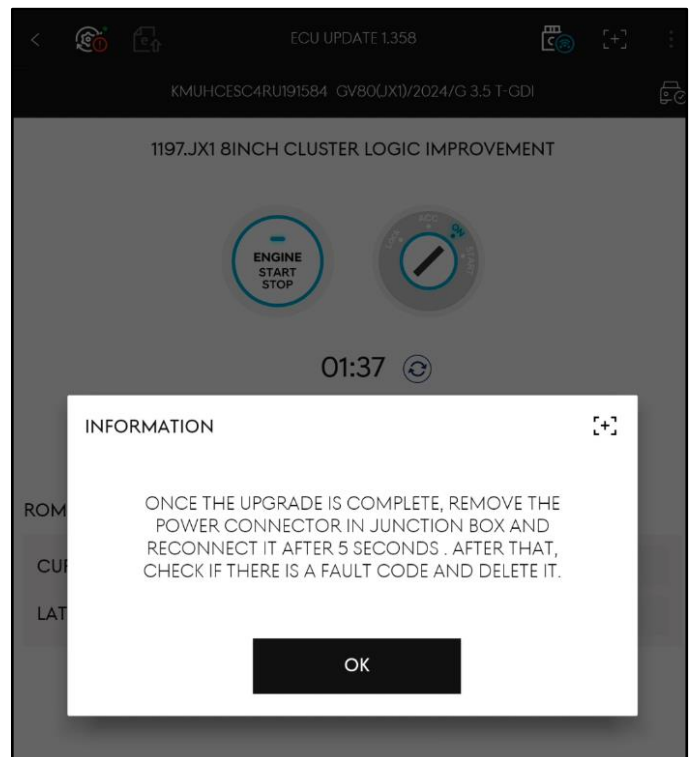
- Perform the prompted procedure after the software update is completed.

Software update is completed when the **“SUCCESS”** screen is displayed on the GDS.

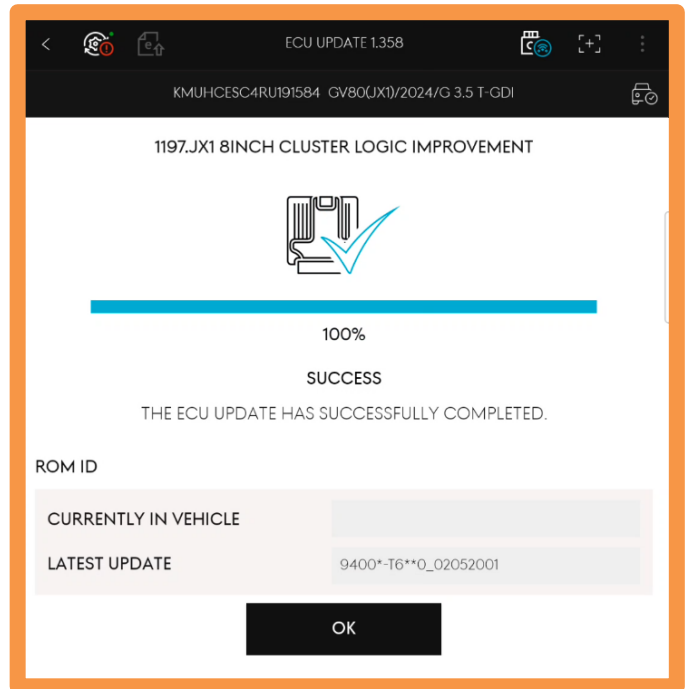
6.

Take a screenshot of the ECU update complete screen using your tablet and upload to STUI.

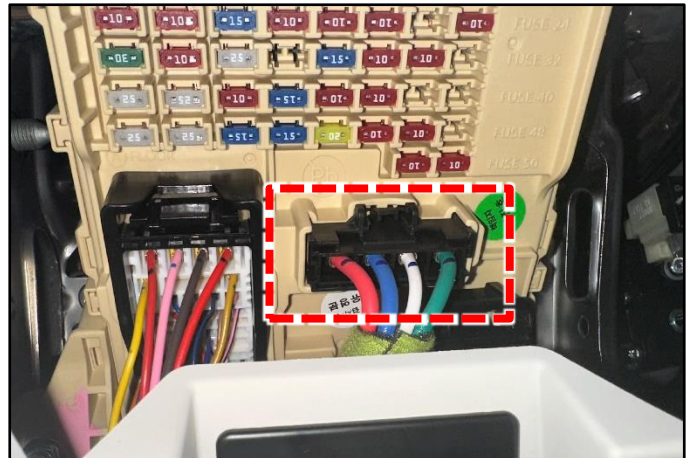
7. Remove the power connector of the indoor fuse box and reconnect after **5 seconds**.
