Safety Recall

Code: 90VC

Subject Instrument Cluster (Virtual Cockpit) Software

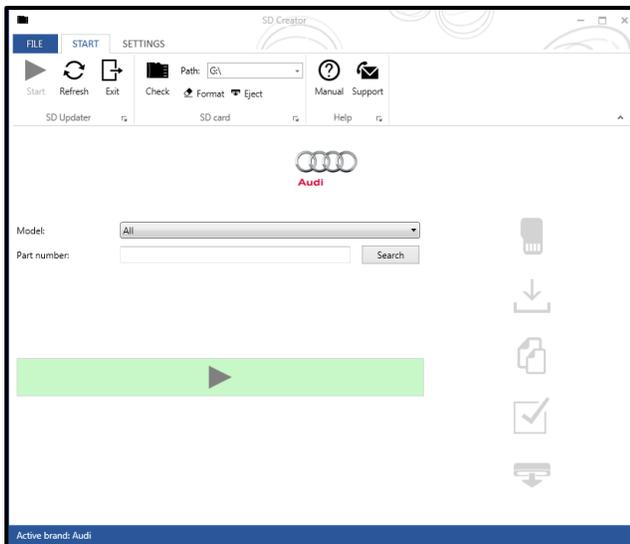
Required USB Drive

- The required software will have to be downloaded onto a USB drive using the SD Creator program or Flash Media Center.

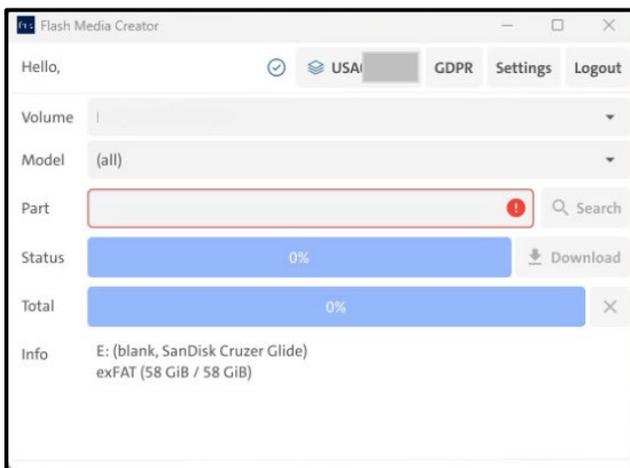
- Reference the latest version of TSB 2047812 (USA), for additional information on the use of the SD Creator program.
- Minimum size of USB drive = 4 GB
- Do not use USB drives over 32GB. If a USB drive larger than 32GB is used, the vehicle may not load the software update.**
