Compliance Recall

Code: 916C

Subject	Rearview Camera Software																								
Document History	<table border="1"> <thead> <tr> <th style="background-color: #c00000; color: white;">Date</th> <th colspan="4" style="background-color: #c00000; color: white;">Summary</th> </tr> </thead> <tbody> <tr> <td>05/08/2025</td> <td colspan="4">Original publication</td> </tr> </tbody> </table>					Date	Summary				05/08/2025	Original publication													
Date	Summary																								
05/08/2025	Original publication																								
Affected Vehicles	<table border="1"> <thead> <tr> <th style="background-color: #c00000; color: white;">Country</th> <th style="background-color: #c00000; color: white;">Beginning Model Year</th> <th style="background-color: #c00000; color: white;">Ending Model Year</th> <th style="background-color: #c00000; color: white;">Vehicle</th> <th style="background-color: #c00000; color: white;">Vehicle Count</th> </tr> </thead> <tbody> <tr> <td>USA</td> <td>2025</td> <td>2025</td> <td>Q6</td> <td>96</td> </tr> <tr> <td>USA</td> <td>2025</td> <td>2025</td> <td>SQ6</td> <td>2</td> </tr> <tr> <td>CAN</td> <td>2025</td> <td>2025</td> <td>Q6</td> <td>19</

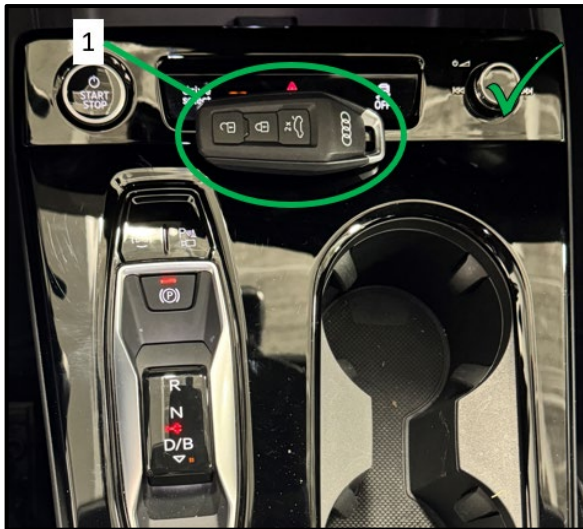
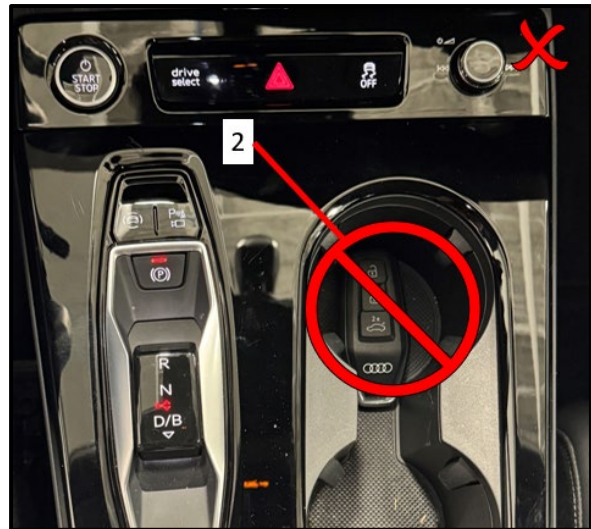
Only one vehicle key is permitted inside the vehicle during the software update. The key must be positioned on the hazard warning light switch <1> and not in the cupholder <2>.

- See Appendix A for specific HMI paths.
- Only one vehicle key is permitted inside the vehicle during the software update. The key must be positioned on the hazard warning light switch and not in the cupholder.

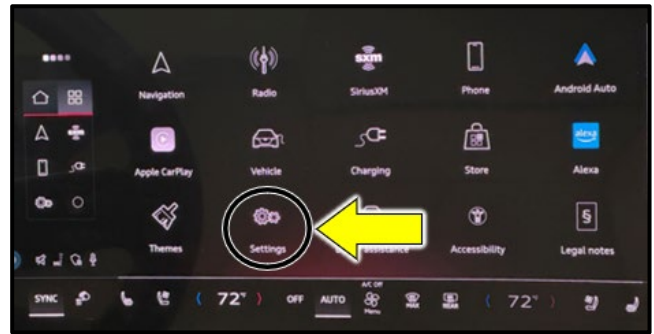
- Select the “Settings” icon <arrow> from the home screen menu.

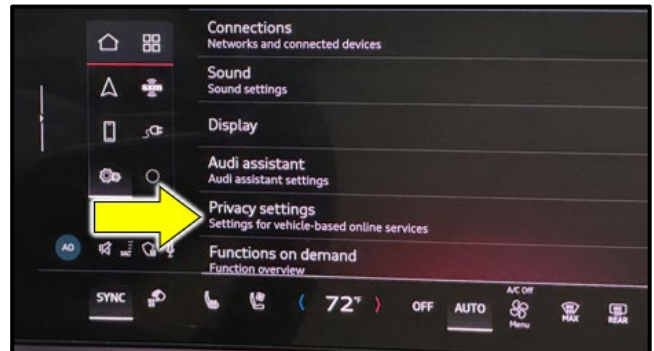
- Select “Privacy settings” <arrow>.

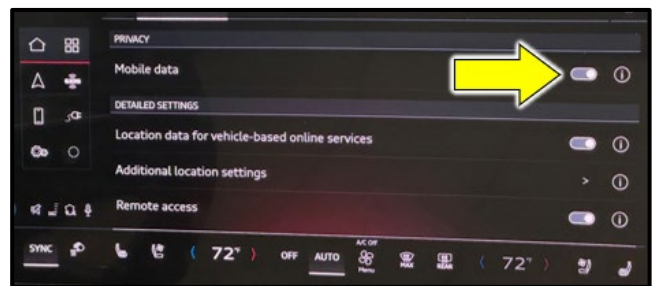
- Turn Mobile data off using the slider <arrow>.

The slider pictured <arrow> is in the “on” position.

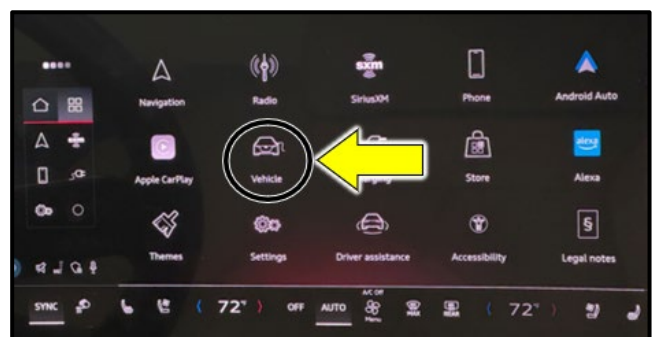
- Select the “Vehicle” icon <arrow> from the home screen menu.

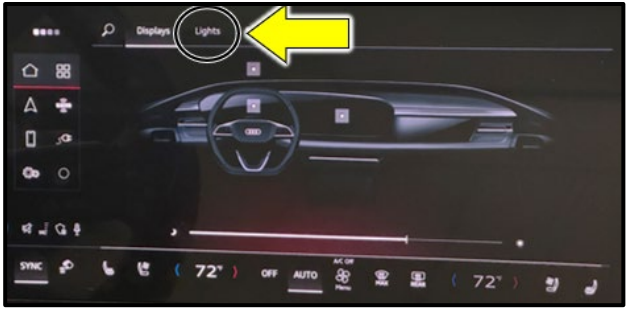
<ul style="list-style-type: none"> • Select “Lights” <arrow>.

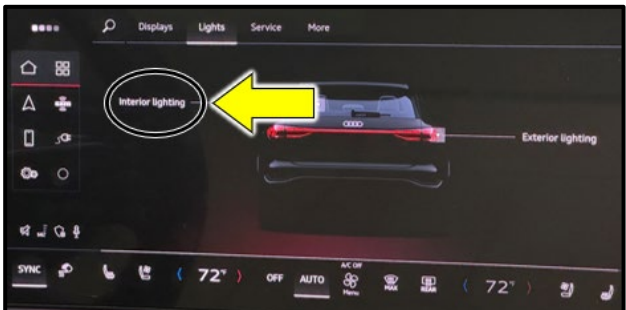
<ul style="list-style-type: none"> • Select “Interior lighting” <arrow>.

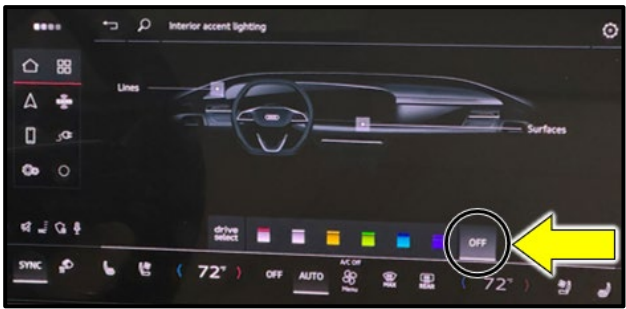
<ul style="list-style-type: none"> • Turn the background lighting off by using the “OFF” button <arrow>.

Irreparable damage may occur if the background lighting (if equipped) is not deactivated prior to starting the software update.

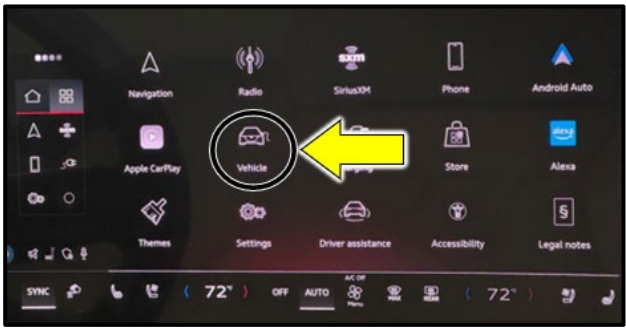
<p>Storing TPMS settings:</p> <ul style="list-style-type: none"> • Select the “Vehicle” icon <arrow> from the home screen menu.

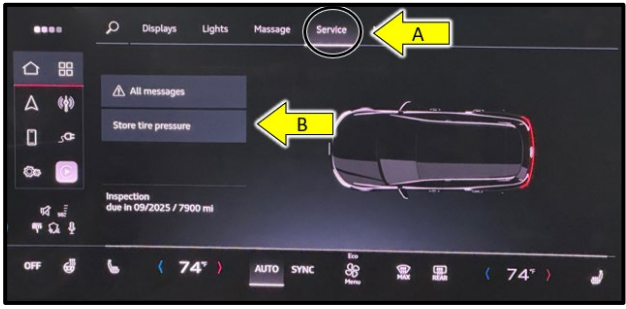
<ul style="list-style-type: none"> • Select “Service” <arrow A> • Select “Store tire pressure” <arrow B>

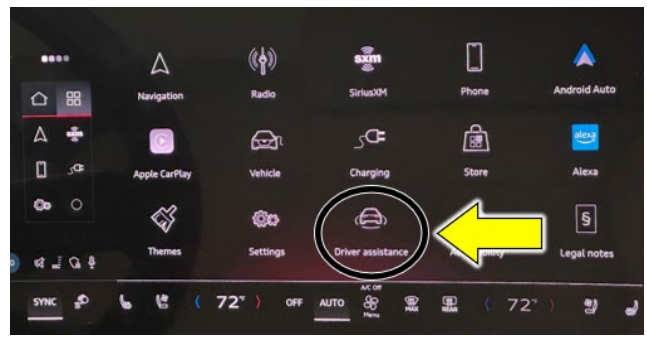
- Select the “Driver assistance” icon <arrow> from the home screen menu.

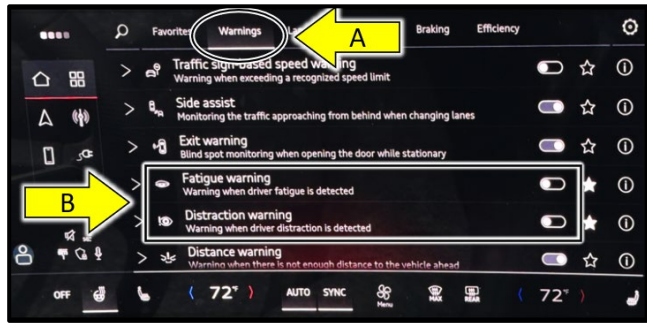
- Select the “Warnings” tab <arrow A>.
- Turn on the “Fatigue warning” and “Distraction warning” <arrow B> using the sliders.

- *Home screen menu > Vehicle > Driver Assistance > Warnings > Fatigue warning.*
 - *Home screen menu > Vehicle > Driver Assistance > Warnings > Distraction warning.*

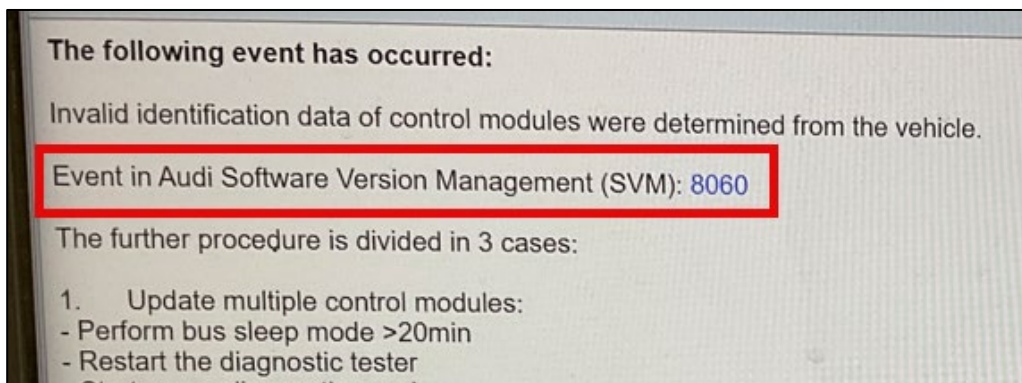
Example of error message:

If an error occurs and code 8060 or 8096 is displayed, and NO specific control module is mentioned in the error description:

- Remove the fuse for the module mentioned for 10 seconds, then reinstall the fuse.
- Perform a 15-20 minute bus sleep and then reattempt the flash.
