Compliance Recall

Code: 90A2

Subject	Instrument Cluster ABS-Brake Telltale			
Document History	Date	Summary		
	06/06/2025	Original publication		
Affected Vehicles	Country	Beginning Model Year	Ending Model Year	Vehicle
	USA	2025	2025	ID. BUZZ
	CAN	2025	2025	ID. BUZZ
	<p>Vehicle Count</p> <p>5,637</p> <p>771</p>			
	<p><i>Check Campaigns/Actions screen in ELSA on the day of repair to verify that a VIN qualifies for repair under this action. ELSA is the <u>only</u> valid campaign inquiry & verification source.</i></p> <ul style="list-style-type: none"> ✓ Campaign status must show "open." ✓ If ELSA shows other open action(s), inform your customer so that the work can also be completed at the same time the vehicle is in the workshop for this campaign. 			
USA	<p>Government regulations require that either the common word "BRAKE" or other prescribed, specific icons are shown in text form for brake system malfunctions. It is possible that certain vehicles included in this recall do not have the correct data container to fulfill the regulatory requirement. Telltales that do not provide the prescribed warning according to regulations may cause driver confusion and, consequently lead to the

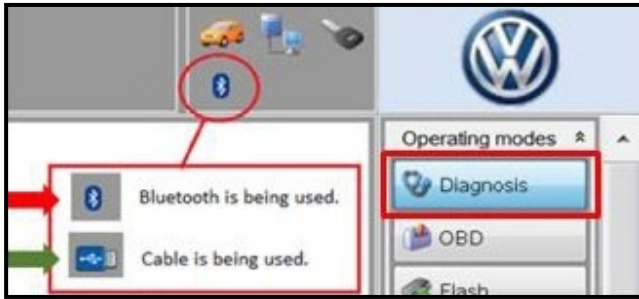
- Connect the diagnostic head to the vehicle.
- Confirm that scan tool is communicating with the diagnostic head by USB <Green Arrow>.
- If the Bluetooth symbol is shown <Red Arrow> then disconnect the diagnostic head from the vehicle and reconnect the USB cable to the diagnostic head and then reattach to the vehicle.
- Upon ODIS startup, verify the “Diagnosis” operating mode is selected <as shown>.

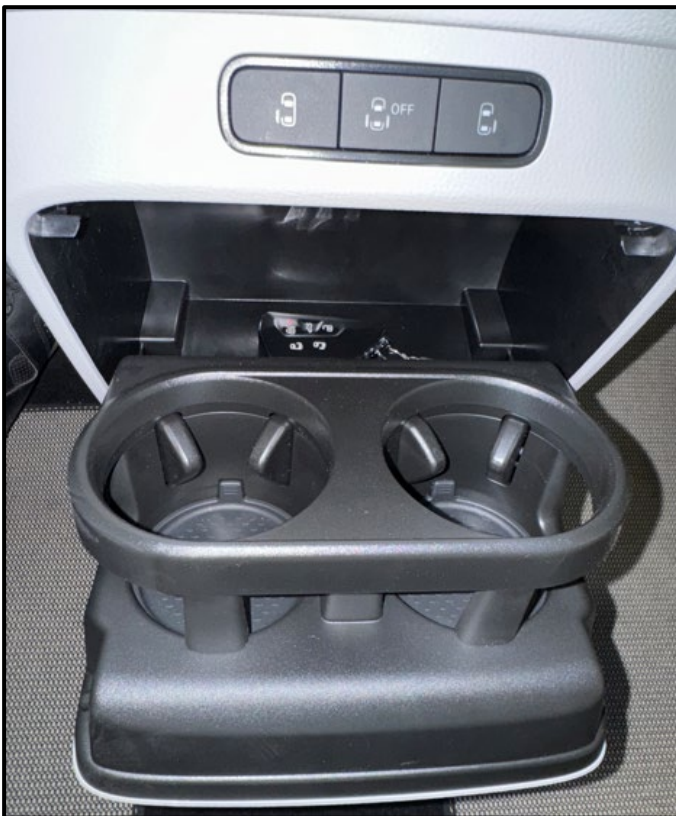
- Place the vehicle key over the reader coil in the cup holder area as shown.
- Any additional keys must be a minimum of 20 meters away from the vehicle.

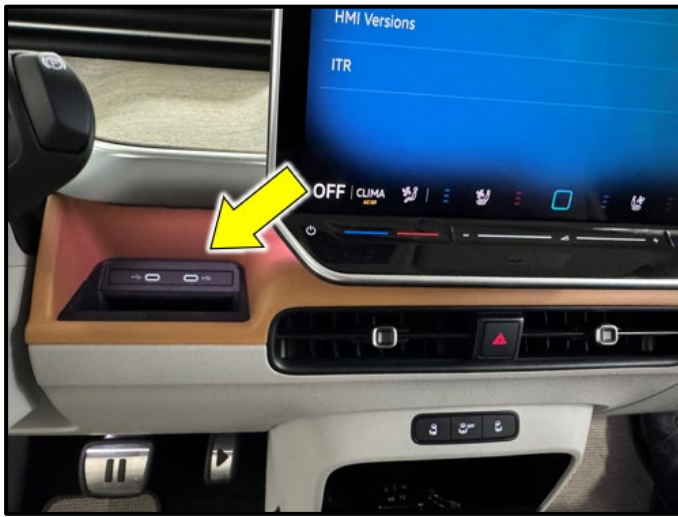
- Insert the USB drive into one of the USB ports.
- Turn the ignition ON.

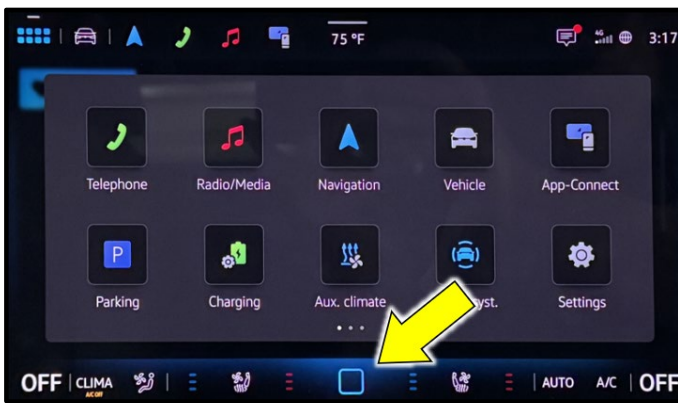
- Press and hold the home key.
- During the update, the instrument cluster display will change multiple times.

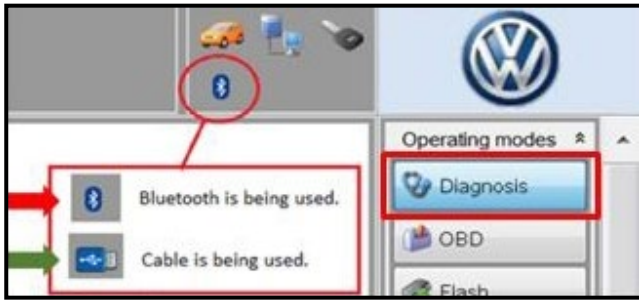
- Confirm that scan tool is communicating with the diagnostic head by USB <Green Arrow>.
 - If the Bluetooth symbol is shown <Red Arrow> then disconnect the diagnostic head from the vehicle and reconnect the USB cable to the diagnostic head and then reattach to the vehicle.
- Upon ODIS startup, verify the "Diagnosis" operating mode is selected <as shown>.
