# Compliance Recall

## Code: 90A2

| Subject<br>Document History | Instrument Cluster ABS-Brake Telltale | | | | |

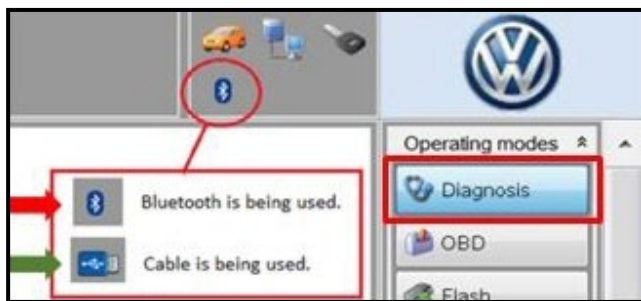
- Connect the diagnostic head to the vehicle.
- Confirm that scan tool is communicating with the diagnostic head by USB <Green Arrow>.
- If the Bluetooth symbol is shown <Red Arrow> then disconnect the diagnostic head from the vehicle and reconnect the USB cable to the diagnostic head and then reattach to the vehicle.
- Upon ODIS startup, verify the “Diagnosis” operating mode is selected <as shown>.

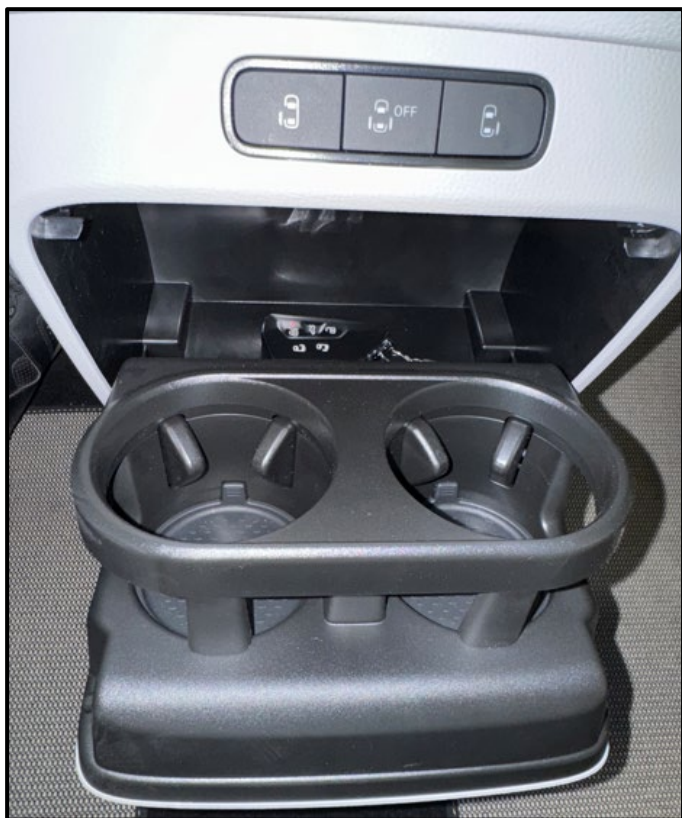
- Place the vehicle key over the reader coil in the cup holder area as shown.
- Any additional keys must be a minimum of 20 meters away from the vehicle.

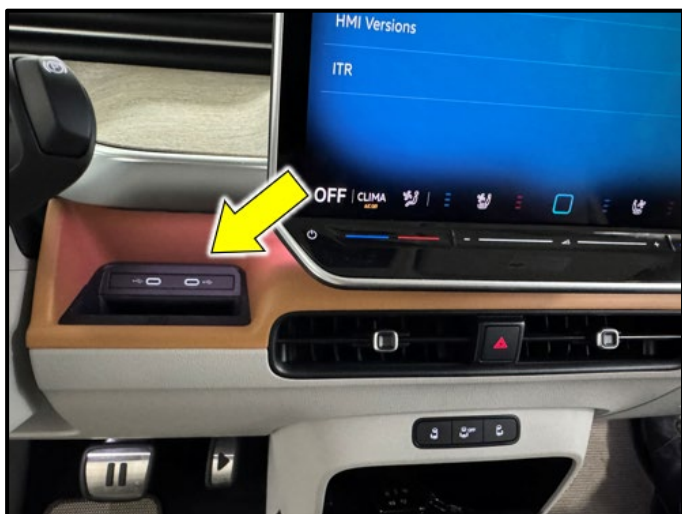
- Insert the USB drive into one of the USB ports.
- Turn the ignition ON.

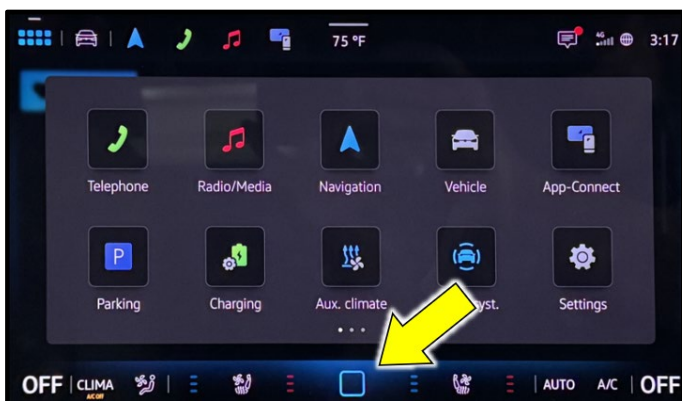
- Press and hold the home key.
- During the update, the instrument cluster display will change multiple times.

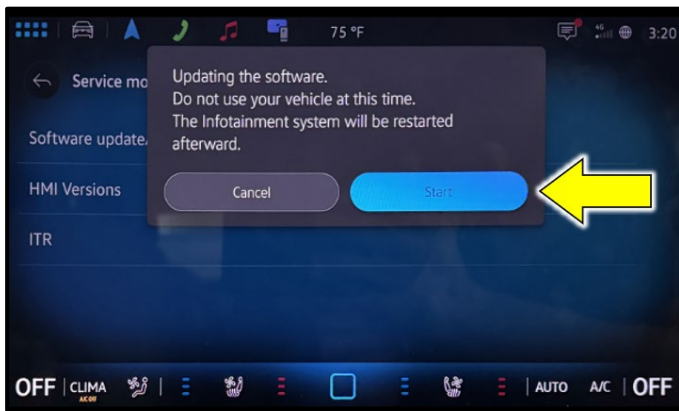
- Select “Start” when prompted.

After selecting the “Start” option, the infotainment screen will go blank and the red engineering menu (REM) will populate after a few moments.

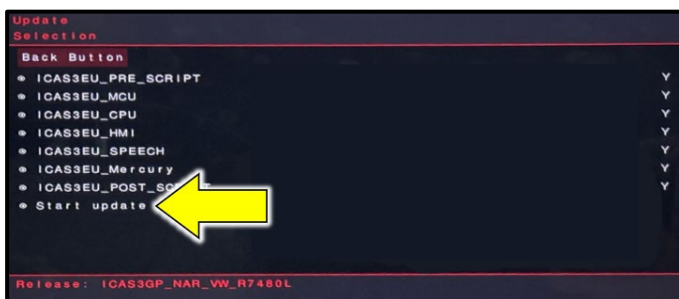
- Select “Start update”.

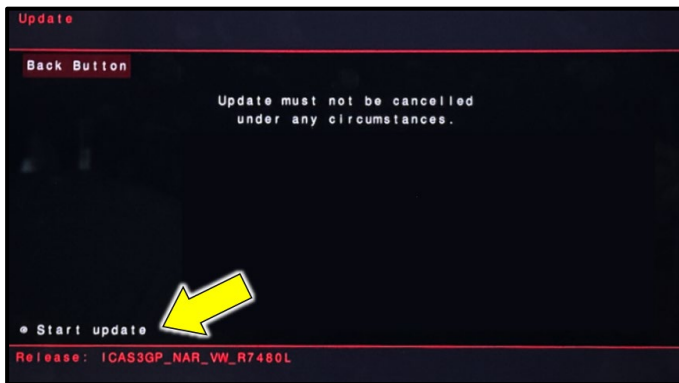
- Select “Start update”.

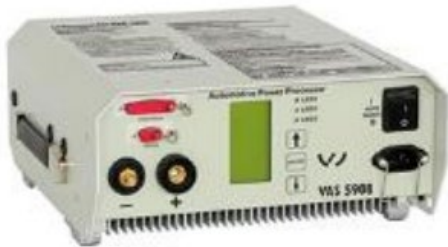
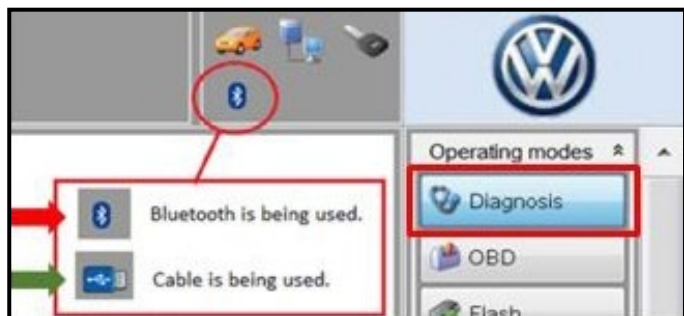
- Turn battery charger OFF, then back ON.
- Connect battery charger.
- Cycle the ignition off and on.
- Confirm that scan tool is communicating with the diagnostic head by USB <Green Arrow>.
  - If the Bluetooth symbol is shown <Red Arrow> then disconnect the diagnostic head from the vehicle and reconnect the USB cable to the diagnostic head and then reattach to the vehicle.
- Upon ODIS startup, verify the “Diagnosis” operating mode is selected <as shown>.
- Once the GFF scan is complete, select “Test plan” <arrow A>, then “Software version management” <arrow B>, then “Adapting software” <arrow C>, then select “Attach to the test plan” <arrow D>.
  - Select “Adapting software” <arrow A> from the test plan list.
  - Select “Perform test” <arrow B>.
