Safety Recall

N252494000 L87 Engine Loss of Propulsion

Release Date: June 2025

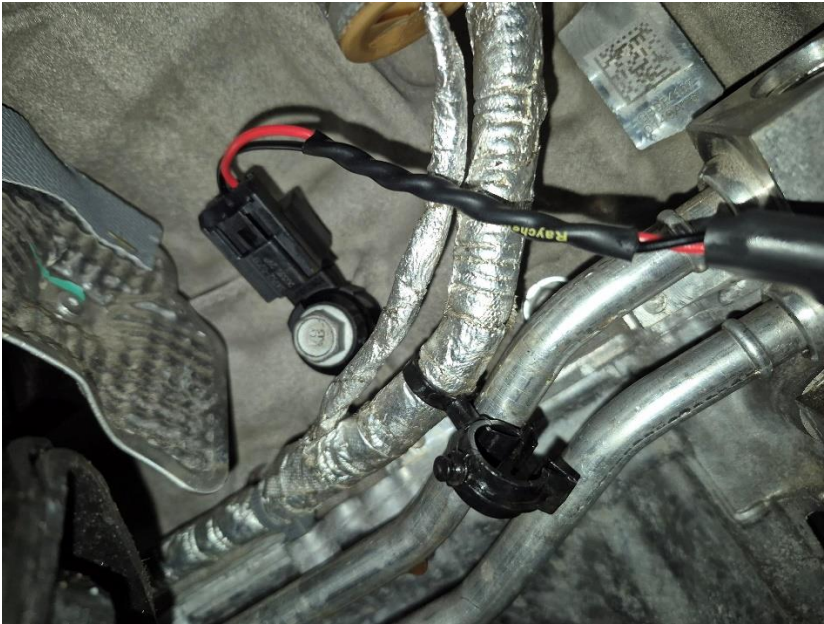
6932366

Caution: Using compressed air, blow out the M8 boss in which the test sensor is installed in the above picture.

- Install the test sensor into the unused M8 boss on the left-hand side of the engine directly above and in front of the engine oil cooler line junction block. Torque the M8X1.25X35 bolt to 16 lb-ft/22 N-m.
- Route the test sensor harness in a manner in which it is not contacting any hot components of the vehicle and which allows the harness to reach your laptop or PC.

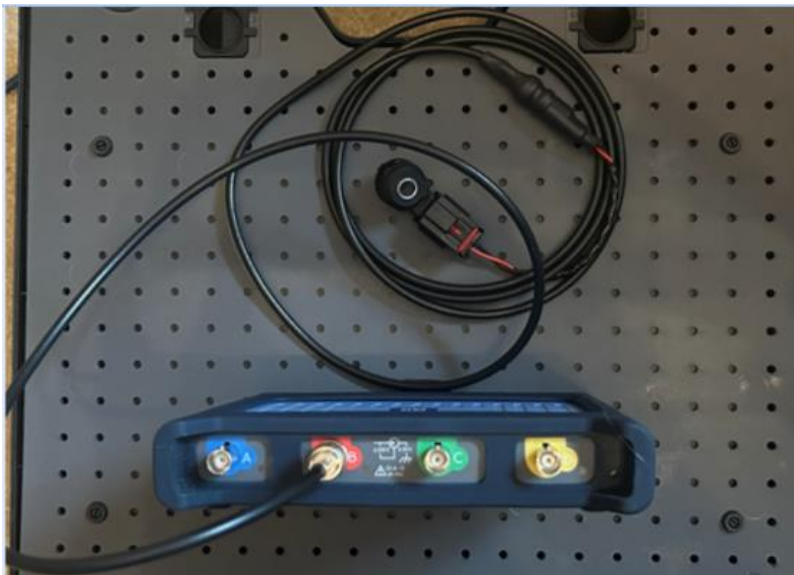
6952616

- Connect the Test Sensor Harness directly into Channel B of the PicoScope. **The additional NVH interface is NOT required for this procedure.**
