# SAFETY RECALL

## Side Curtain Airbag

Reference: 06C / NHTSA 25V-302

2022-2025 (RU) Chrysler Pacifica  
2022-2025 (RU) Chrysler Voyager

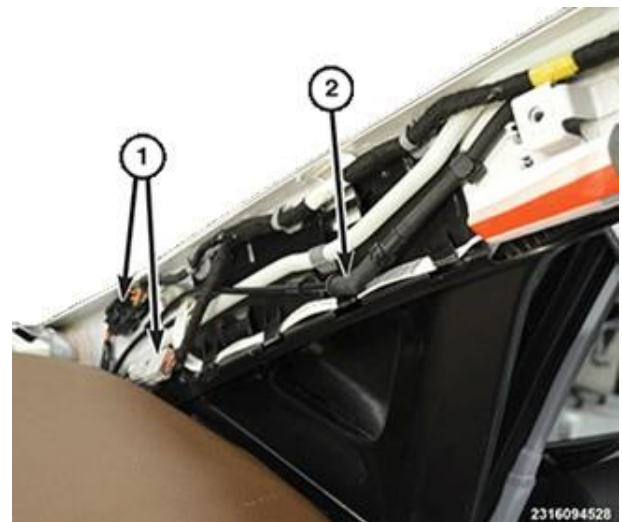
**Figure 3 – A-Pillar**

10. Disconnect the wire harness connectors and unclip the wire harness from the passenger side A-pillar (Figure 3).
11. Disconnect the rear washer hose (and unclip the hose from the passenger side A-pillar, if equipped (Figure 3).

- 1 - Wire Harness Connectors
- 2 - Washer Hose

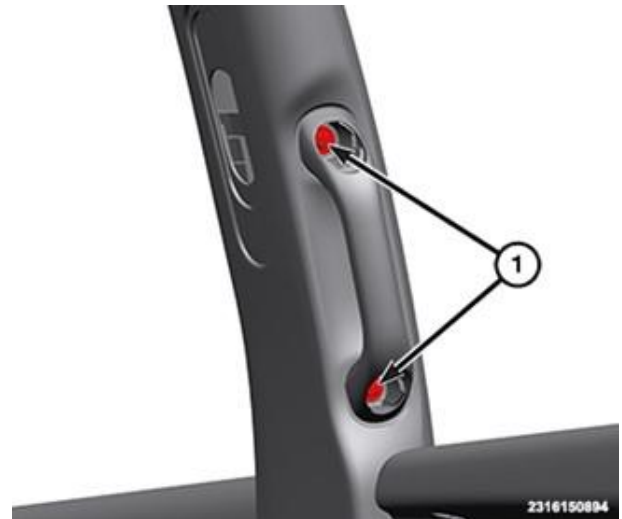
**Figure 6 – Grab Handle**

16. Using a small flat bladed tool, remove the bolt covers then the grab handle bolts (Figure 6).

1 - Grab Handle Bolts

92. Tighten the grab handle bolts securely (Figure 6).
93. Install the B-pillar extension and engage the remaining clips (Figure 5).

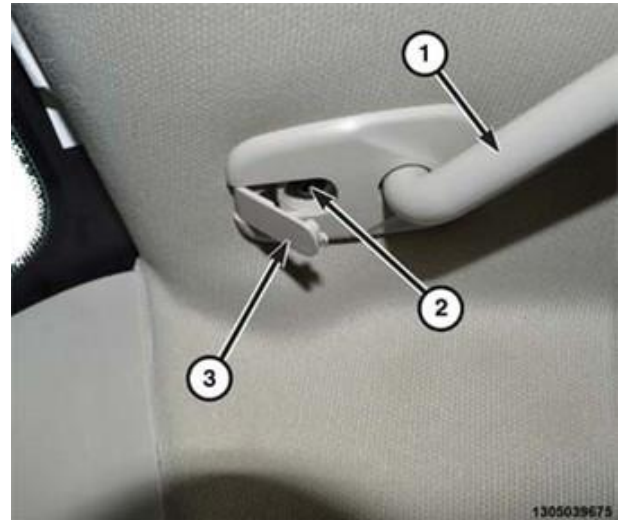
**Figure 17 – Sun Visor**

39. Using a small pry tool, open the visor screw cover and remove the screw (Figure 17).
40. Rotate the visor upward towards the roof to remove it from the opening (Figure 17).
41. If equipped, disconnect the harness connector from the visor (Figure 17).

- 1 - Sun Visor
- 2 - Screw
- 3 - Screw Cover

73. If equipped with grab handles, position the grab handle to the headliner, install the screws and tighten securely then install the screw covers (Figure 22).
74. Position the coat hook to the headliner, install the screw and tighten securely then close the screw cover (Figure 21).
75. Connect the wire harness connectors to the lamp and camera, install the rear dome lamp / camera to the headliner (Figure 20).
76. Install the two screws securing the front overhead console (Figure 19).
77. Close the front overhead console rear observation mirror (Figure 19).
78. Position the sun visor support and install the screw, tighten securely then close the screw cover (Figure 18).
79. Connect the harness connector to the visor (Figure 17).
80. Install the visor to the roof and install the screw, tighten securely then close the screw cover (Figure 17).

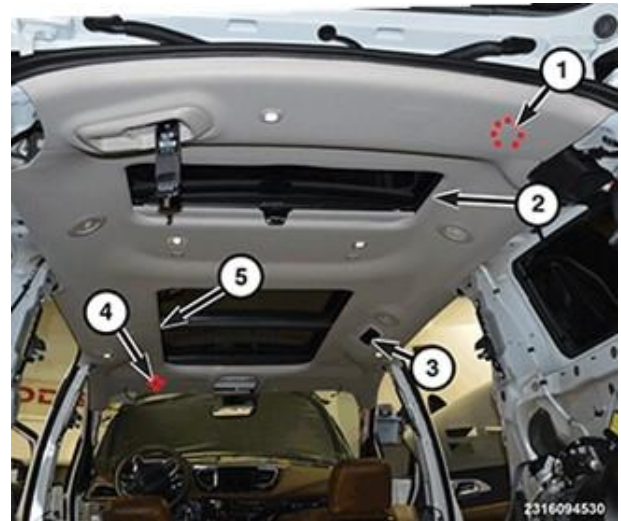
**Figure 23 – Headliner**

49. Using a trim stick or equivalent, release the push fastener at the location at the rear of the headliner (Figure 23).
50. With the help of an assistant starting at the rear of the vehicle, release the hook and loop fasteners by hand, then around the sunroof openings, if equipped (Figure 24).
51. Using a long trim stick, reach up above the headliner and release the three steel retainers that retain the rear heater controls bracket to the roof panel (Figure 23).

- 1 - Push Fastener
- 2 - Sunroof Opening
- 3 - Rear Heater Controls
- 4 - Push Fastener
- 5 - Sunroof Opening

70. Connect the rear window washer hose (Figure 24).
71. Attach all the hook and loop fasteners (Figure 24).
72. Attach the three steel retainers that retain the rear heater controls bracket to the roof panel (Figure 23).
