# VOLUNTARY RECALL CAMPAIGN

## VOLUNTARY SAFETY RECALL CAMPAIGN 2025 FRONTIER; CENTER DISPLAY SCREEN WITH TELEMATICS

**CAMPAIGN ID #:** PD152  
**APPLIED VEHICLES:** 2025 Frontier (D41) with TCU

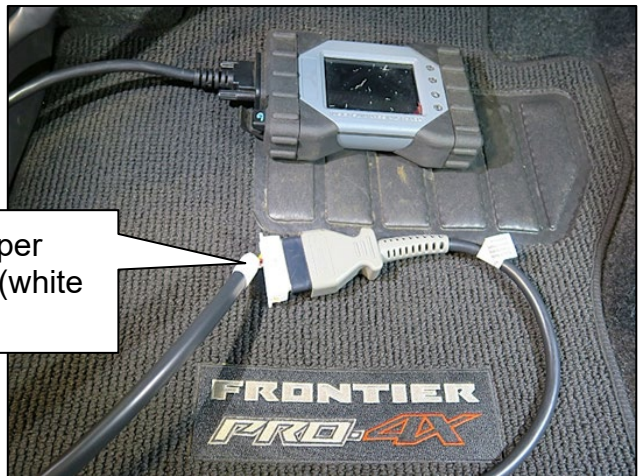
Figure 9

10. Connect the jumper harness DLC connector (white tape) into a VI3 (Figure 9).

NI-53395 male jumper harness connector (white tape)
