# VOLUNTARY RECALL CAMPAIGN

| AN25-005A | NTB25-028A | May 30, 2025 |

## VOLUNTARY SAFETY RECALL CAMPAIGN 2025 FRONTIER; CENTER DISPLAY SCREEN WITHOUT TELEMATICS

**CAMPAIGN ID #:** PD153  
**APPLIED VEHICLES:** 2025 Frontier (D41)

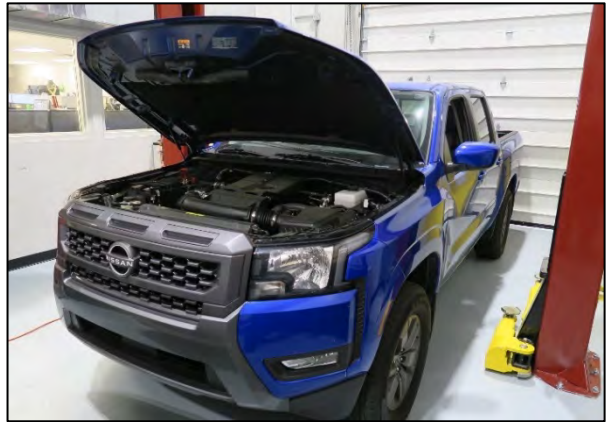
Figure 2

2. Open the hood.

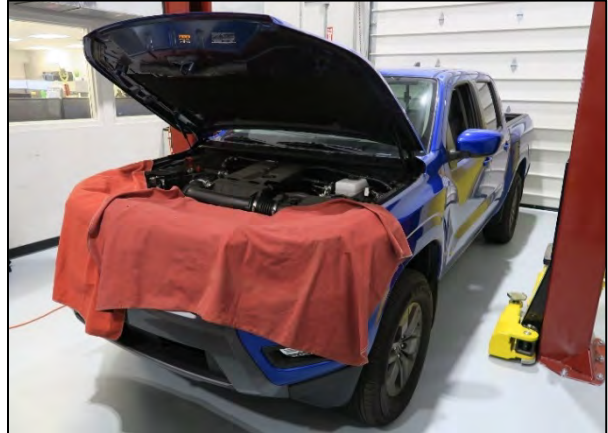
Figure 3

3. Install fender and grille protection.

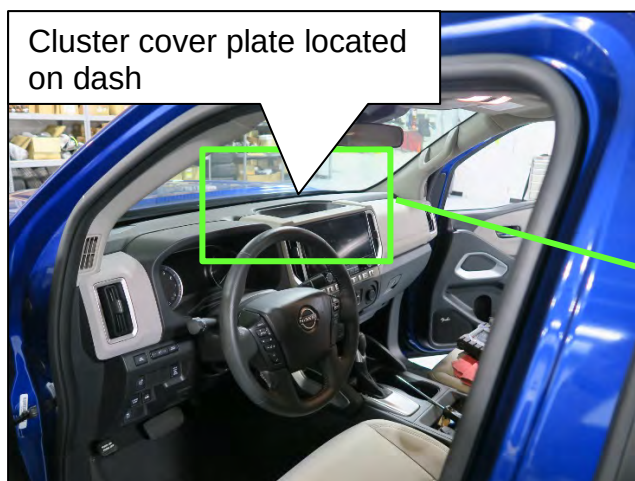
5. Locate the cluster cover plate on top of the dash (Figure 4 and Figure 5).

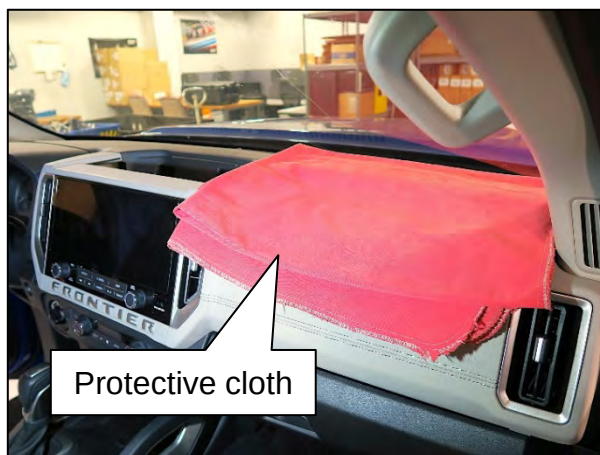
Figure 7

7. Move to the front passenger (RH) seat, and place a protective cloth on the dash (Figure 7).

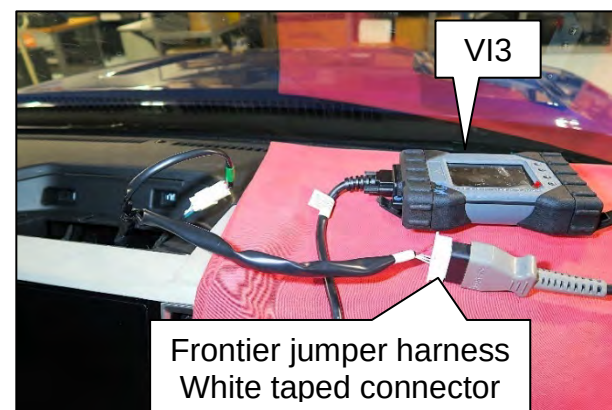
Figure 14

12. Connect the White connector on the Frontier jumper harness to the **VI3**.

- Connect the VI3 to the CONSULT PC using a USB cable.

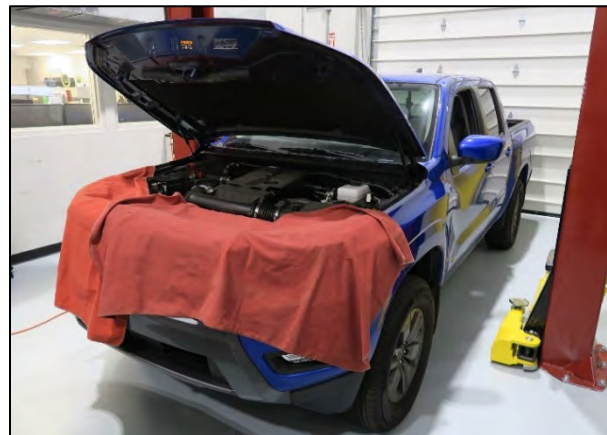
Figure 46

62. Close C-III plus and disconnect the VI3 from the Data Link Connector, remove it from the vehicle.

63. Remove any fender and grille protection from the vehicle.

64. Close the hood.
