**REPAIR PROCEDURE – SAS REPROGRAMMING  
SAFETY RECALL CAMPAIGN 7525E**

\*\*\*\*June 19, 2025 updated warnings for damage caused during reprogramming\*\*\*\*

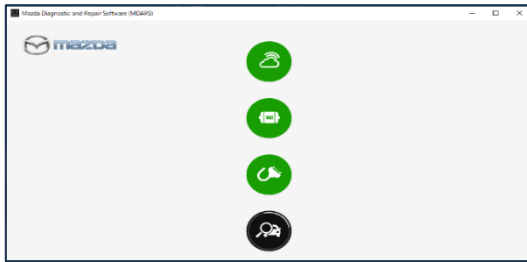
- The Vehicle Identification process will start and automatically inspect every connection and then collect the vehicle information.

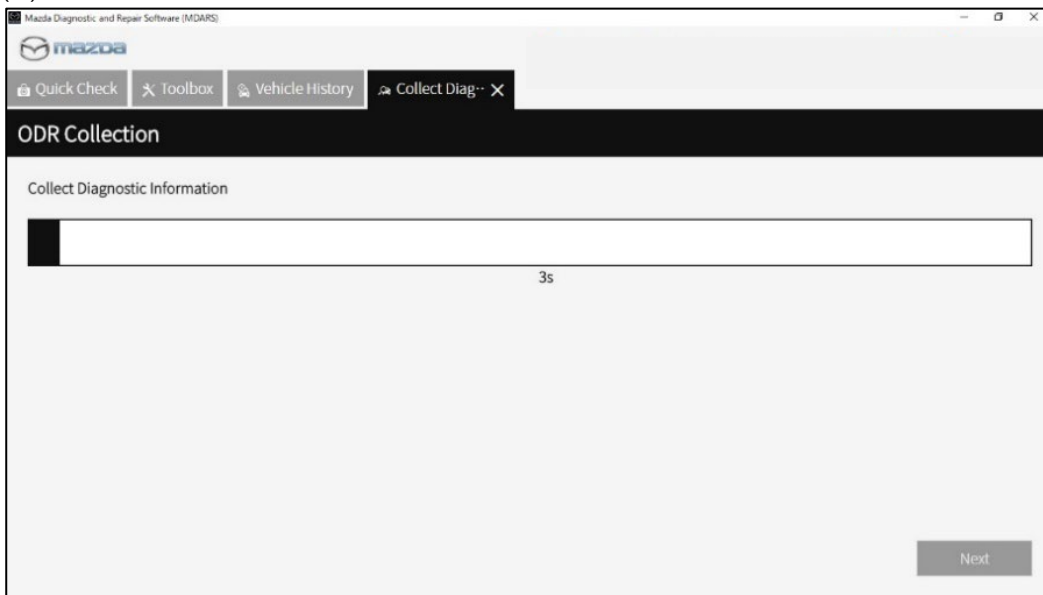
(3) It takes around 60 seconds.
