**Attention All Mazda Dealers: This repair procedure is for SAS Unit replacement only for certain Japan built Mazda3 vehicles that show replacement required in the Repair Calculator.**

### SAS CONTROL MODULE REPLACEMENT

## REPAIR PROCEDURE – SAS MODULE REPLACEMENT SAFETY RECALL CAMPAIGN 7525E

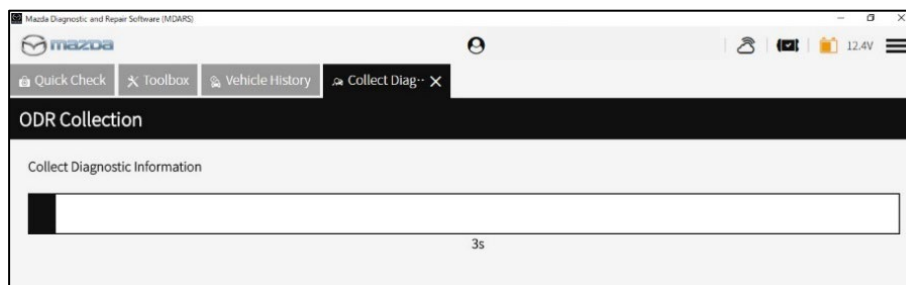
- (3) It takes around 60 seconds.
