# SAFETY RECALL BULLETIN

| <b>ALLIANCE IN-VEHICLE INFOTAINMENT (A-IVI)<br/>OPERATION FAILURE – SAFETY RECALL CAMPAIGN</b> | | | DATE: <b>June 2025</b> |

This Campaign Bulletin provides instructions for reprogramming the In-Vehicle Infotainment (IVI) system with modified software.

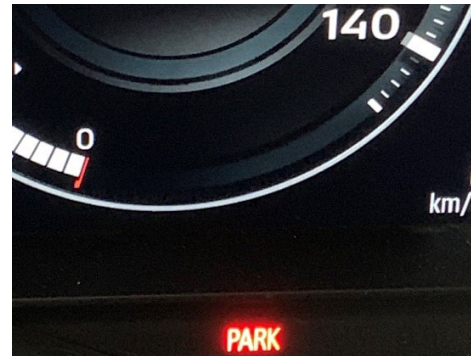
- a. Turn the engine on (set Outlander Plug-in Hybrid to "READY") and engage the parking brake. Make sure the "P" in the cluster and Parking Brake Indicator illuminates.

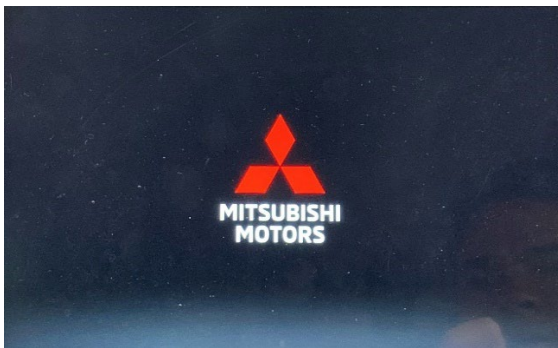
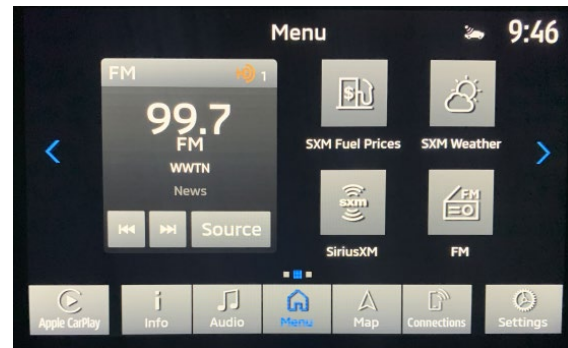
- b. The vehicle must remain idling with the parking brake ON. Never move the vehicle during software update.
- c. The IVI display may display the Mitsubishi Logo followed by the menu.  
**(Please note it may take approximately 1 minute after the power switch is turned on for the menu to display.)**

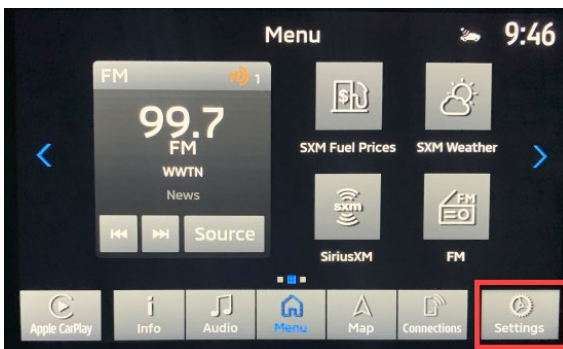
- a. Go to "Settings", then arrow right ">".

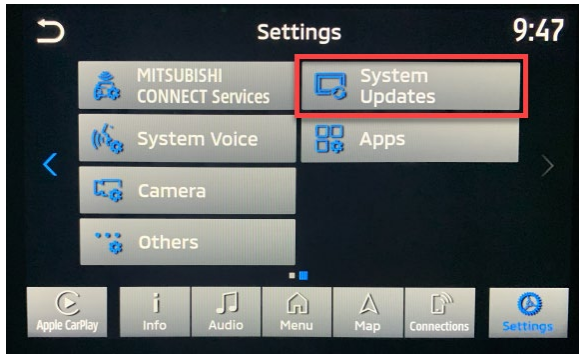
b. Go to "System Updates", then "Version Information".

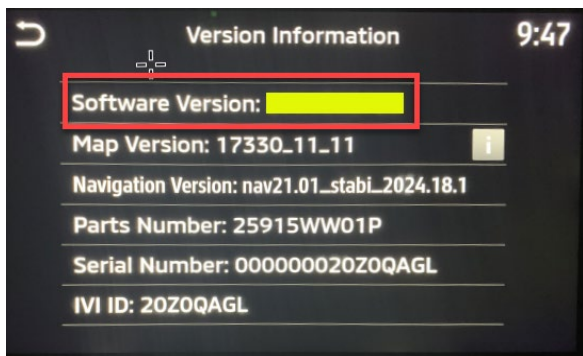
c. Check "Software Version" and determine whether updating is necessary.

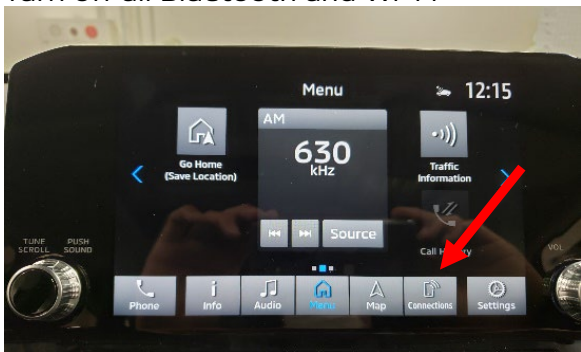
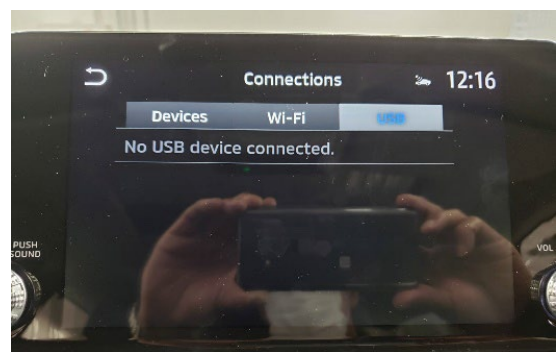
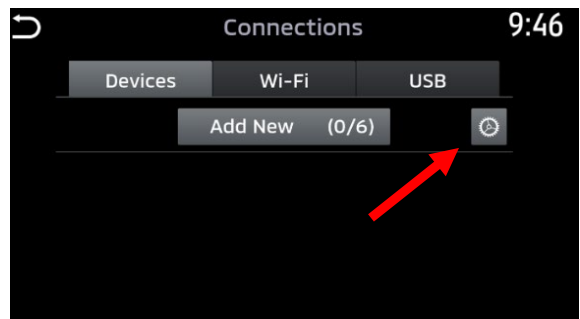
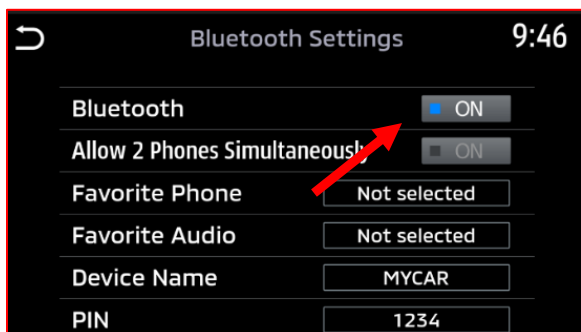
c. Switch off the A/C system and Audio system while updating.

d. Turn off all Bluetooth and Wi-Fi

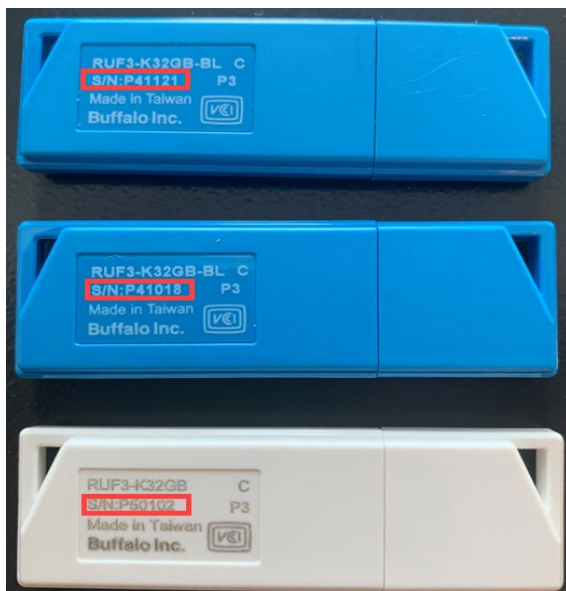
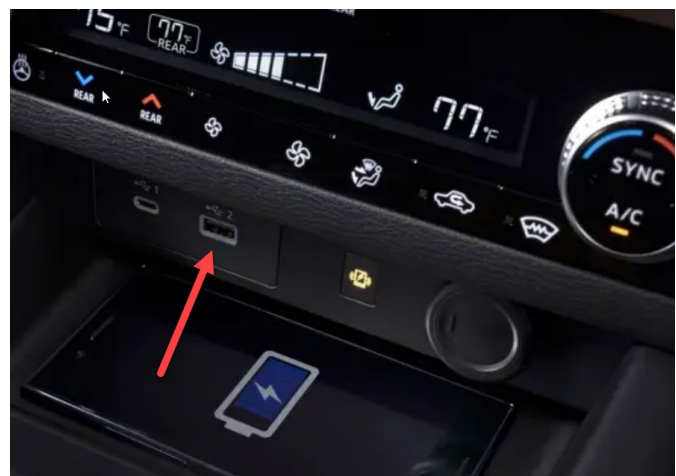
- a. Insert the USB drive for updating into the USB port (Type A; right side) on the center console. Section 7 describes troubleshooting related to updating.

**PLEASE ONLY USE THE BLUE OR WHITE USB DRIVES WITH SERIAL NUMBERS P41018 (Blue), P41121 (Blue) AND P50102 (White) WHEN PERFORMING THIS RECALL.**

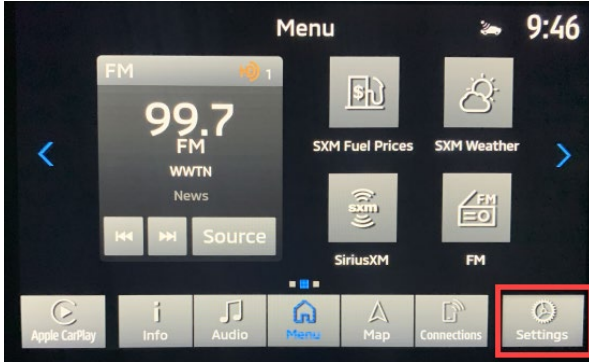
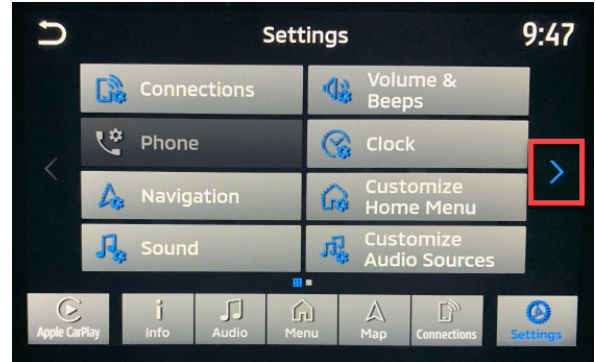
- a. Make sure that the software version is now "283C38872E".
  - The smartphone link A-IVI clock is reset, but the correct time is displayed when GPS is received.
  - Go to "Settings", then arrow right ">".

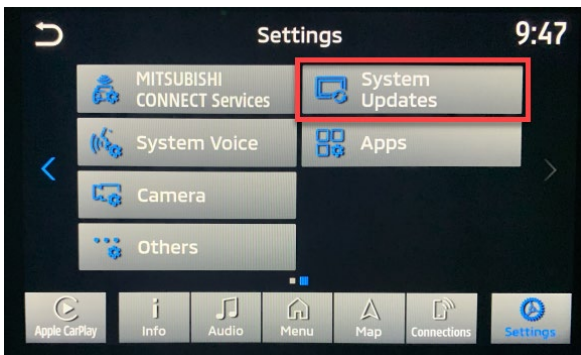
- b. Go to "System Updates", then "Version Information".

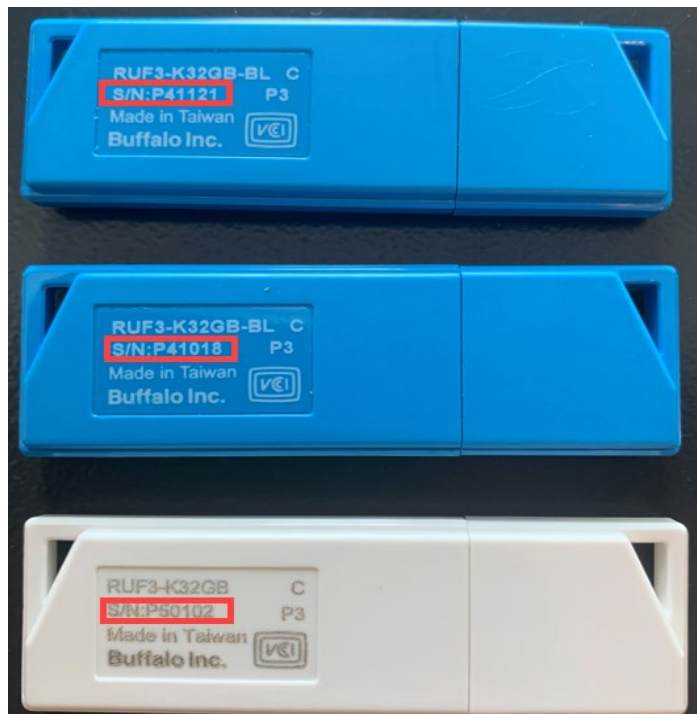
**Two USB drives containing the reprogramming software were sent FedEx to the Service Managers' attention at each dealership. You should receive them June 16, 2025.**

**PLEASE ONLY USE THE BLUE OR WHITE USB DRIVES WITH SERIAL NUMBERS **P41018** (Blue), **P41121** (Blue) AND **P50102** (White) WHEN PERFORMING THIS RECALL.**
