**REPAIR PROCEDURE – SAS REPROGRAMMING
SAFETY RECALL CAMPAIGN 7525E**

Attention All Mazda Dealers: This repair is for reprogramming only. This repair procedure is not to be used for certain Japan built Mazda3 vehicles requiring SAS Unit replacement.

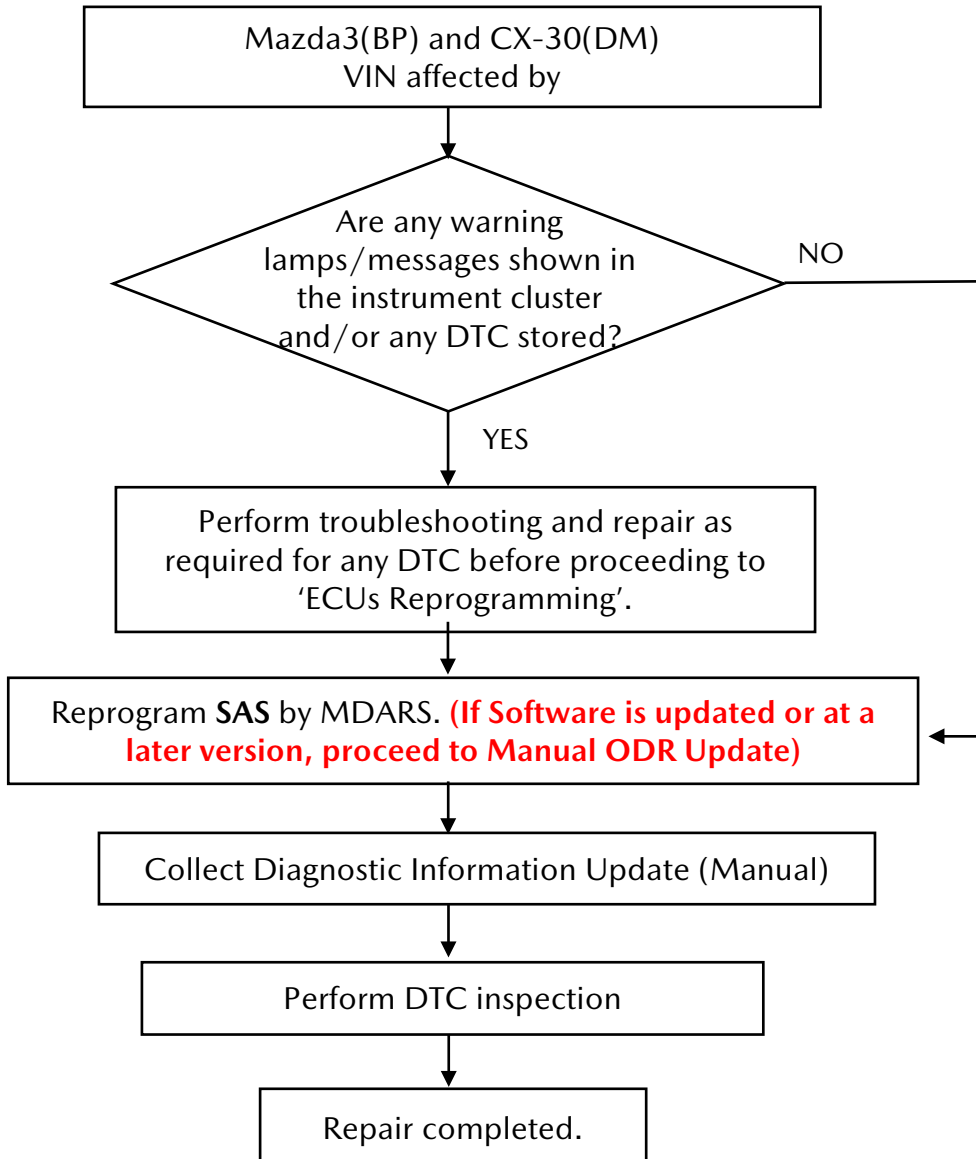
Section A: Flow Chart

NOTE: You must clear any DTC's (diagnose and repair) before performing any campaigns. Once repaired, then start the repair process.

NOTE: This Flow Chart needs to be followed strictly

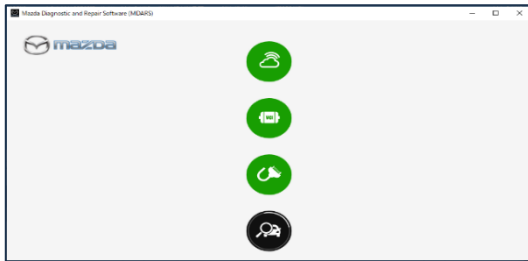
- The Vehicle Identification process will start and automatically inspect every connection and then collect the vehicle information.

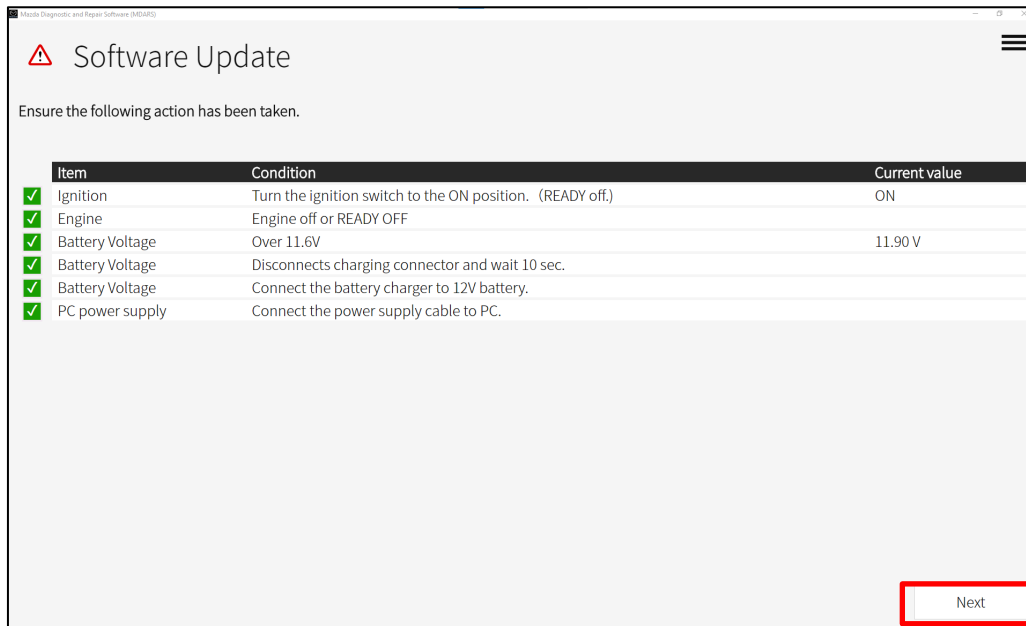
(1) Follow instructions in the screen and click "Next".

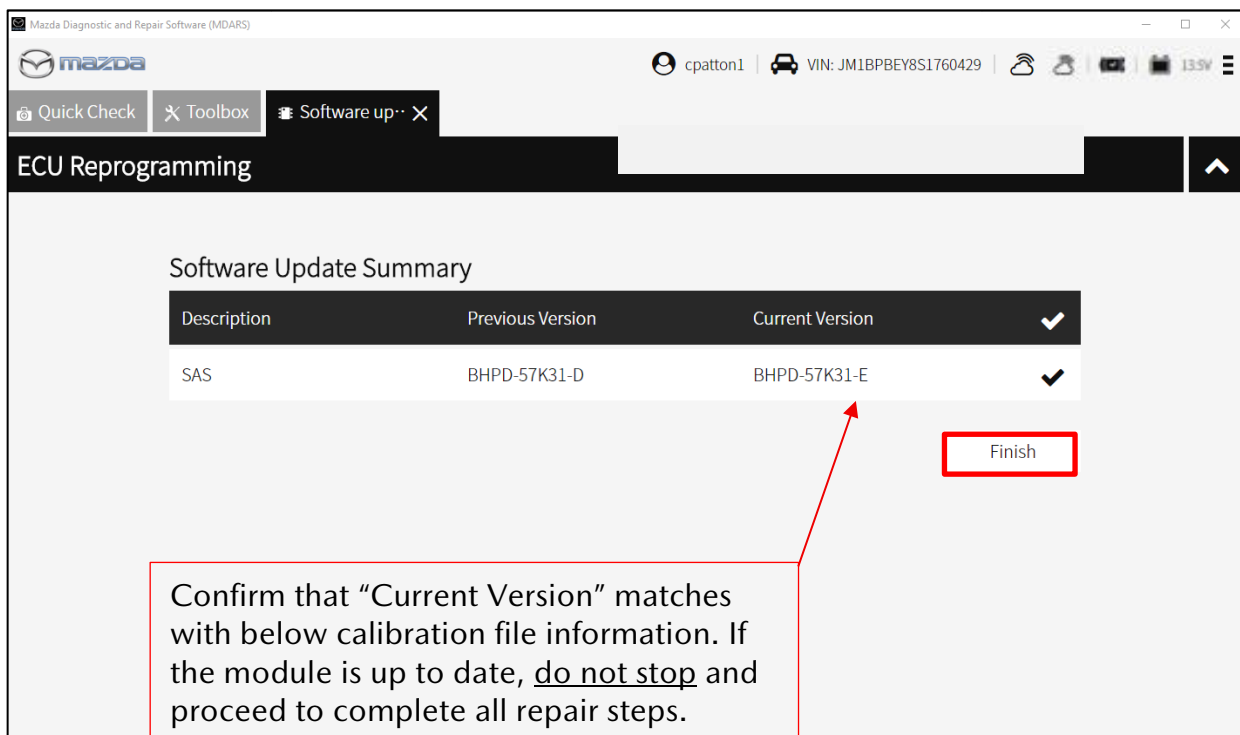
Calibration file information

6. After completion of the software update, the previous and current software version are shown.
(1) Check current version at "Calibration File information below".

(2) Then, click on “Finish” to exit the ECU reprogramming.

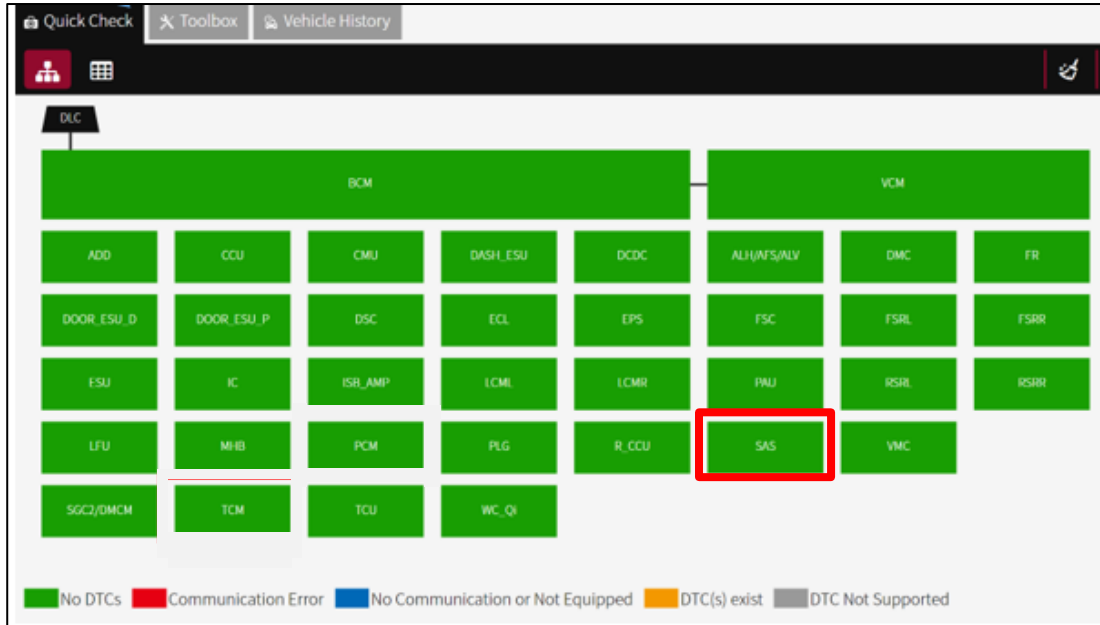
9. Confirm with Quick Check the SAS is highlighted in Green after updating the module.

NOTE: If any DTCs exist in yellow, follow the Workshop Manual or applicable TSB for the concern.

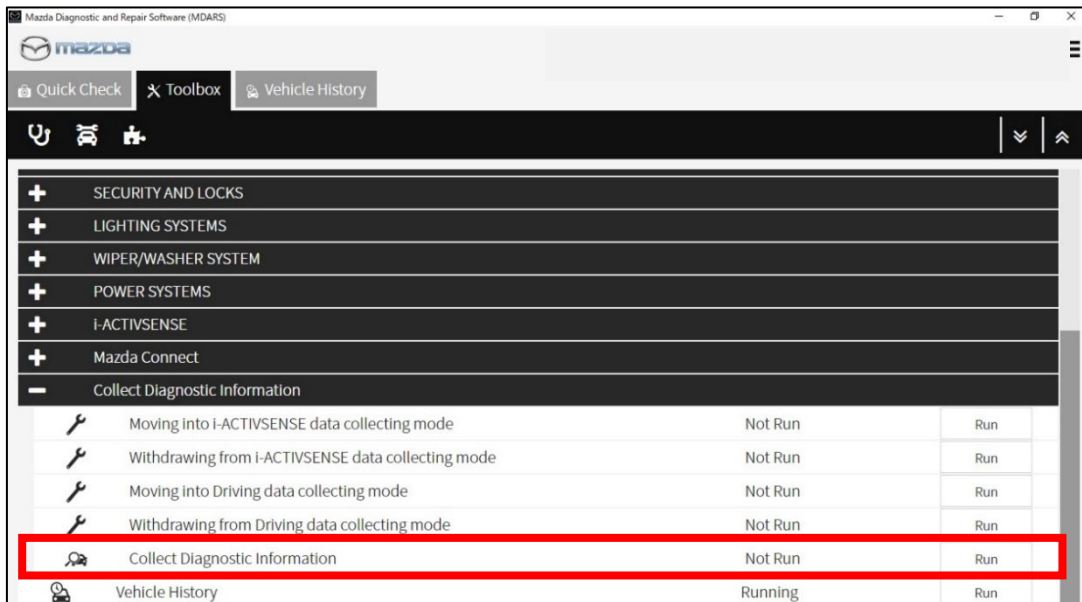
(1) At the toolbox tab, select "Collect Diagnostic information" then click 'Run'.
