# INSTRUCTION TO SERVICE

ITS61435		Sept 4, 2025
<b>SECTION:</b>	290-ELECTRICAL SCHEMATICS	
<b>SUBJECT:</b>	FEBS BATTERY PROGRAM UPDATE PROCEDURE – FW 2524	
<b>SUMMARY:</b>	FW2524 offers: <ul style="list-style-type: none"><li>• Robust detection of failure modes through DTCs</li><li>• SOHR accuracy improvement</li><li>• RTC battery DTCs removed.</li><li>• Logic improvements for better integration with application</li></ul>	
<b>AFFECTED SR:</b>	ELFA3 XE and XHE Buses

# ITS61435

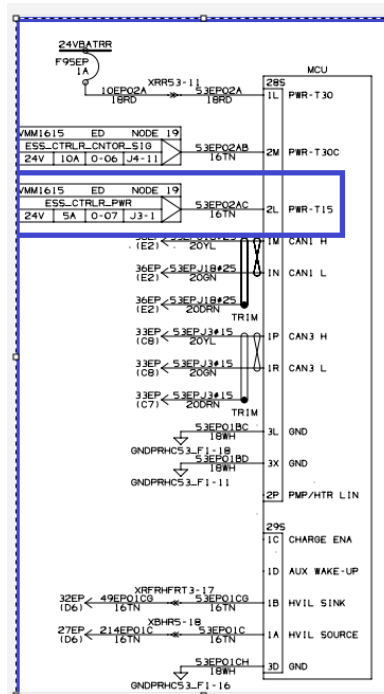
Fig 3: T15 from Vansco

output set to true. As an example, from Fig 3: Node 19 output 7 connected to T15 of the MCU, this means, search O19-7 in the PLC program to force it to be true while updating the Bootloader.

- i. **For SRs with 1615 module** – Go to Vansco Diagnostics mode, force the MCU enable output signal to the active/ON state i.e. MCU T15 vansco

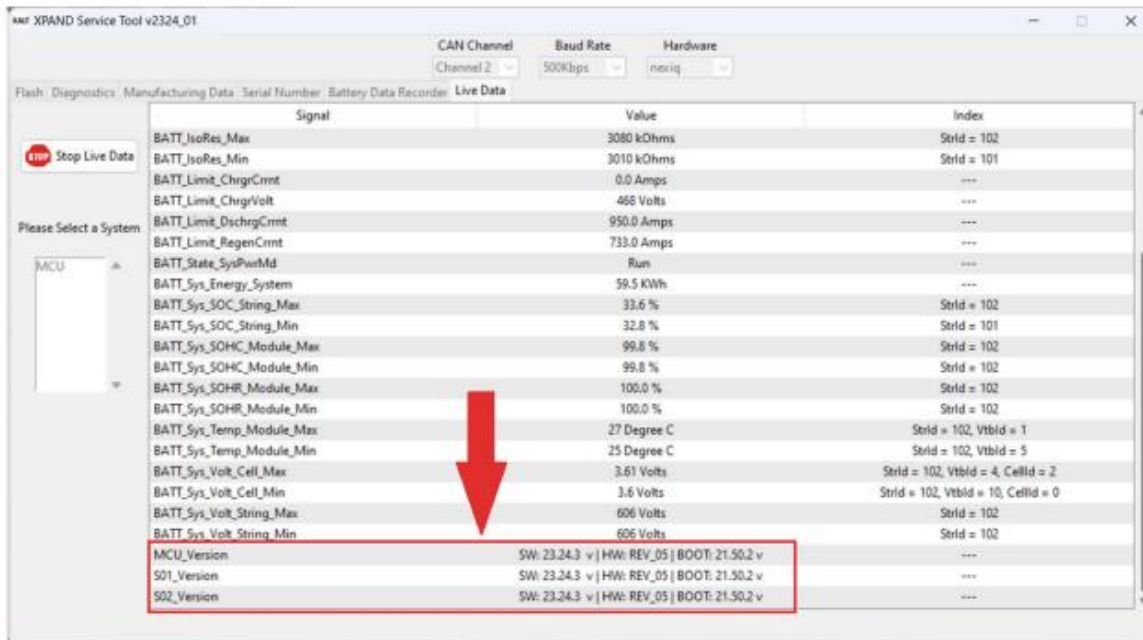
The screenshot shows the XST software interface with the 'Live Data' tab selected. A red arrow points to the 'MCU\_Version' row, which is highlighted with a red box. The 'MCU\_Version' row contains the text: 'SW: 23.24.3 v | HW: REV\_05 | BOOT: 21.50.2 v'. Other rows in the table include various battery and system parameters like BATT\_IsoRes\_Max, BATT\_Limit\_ChrgCrmt, BATT\_State\_SysPwrMd, and BATT\_Sys\_Volt\_Cell\_Max.

Signal	Value	Index
BATT_IsoRes_Max	3080 kOhms	Strid = 102
BATT_IsoRes_Min	3010 kOhms	Strid = 101
BATT_Limit_ChrgCrmt	0.0 Amps	---
BATT_Limit_ChrgVolt	466 Volts	---
BATT_Limit_DschrgCrmt	950.0 Amps	---
BATT_Limit_RegenCrmt	733.0 Amps	---
BATT_State_SysPwrMd	Run	---
BATT_Sys_Energy_System	59.5 kWh	---
BATT_Sys_SOC_String_Max	33.6 %	Strid = 102
BATT_Sys_SOC_String_Min	32.8 %	Strid = 101
BATT_Sys_SOHC_Module_Max	99.8 %	Strid = 102
BATT_Sys_SOHC_Module_Min	99.8 %	Strid = 102
BATT_Sys_SOHR_Module_Max	100.0 %	Strid = 102
BATT_Sys_SOHR_Module_Min	100.0 %	Strid = 102
BATT_Sys_Temp_Module_Max	27 Degree C	Strid = 102, Vtblid = 1
BATT_Sys_Temp_Module_Min	25 Degree C	Strid = 102, Vtblid = 5
BATT_Sys_Volt_Cell_Max	3.61 Volts	Strid = 102, Vtblid = 4, Cellid = 2
BATT_Sys_Volt_Cell_Min	3.6 Volts	Strid = 102, Vtblid = 10, Cellid = 0
BATT_Sys_Volt_String_Max	606 Volts	Strid = 102
BATT_Sys_Volt_String_Min	606 Volts	Strid = 102
MCU_Version	SW: 23.24.3 v   HW: REV_05   BOOT: 21.50.2 v	---

- 9.1. Keep the MRS to the ON position
- 9.2. Reopen the XST software, navigate to the Flash tab.
- 9.3. Use the settings CAN Channel - **Channel 2**; Baud rate – **500K**; Hardware – **Nexiq**.
- 9.4. Under the Live Data tab, you can find the current software version flashed to the MCU, and each battery string. This means, the process is successful.
- 9.5. After loading the files, you may notice the **HV battery fail** light triggered on the dash, even though all the strings are connected. In such cases, turn the MRS off -> wait for 5 mins -> knife off the bus -> wait for 1 min -> restart the bus and eventually no light should trigger. Additionally, please reverify diagnostics tab for any active DTCs
