**TECHNICAL INSTRUCTIONS**  
**FOR**  
**25LA05**  
**REPROGRAMMING FOR COMBINATION METER ASSEMBLY**

**CERTAIN**  
**2024 -2025 LS500 vehicles**  
**2024 – 2025 LS500h vehicles**  
**2024 - 2025 TX350 vehicles**  
**2024 TX500h vehicles**  
**2024 TX 550h+ vehicles**

**2025 RX350**  
**2025 RX350H**  
**2025 500H**

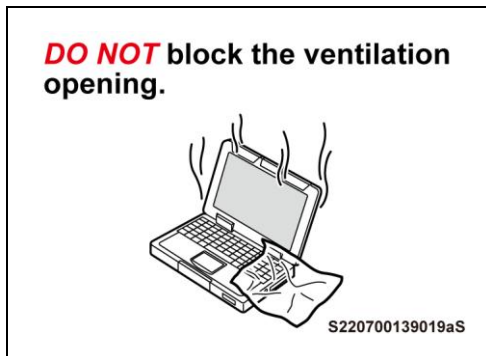
- c) **DO NOT** block the ventilation opening for the cooling fan of the personal computer.

If the ventilation opening for the cooling fan is blocked with a sheet cover or the like, the personal computer may be heated excessively, causing the operation of the personal computer to stop.

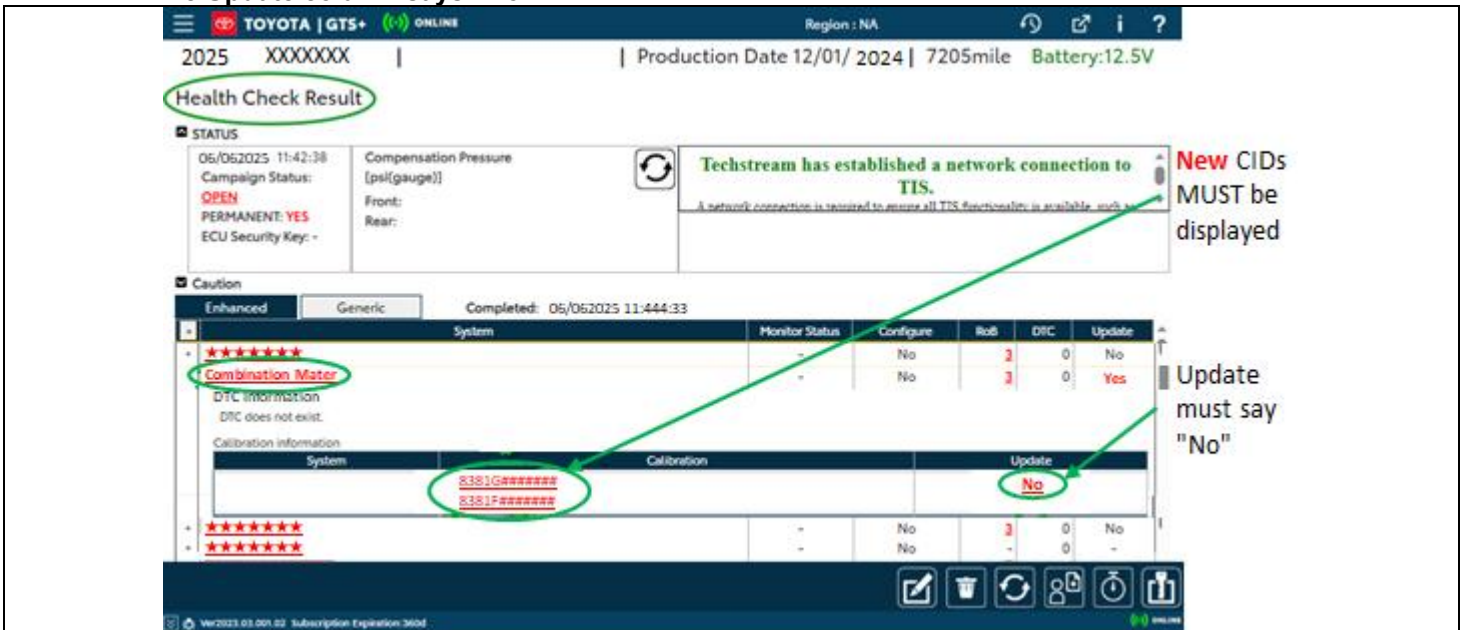
5. **CONFIRM CID UPDATE**

- a) On the Stored Data tab, confirm the following for the Combination Meter System:
  - The Calibration number has the "**NEW CID**" number.
  - The Update column says "**No**".
