◀ IMPORTANT UPDATE ▶

TECHNICAL INSTRUCTIONS
FOR
25LA05
COMBINATION METER ASSEMBLY – REPLACEMENT ONLY
CERTAIN 2024 TX 550h+ vehicles

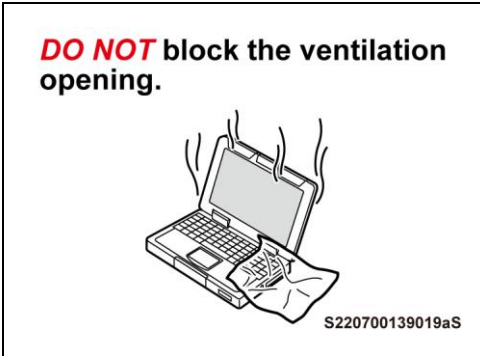
- c) **DO NOT** block the ventilation opening for the cooling fan of the personal computer.

If the ventilation opening for the cooling fan is blocked with a sheet cover or the like, the personal computer may be heated excessively, causing the operation of the personal computer to stop.
