**TECHNICAL INSTRUCTIONS**  
**FOR**  
**25TA08**  
**COMBINATION METER ASSEMBLY REPLACEMENT & REFLASH**  
**CERTAIN 2021 - 2025 RAV4 PLUG-IN HYBRID Vehicles**

## I. OPERATION FLOW CHART

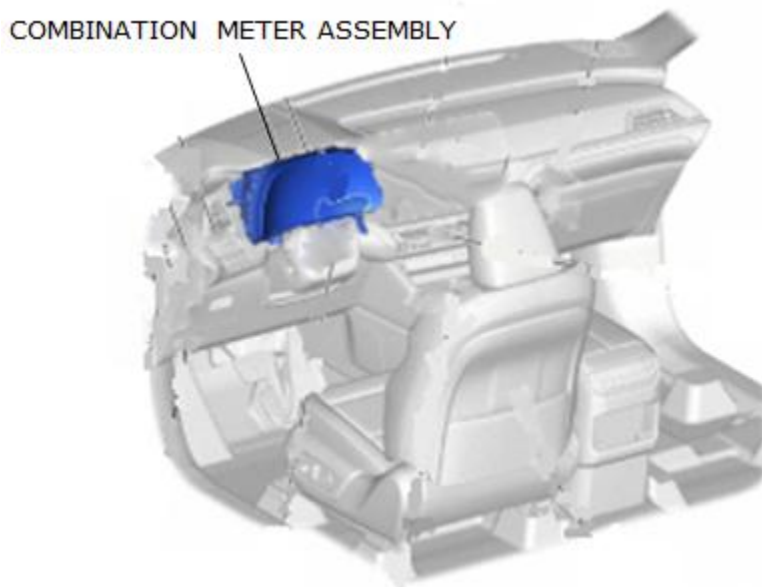
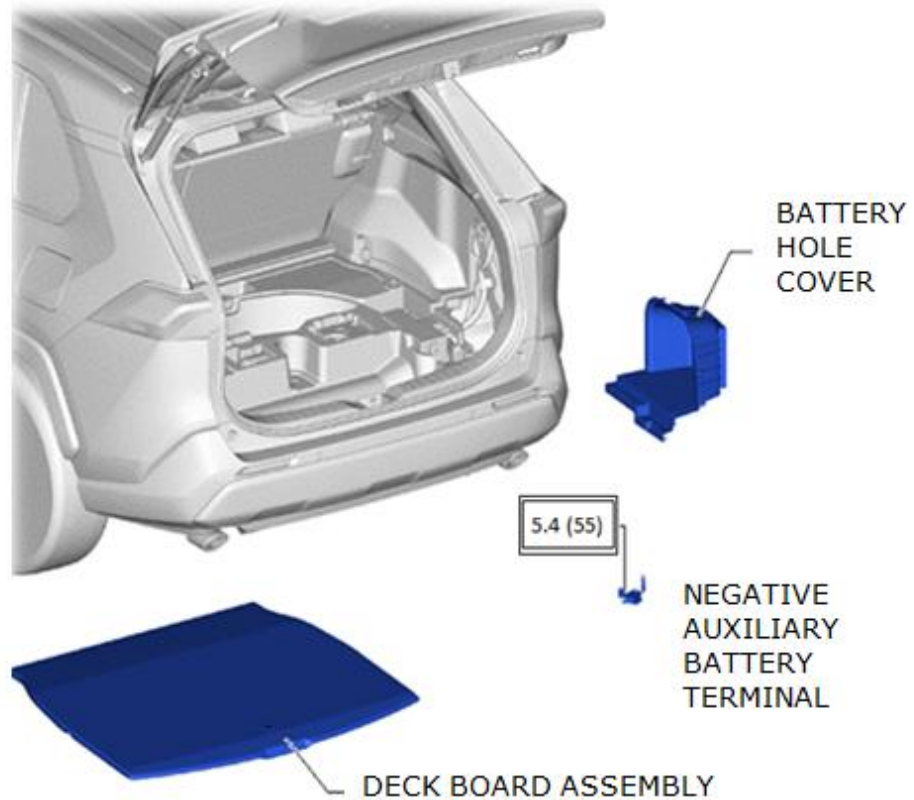
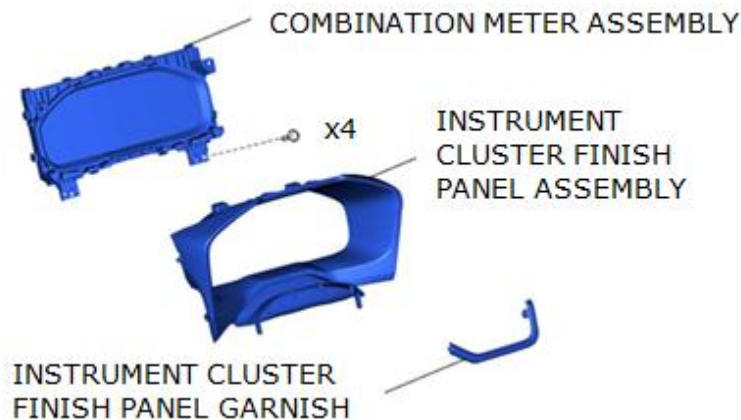
## VI. COMPONENTS

**N\*m (kgf\*cm, ft. \*lbf)** :Tightening torque for "Major areas involving basic vehicle performance such as moving/turning/stopping"

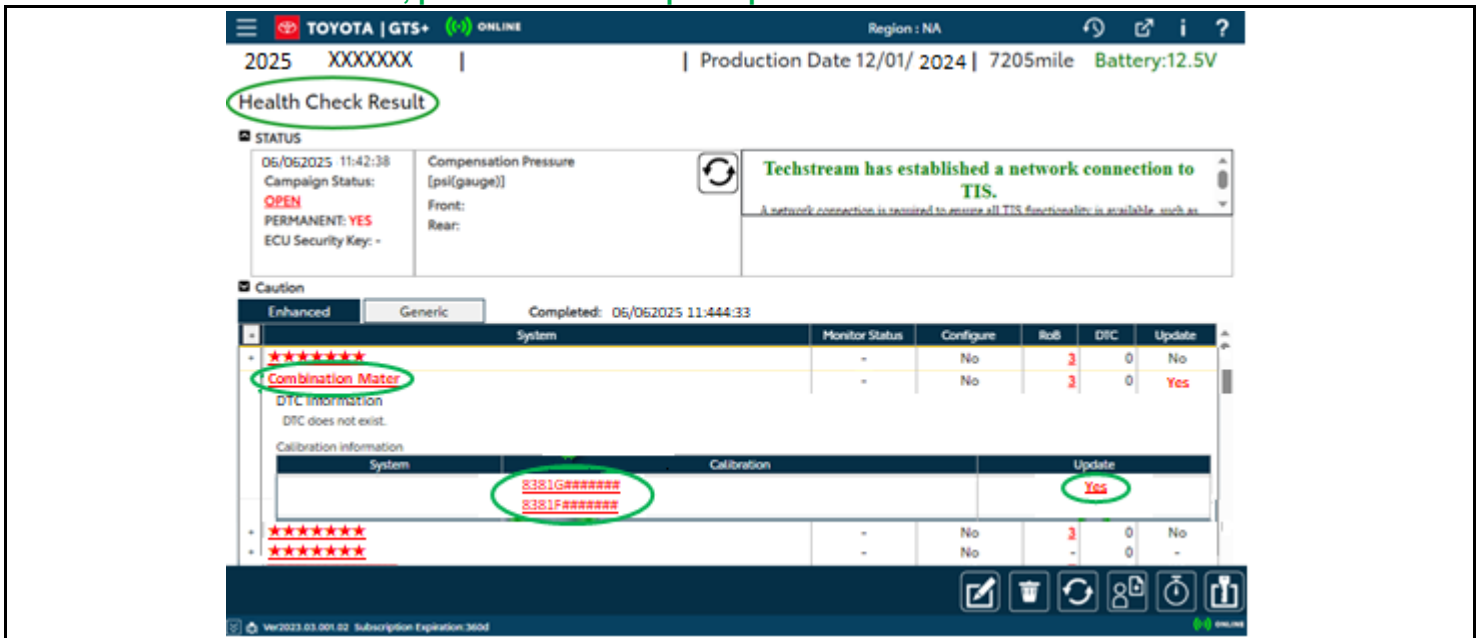
- a) Locate the "Update" column of the "Calibration Information" for the Combination Meter system on the "Health Check Result" screen.
- b) Determine the status of an available update; indicated by a YES or NO.

If the CIDs indicate 'Yes', proceed with the update procedure.
