TECHNICAL INSTRUCTIONS
FOR
25TA08
REPROGRAMMING FOR COMBINATION METER ASSEMBLY

2025 CAMRY HV
2023 - 2025 CROWN
2025 CROWN SIGNIA
2023 - 2025 GR COROLLA
2024-2025 GRAND HIGHLANDER
2024-2025 GRAND HIGHLANDER HV
2023 - 2024 RAV4 PRIME
2024-2025 TACOMA
2024-2025 TACOMA HV
2023 - 2024 VENZA HV
2025 4Runner
2025 4Runner HV

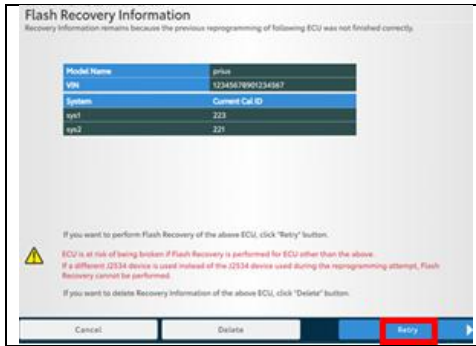
There are four files for the reprogramming software. Be sure to execute all four files.
