TECHNICAL INSTRUCTIONS
FOR
25LA05 – Phase 1
COMBINATION METER ASSEMBLY
CERTAIN 2024 TX550h+ Vehicles

I. OPERATION FLOW CHART

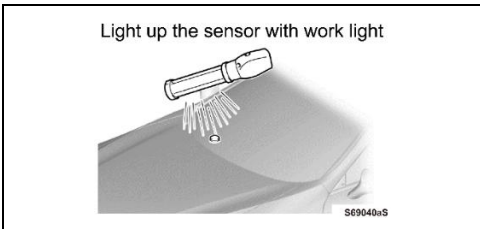
- Confirm the following conditions:
 - Vehicle in the IG position (READY OFF).
 - Transaxle in Park.
 - Parking brake engaged.
 - Turn off all electrical accessories (i.e. climate control, audio system, etc.)
 - Headlight switch in the DRL OFF position.
 - Windshield wiper switch in the OFF position.

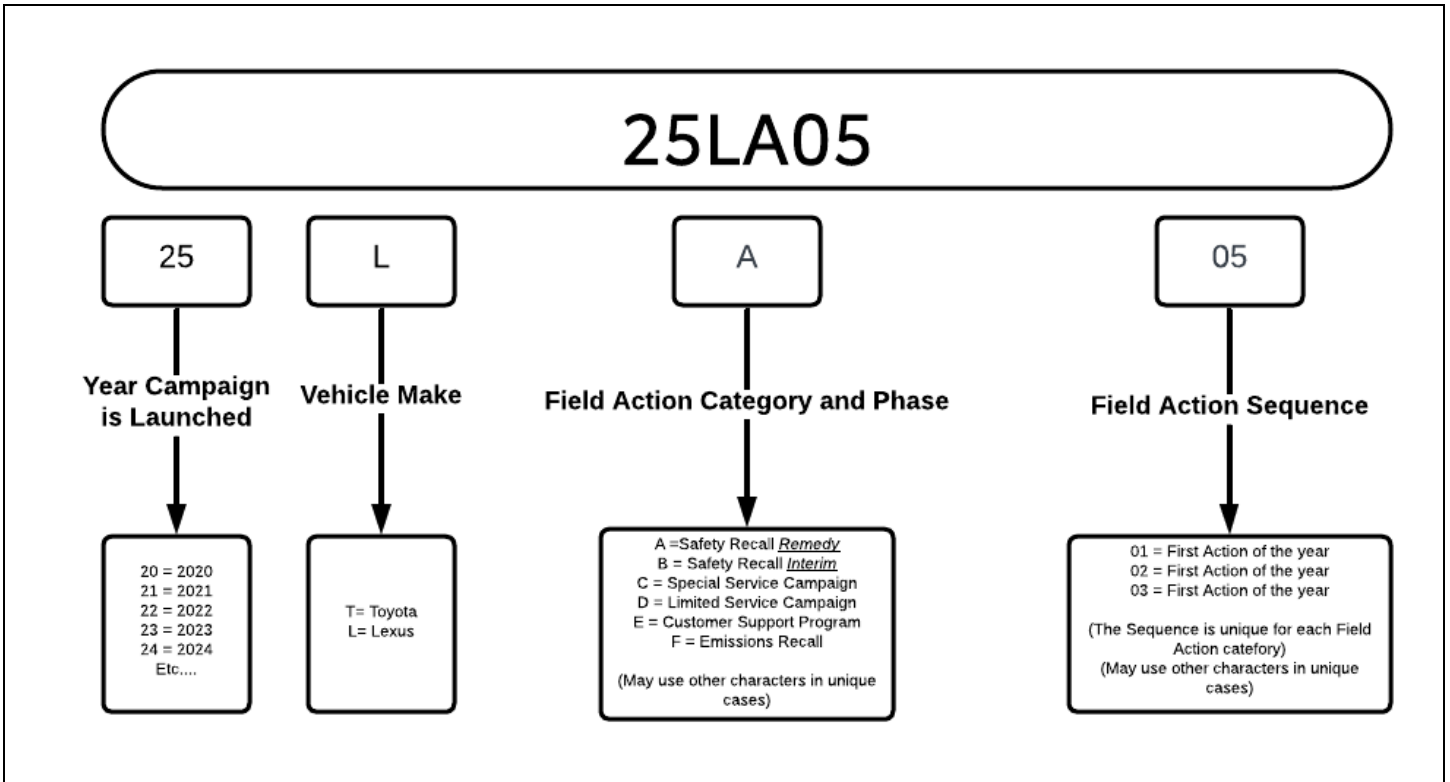
A. CAMPAIGN DESIGNATION DECODER

- 19LA01 = Launched in 2019, Toyota, Safety Recall Remedy Phase, 1st Safety Recall Launched in 2019
- 20LC02 = Launched in 2020, Special Service Campaign, 2nd Special Service Campaign Launched in 2020
- 21LE05 = Launched in 2021, Customer Support Program, 5th Customer Support Program Launched in 2021
