TECHNICAL INSTRUCTIONS
FOR
25TA08
REPROGRAMMING FOR COMBINATION METER ASSEMBLY

2025 CAMRY HV
2023 - 2025 CROWN
2025 CROWN SIGNIA
2023 - 2025 GR COROLLA
2023 - 2025 HIGHLANDER
2023 - 2025 HIGHLANDER HV
2024-2025 GRAND HIGHLANDER
2024-2025 GRAND HIGHLANDER HV
2023 - 2025 RAV4
2023 - 2025 RAV4 HV
2023 - 2024 RAV4 PRIME
2024-2025 TACOMA
2024-2025 TACOMA HV
2023 - 2024 VENZA HV
2025 4Runner
2025 4Runner HV

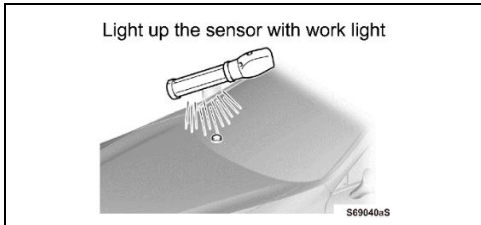
- Vehicle in the IG position (READY OFF).
- Transaxle in Park.
- Parking brake engaged.
- Turn off all electrical accessories (i.e. climate control, audio system, etc.)
- Headlight switch in the DRL OFF position.
- Windshield wiper switch in the OFF position.

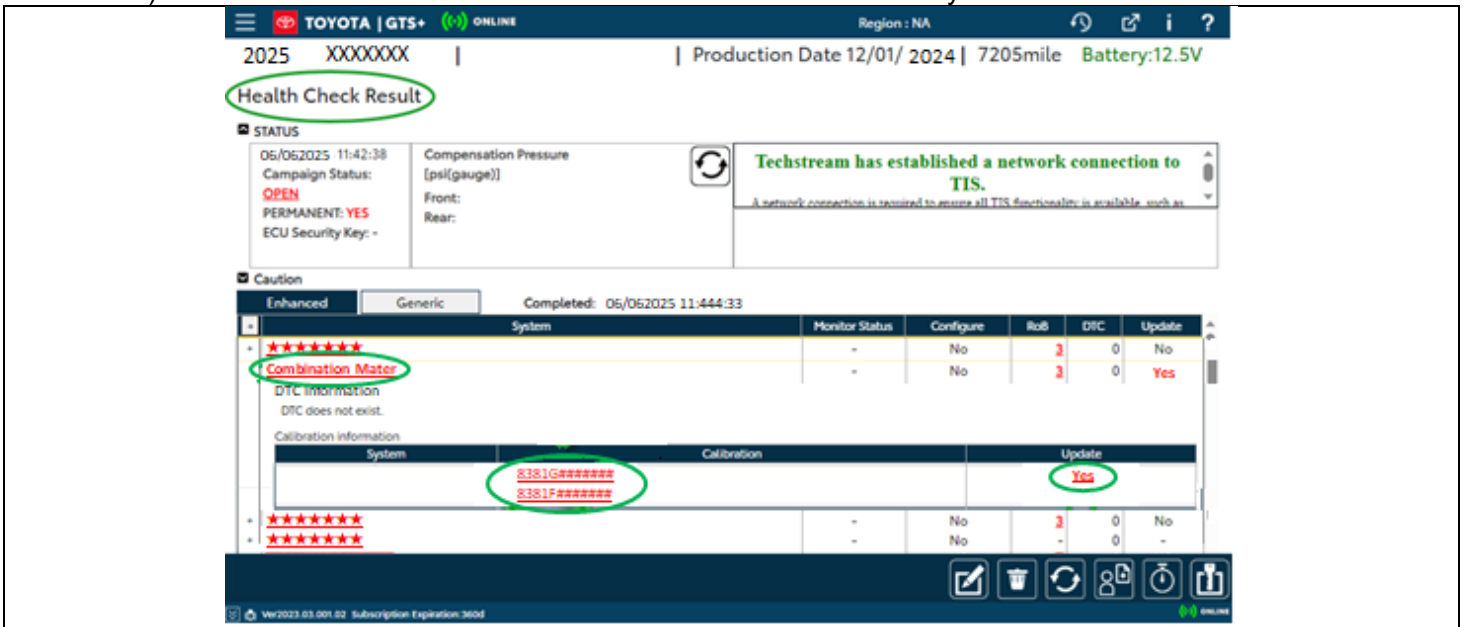
1. CONFIRM THE CALIBRATION ID FOR THE COMBINATION METER SYSTEM

a) Confirm the current calibration ID in the Combination Meter System.

Confirm the CIDs has been updated successfully to the NEW CIDs by someone other than the individual who performed the repair. Refer to page 6.

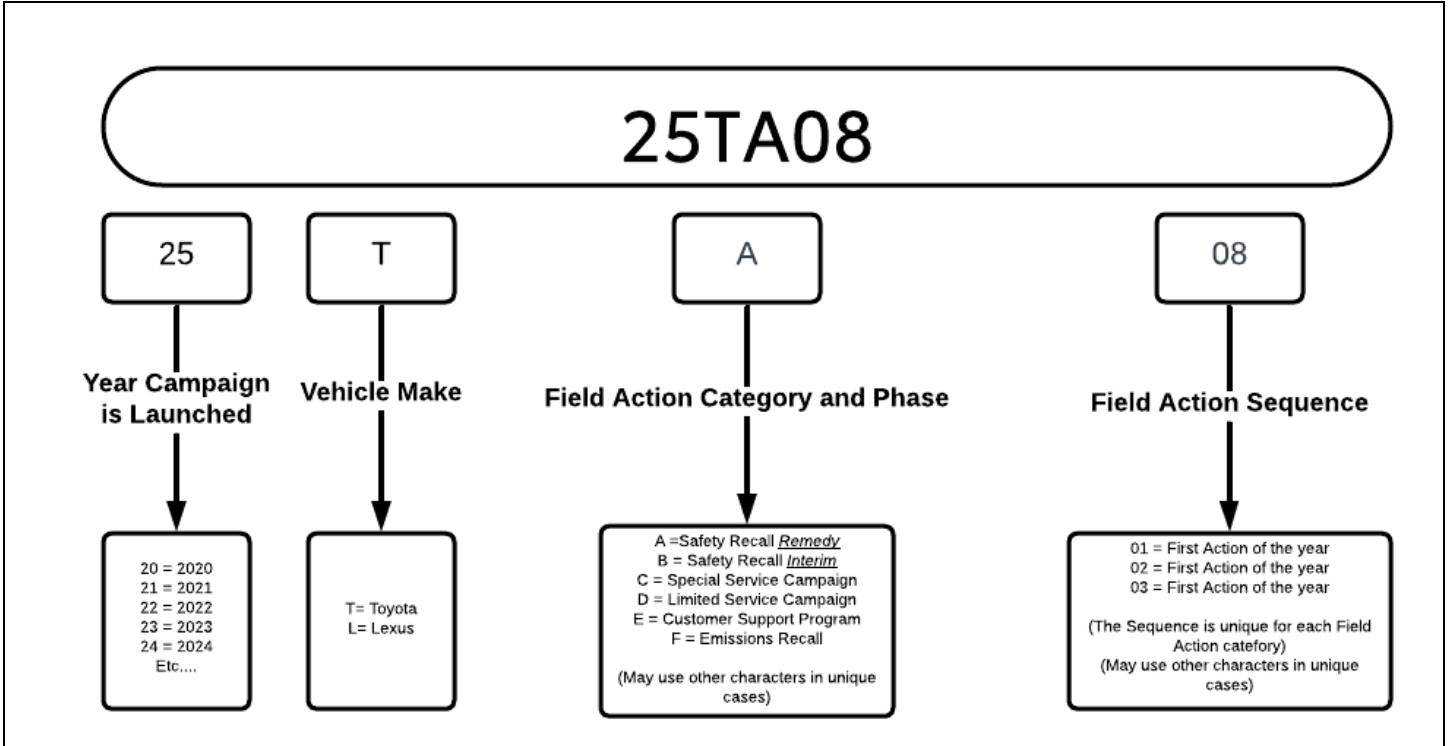
A. CAMPAIGN DESIGNATION DECODER

19TA01 = Launched in 2019, Toyota, Safety Recall Remedy Phase, 1st Safety Recall Launched in 2019
20TC02 = Launched in 2020, Special Service Campaign, 2nd Special Service Campaign Launched in 2020
21TE05 = Launched in 2021, Customer Support Program, 5th Customer Support Program Launched in 2021
