TECHNICAL INSTRUCTIONS
FOR
25TA08
REPROGRAMMING FOR COMBINATION METER ASSEMBLY

2025 CAMRY HV
2023 - 2025 CROWN
2025 CROWN SIGNIA
2023 - 2025 GR COROLLA
2024-2025 GRAND HIGHLANDER
2024-2025 GRAND HIGHLANDER HV
2023 - 2024 RAV4 PRIME
2024-2025 TACOMA
2024-2025 TACOMA HV
2023 - 2024 VENZA HV
2025 4Runner
2025 4Runner HV

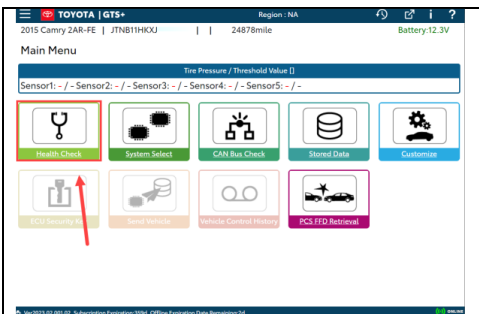
1. CHECK FOR DTC'S

- a) Using a GTS+, click the "Health Check" button on the Main Menu.

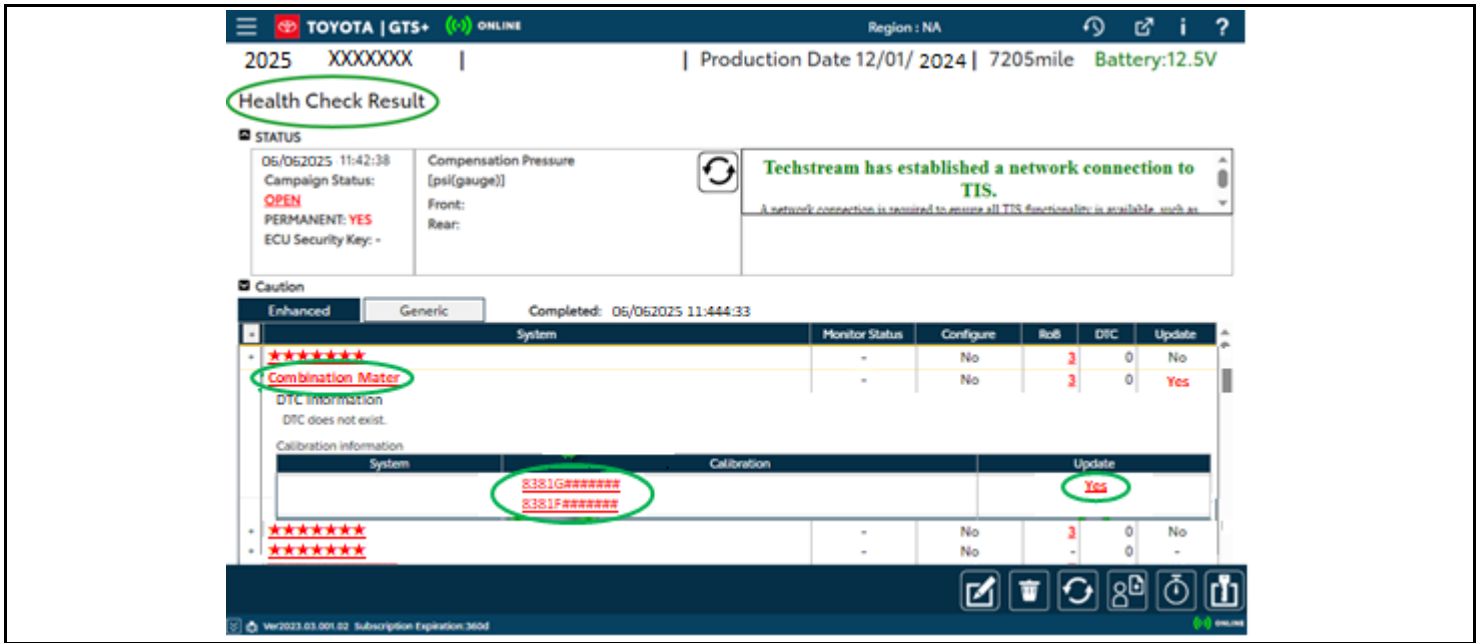
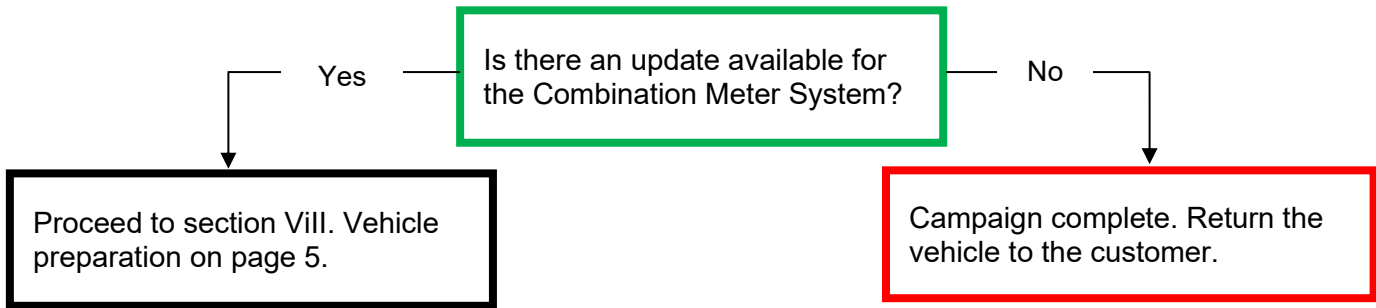
2. CHECK CURRENT CALIBRATION

- a) Locate the "Update" column of the "Calibration Information" for the Combination Meter system on the "Health Check Result" screen.
- b) Determine the status of an available update; indicated by a YES or NO.

HINT:

If the CIDs indicate 'Yes', proceed with the update procedure.

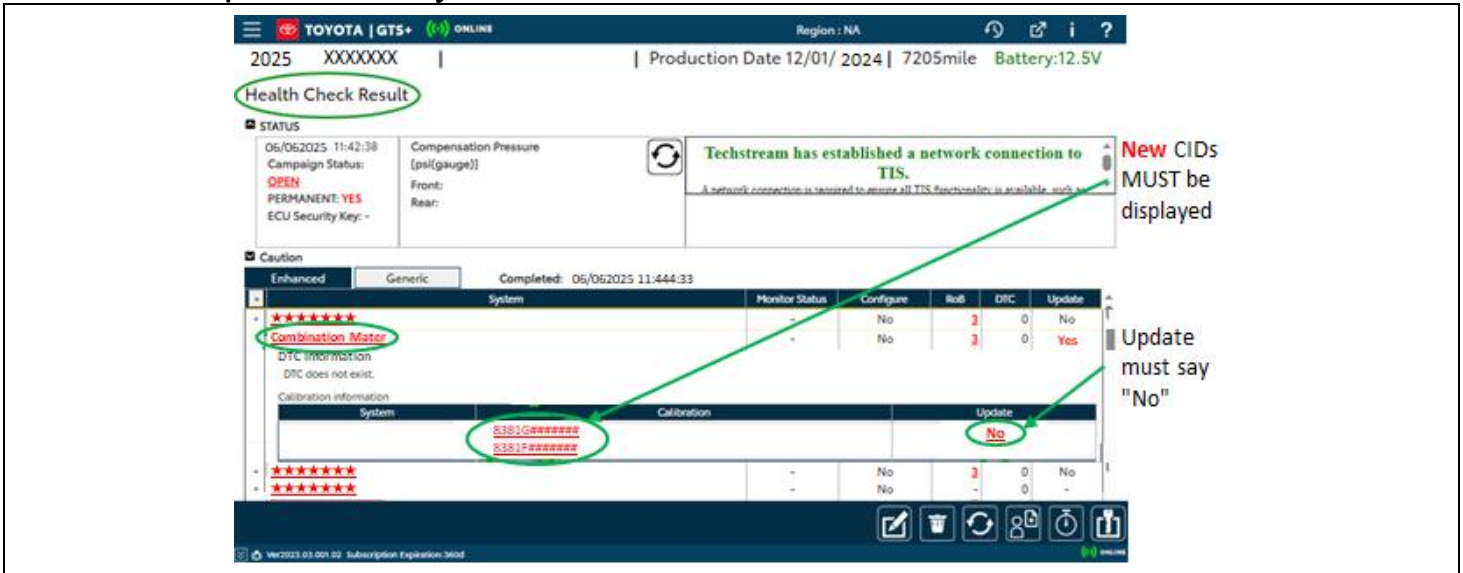
5. CONFIRM CID UPDATE

- On the Stored Data tab, confirm the following for the Combination Meter System:
 - The Calibration number has the "**NEW CID**" number.
 - The Update column says "**No**".

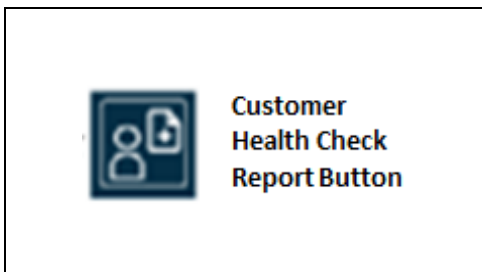
6. PRINT CUSTOMER HEALTH CHECK REPORT

- From the Stored Data tab, select the Customer Health Check Report button (TIS will launch when button is pressed).
- Log in to TIS.
- Input Vehicle Mileage and Repair Order number.
- Check the "Performed" campaign button for the applicable campaigns.
- Select the Report button.
