# INSTRUCTION TO SERVICE

| ITS61469 | | September 24, 2025 |
| SUBJECT: | Update PLC Program + IP Configuration per EEB-0047 | |
| ISSUE: | Freudenberg Gen 3 batteries (XMOD125E, XMOD123E, XMP123E) recall. | |

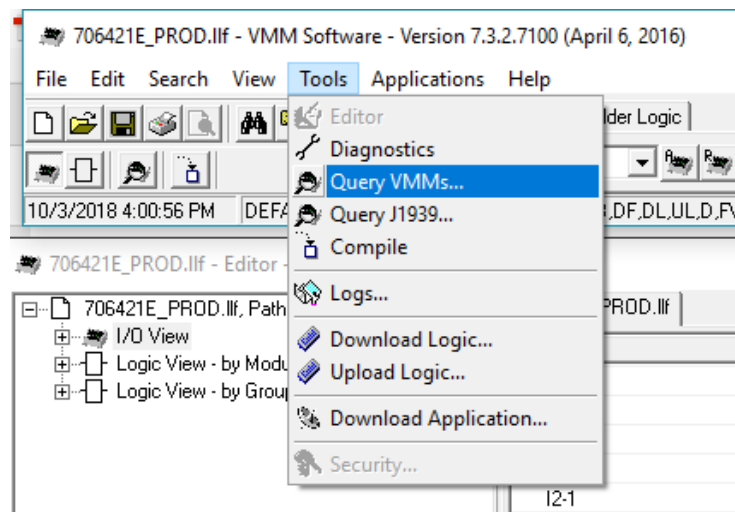
**Figure 1: Query VMMs Option**

5. Connect the USB interface of your NEXIQ to your laptop.
6. Connect the CAN interface of your NEXIQ to Channel 1 (Pins C and D) of the Rear Vehicle Diag port.
7. Open the PLC program in the VMM software.
8. Select Tools and Query VMMs.

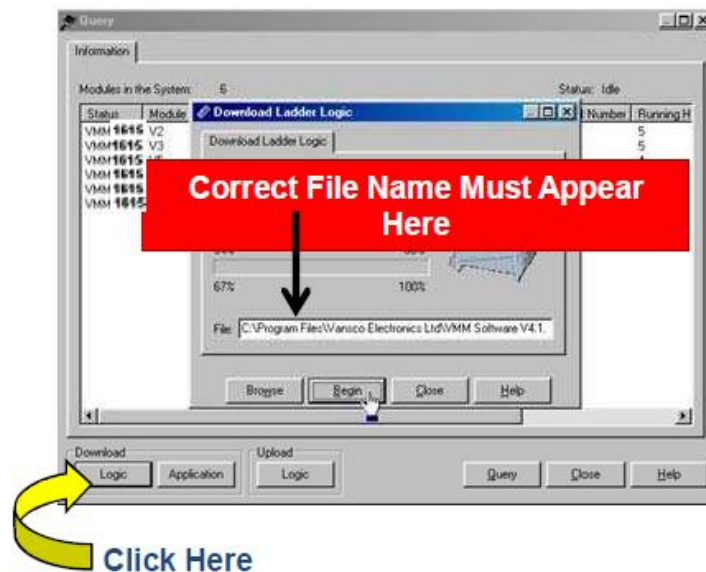
**Figure 2: File Selection and Flashing Start**

11. Ensure the correct file name and revision appear in the file window.

12. The software will verify the correct number of VMMs are found. Do not download program if all VMMs are not located. If the correct number of VMMs were found, select Yes.
13. Flashing will happen in two parts; the main logic and the J1939 Table data will be 2 separate progress screens. Make sure not to close anything after the first progress screen reaches 100% as another one will appear after that also needs to complete before flashing is completed.
14. Once flashing has truly finished, allow the bus to stay awake for 15 minutes without knifing the bus or turning off the hazards.

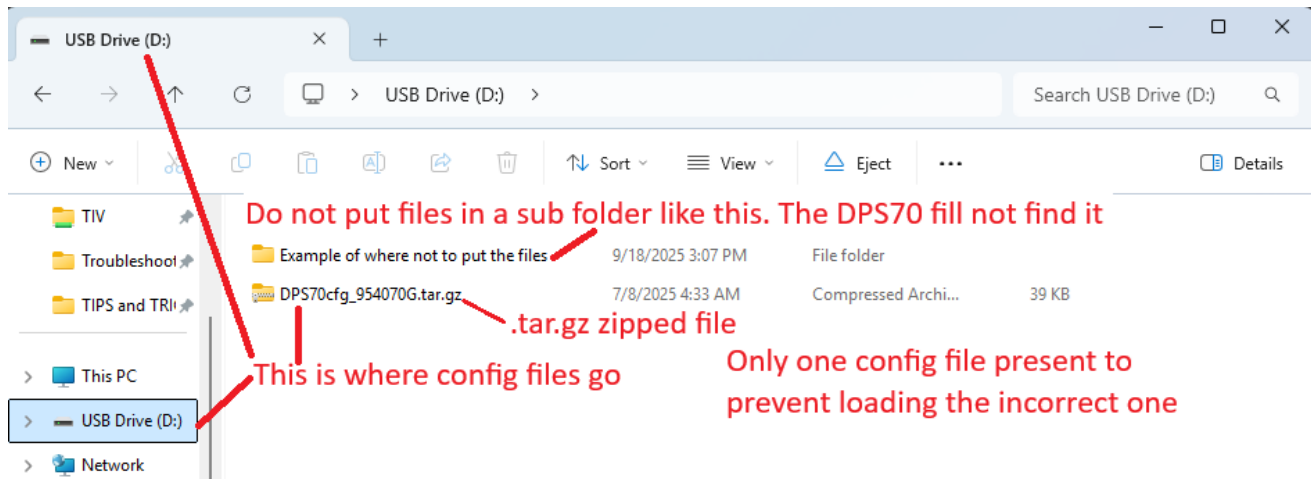
**Figure 3: Flash Drive Examples**

- ☞ **NOTE: DO NOT UNZIP THE CONFIG FILE.** It is intentionally packaged as a “.tar.gz” file and needs to stay that way for flashing.
- ☞ **NOTE: DO NOT PUT THE CONFIG FILE INTO A SUB-FOLDER.** It needs to be right in the root (the base directory, shown below) of the flash drive for the Cluster to find the file. It should be the only config file in the root of the flash drive intended to be used to be sure the correct file is selected.

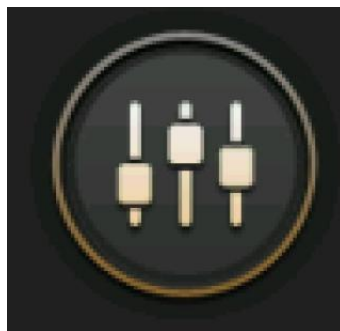
**Figure 1: Service Mode Icon**

16. Connect the flash drive to the dash, either through the external USB-A connector underneath the dash, or with an added harness directly into the back of the dash's 4-pin USB connector port (only applies to a very small selection of dashes that lack the added USB port underneath).
17. Turn the MRS to the ON position.
18. Enter the IP Cluster into Service Mode by tapping on the Service Mode Icon (shown below) in the top right corner of the touch screen.

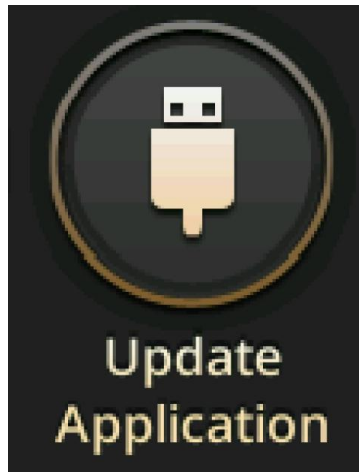
**Figure 2: Update Application Button**

19. A prompt for a password will appear, it is “9876543210” which gives full access to diagnostic mode and many diagnostic features.
20. Once in Service Mode, tap on the “Update Application” button (shown below).
