SAFETY RECALL

Radio Black Screen

FCA US LLC

Reference: A2C

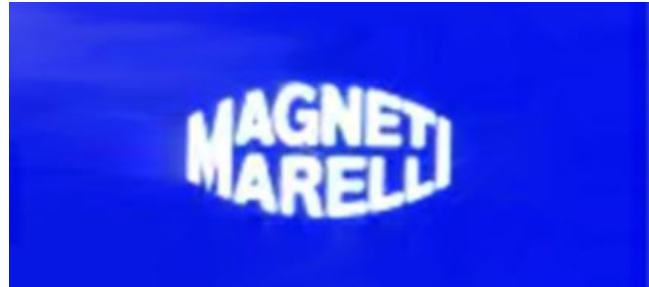
42. A blue screen with Marelli logo will appear.

43. The counter for the integrity check is displayed on the same screen.

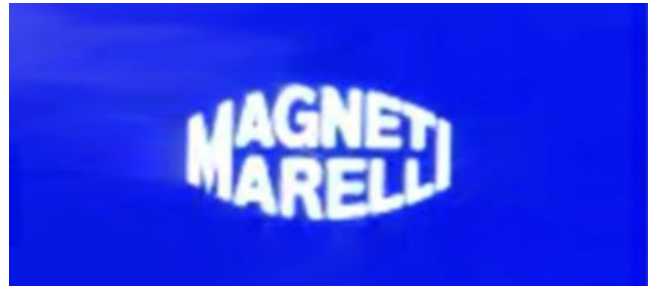
52. A blue screen with Marelli logo will appear.

53. The counter for the integrity check is displayed on the same screen.

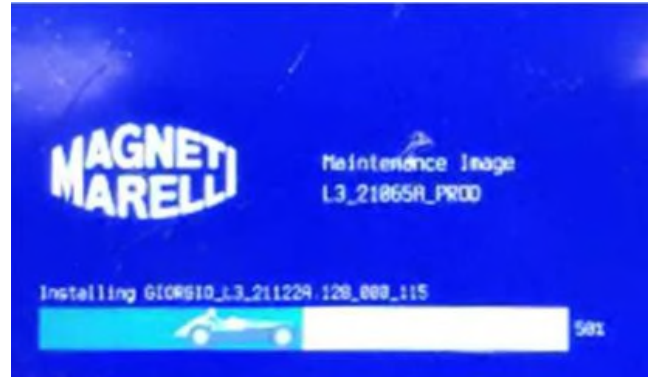
55. After rebooting, the BLUE screen with the "Marelli" logo will appear again also contains a bar indicating the progress of the installation in progress.

56. Wait for the bar to turn green with a message indicating that you can remove the USB drive.
