SAFETY RECALL

Radio Black Screen

FCA US LLC

Reference: **A2C**

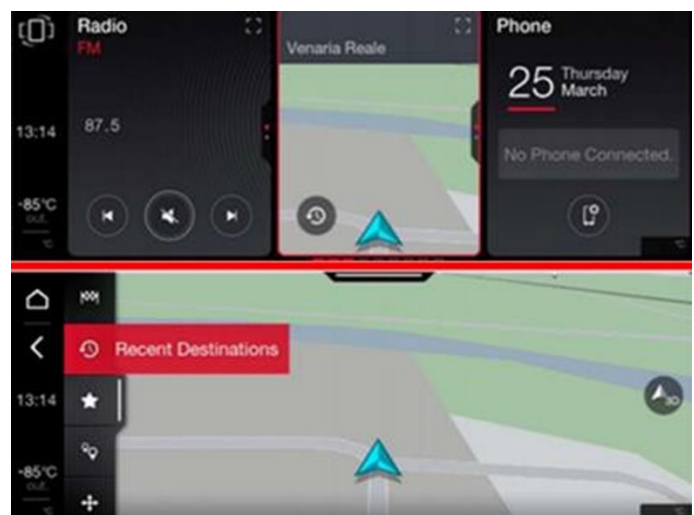
1. Switch on the system and on the press the "Navigation" widget Home screen.
2. Press the "Recent Destinations" icon.

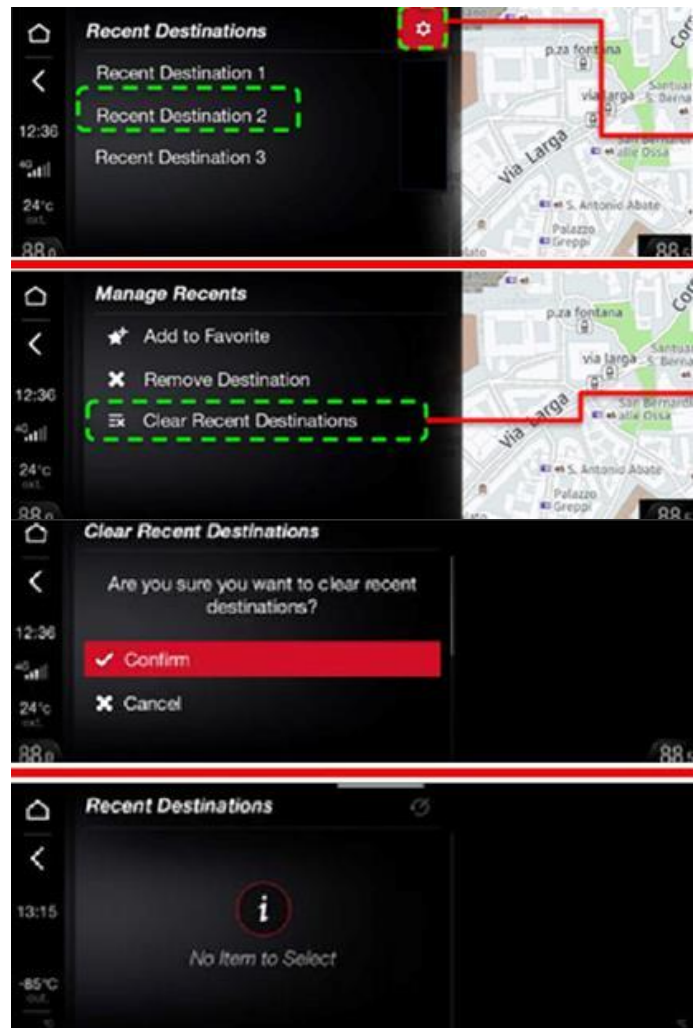
3. Press the "Settings".
4. Press the "Delete recent destinations" command.
5. Confirm the deletion.
6. After deletion, the list will appear empty.

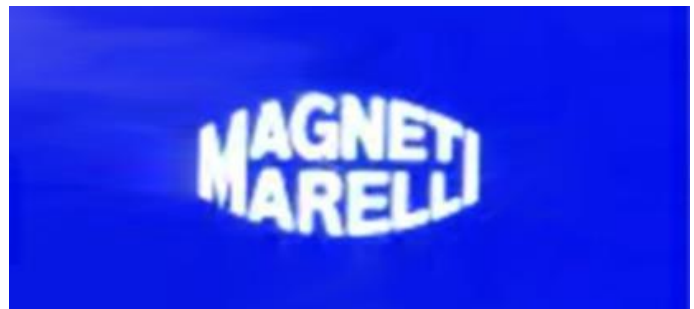
42. A blue screen with Marelli logo will appear.

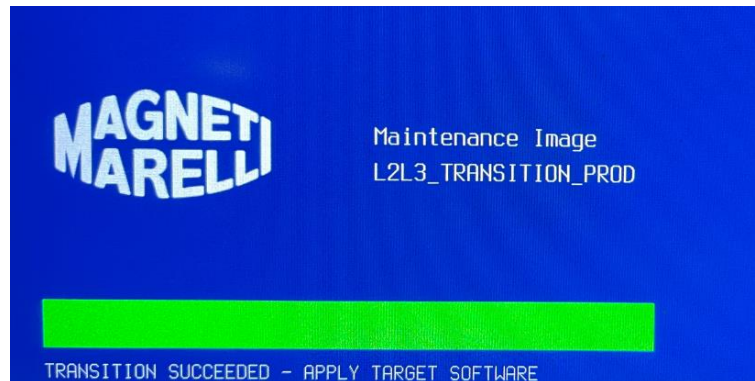
45. After rebooting, the message "Transition succeeded" and a green bar will appear.

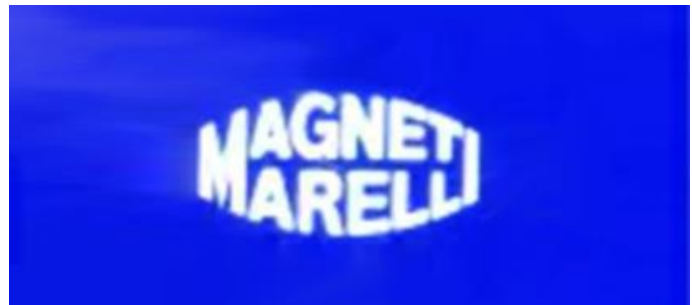
48. Switch on the system if it has not been switched on before.
49. Remove any media connected to the USB port.
50. Connect the USB drive containing the target software to the USB port of the system.
51. Installation of the target software will start after a few seconds.
52. A blue screen with Marelli logo will appear.

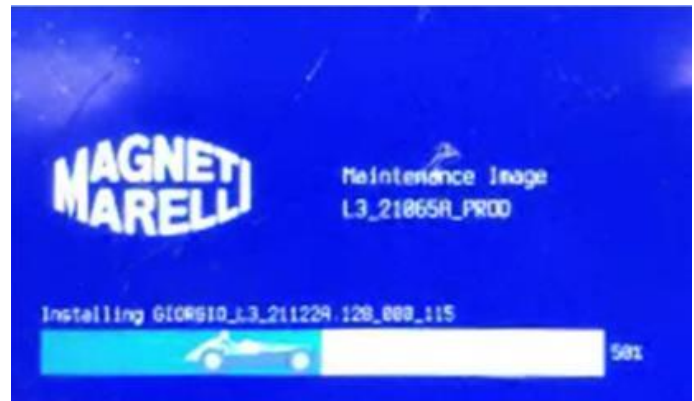
55. After rebooting, the BLUE screen with the "Marelli" logo will appear again also contains a bar indicating the progress of the installation in progress.
