SAFETY RECALL

Radio Black Screen

FCA US LLC

Reference: **A2C / NHTSA 25V667**

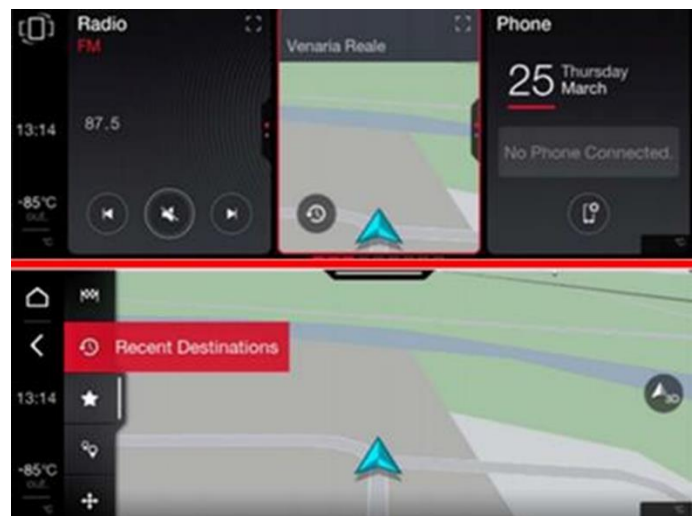
1. Switch on the system and on the press the "Navigation" widget Home screen.
2. Press the "Recent Destinations" icon.

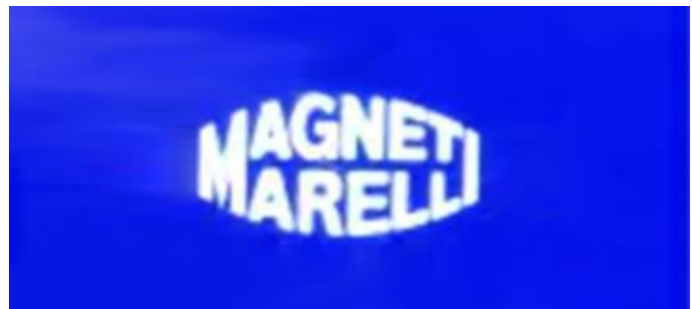
42. A blue screen with Marelli logo will appear.

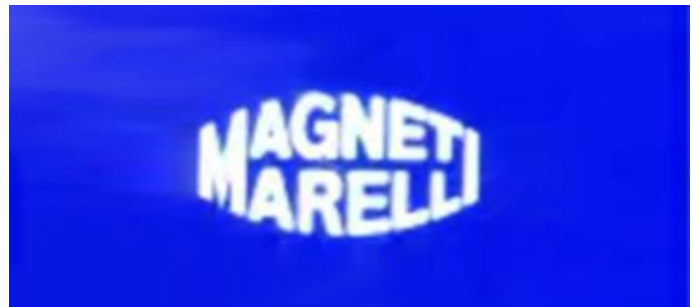
48. Switch on the system if it has not been switched on before.
49. Remove any media connected to the USB port.
50. Connect the USB drive containing the target software to the USB port of the system.
51. Installation of the target software will start after a few seconds.
52. A blue screen with Marelli logo will appear.

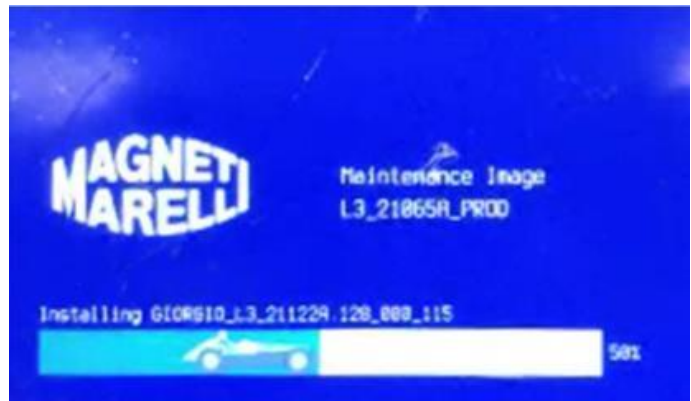
55. After rebooting, the BLUE screen with the "Marelli" logo will appear again also contains a bar indicating the progress of the installation in progress.
