**TECHNICAL INSTRUCTIONS  
FOR  
SAFETY RECALL 25TA13  
REPROGRAMMING FOR  
CIRCUMFERENCE MONITORING CAMERA CONTROL MODULE**

**CERTAIN  
bZ4X, CAMRY, CROWN, CROWN SIGNIA,  
GRAND HIGHLANDER, HIGHLANDER,  
LAND CRUISER, MIRAI, PRIUS, RAV4, SIENNA, VENZA,**

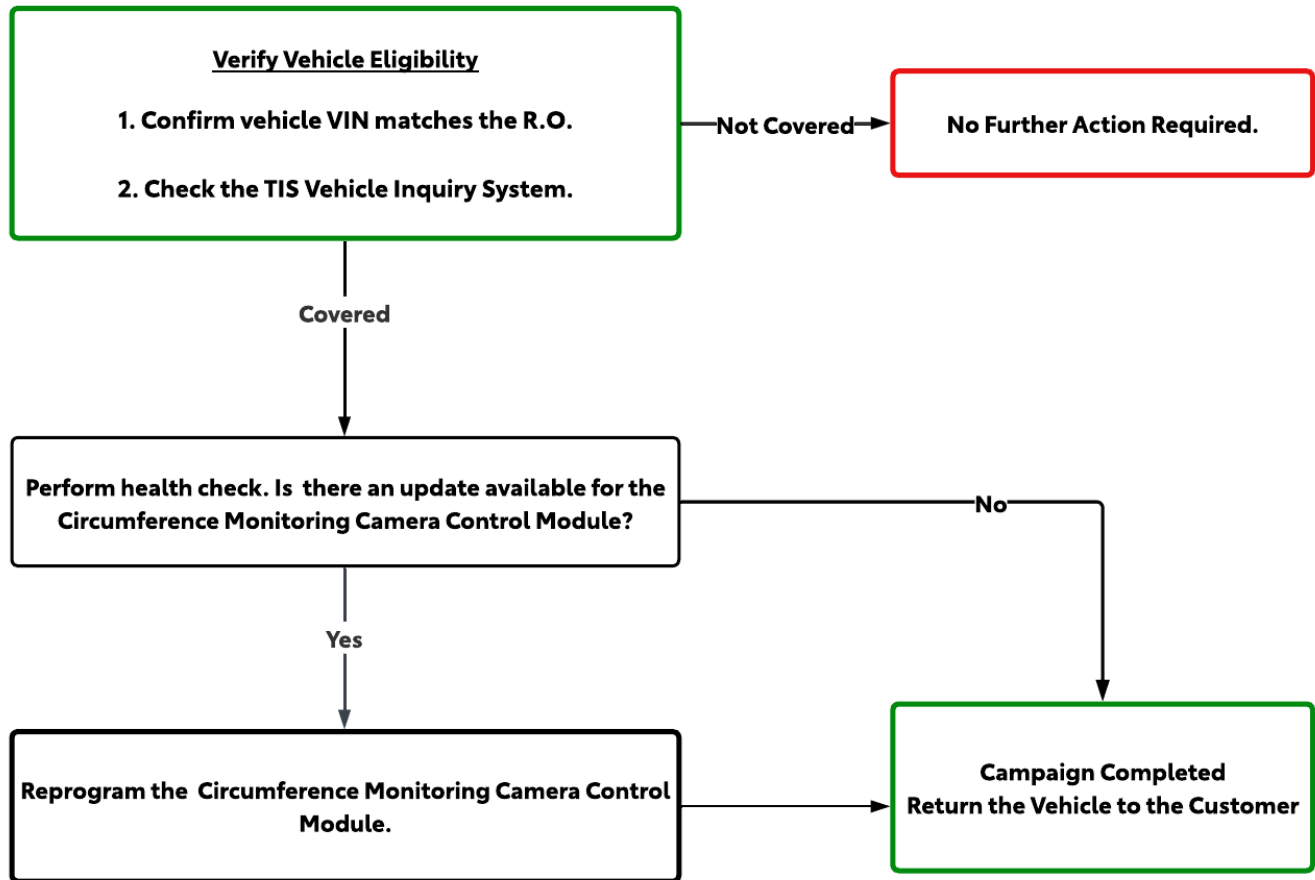
## I. OPERATION FLOW CHART

The flow chart is for reference only. **DO NOT** use it in place of the full technical instructions. Follow **ALL** steps as outlined in the full technical instructions to confirm the campaign is completed correctly.

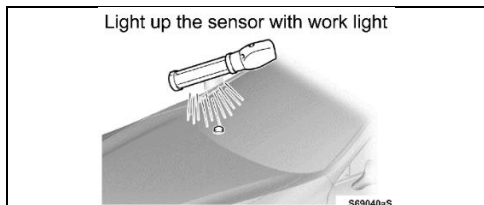
- Vehicle in the IG position (READY OFF).
- Transaxle in Park.
- Parking brake engaged.
- Turn off all electrical accessories (i.e. climate control, audio system, etc.)
- Headlight switch in the DRL OFF position. (w/ DRL OFF position)
- Windshield wiper switch in the OFF position.
