**TECHNICAL INSTRUCTIONS
FOR
SAFETY RECALL 25LA06
REPROGRAMMING FOR
CIRCUMFERENCE MONITORING CAMERA CONTROL MODULE
CERTAIN
ES, GX, LC, LS, LX, NX, RX, RZ & TX350**

I. OPERATION FLOW CHART

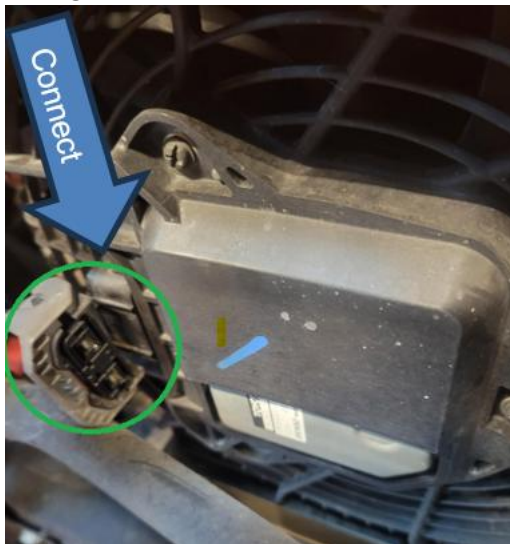
1. DISCONNECT THE DCA-8000
2. RECONNECT THE ELECTRIC RADIATOR FAN (HYBRID VEHICLES)
