**TECHNICAL INSTRUCTIONS
FOR
SAFETY RECALL 25LA06
REPROGRAMMING FOR
CIRCUMFERENCE MONITORING CAMERA CONTROL MODULE
CERTAIN
ES, GX, LC, LS, LX, NX, RX, RZ & TX350**

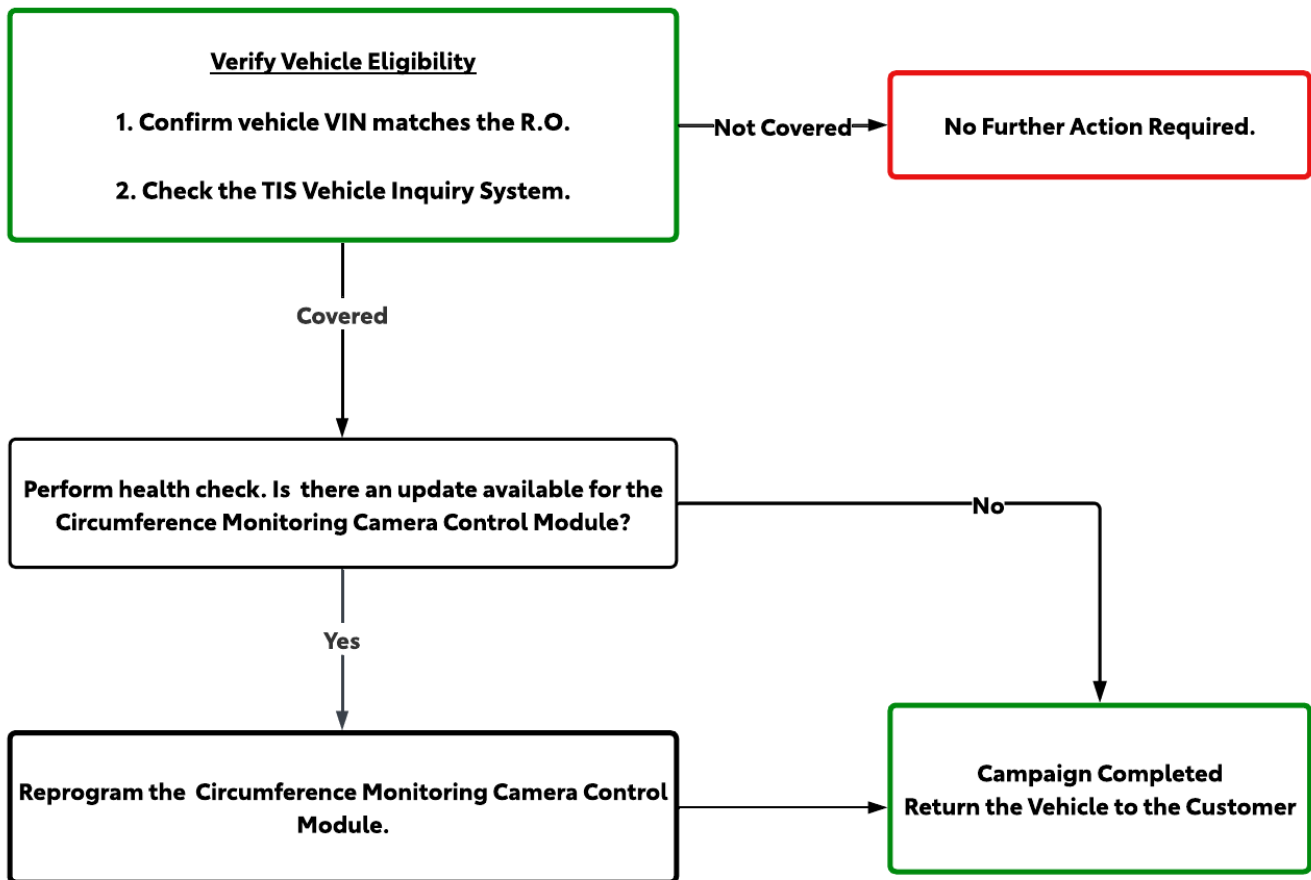
I. OPERATION FLOW CHART

The flow chart is for reference only. **DO NOT** use it in place of the full technical instructions. Follow **ALL** steps as outlined in the full technical instructions to confirm the campaign is completed correctly.

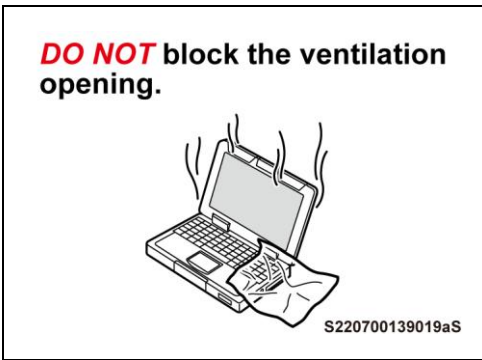
- Turn off the screen saver and power saving mode of the personal computer so that the power to the hard disk is kept supplied.

If the screen saver or power saving mode launches while reprogramming, the communication may be disconnected, resulting in the damage of the ECU.

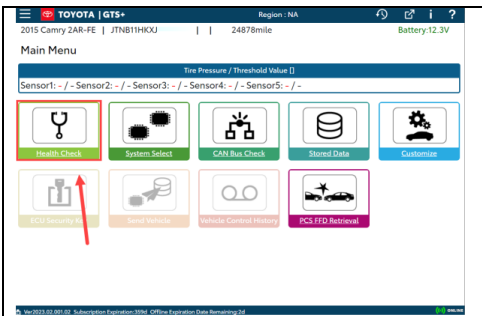
- a) Using a GTS+, click the "Health Check" button on the Main Menu.

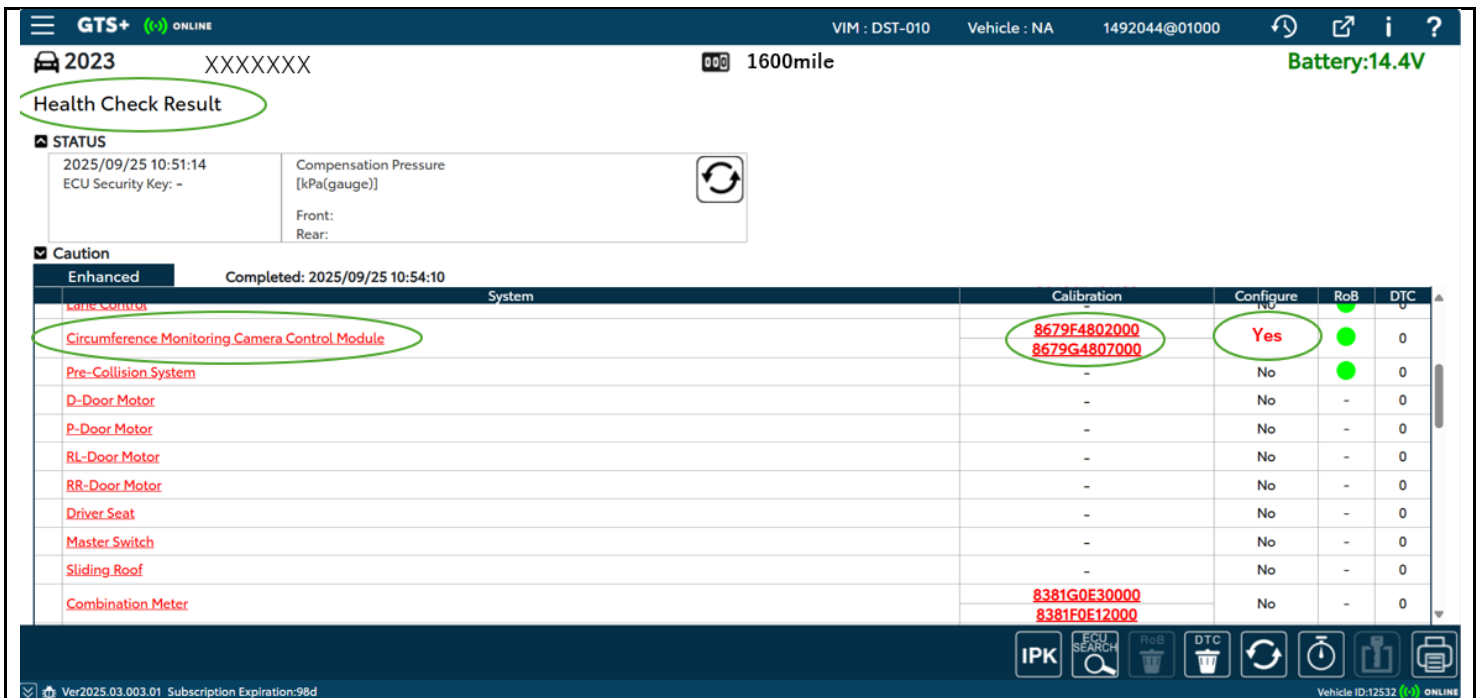
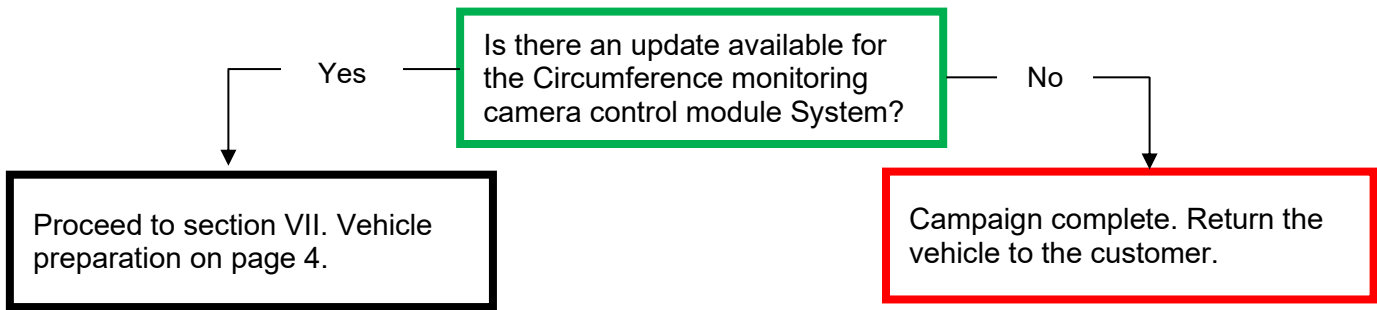
- a) Locate the "Update" column of the "Calibration Information" for the circumference monitoring camera control module system on the "Health Check Result" screen.
- b) Determine the status of an available update; indicated by a YES or NO.

If the CIDs indicate 'Yes', proceed with the update procedure.

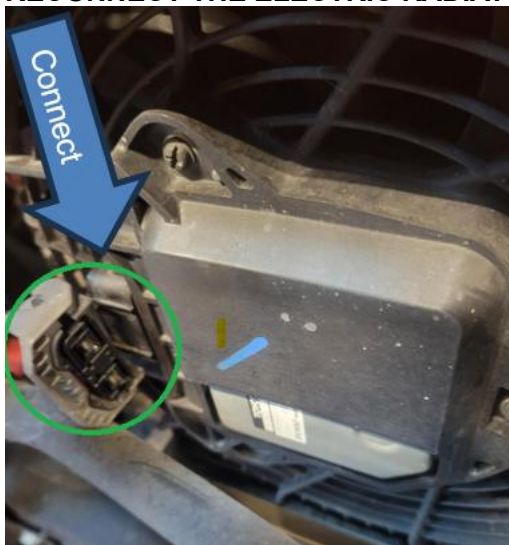
1. DISCONNECT THE DCA-8000
2. RECONNECT THE ELECTRIC RADIATOR FAN (HYBRID VEHICLES)

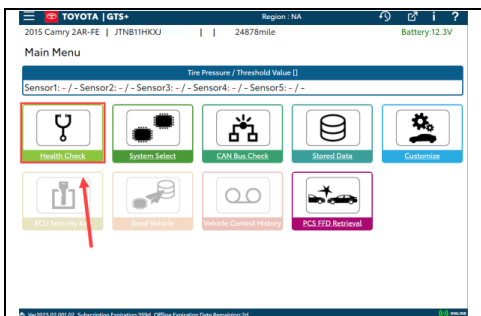
3. PERFORM VERIFICATION HEALTH CHECK

- a) Using a GTS+, click the “Health Check” button on the Main Menu.
- b) Clear DTC’s that may have set during the re-flash procedure.
- c) Re-run the Health Check to confirm that no DTC’s reappear.
