**TECHNICAL INSTRUCTIONS
FOR
SAFETY RECALL 25LA06
REPROGRAMMING FOR
CIRCUMFERENCE MONITORING CAMERA CONTROL MODULE
CERTAIN
RX & TX350**

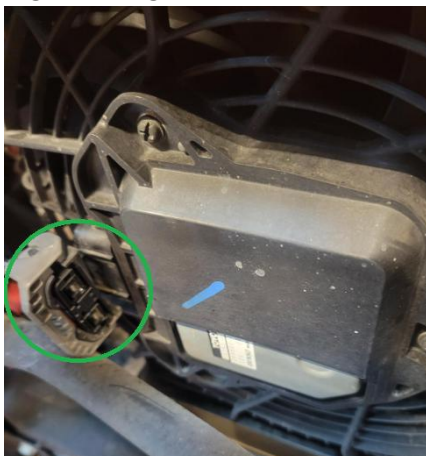
2. FOR HYBRID VEHICLES DISABLE THE ELECTRIC RADIATOR FAN BY UNPLUGGING THE CONNECTOR.
