**TECHNICAL INSTRUCTIONS  
FOR  
SAFETY RECALL 25TA13  
REPROGRAMMING FOR  
CIRCUMFERENCE MONITORING CAMERA CONTROL MODULE**

**CERTAIN  
bZ4X, CAMRY, CROWN, CROWN SIGNIA,  
GRAND HIGHLANDER, HIGHLANDER,  
LAND CRUISER, MIRAI, PRIUS, RAV4, SIENNA, VENZA,**

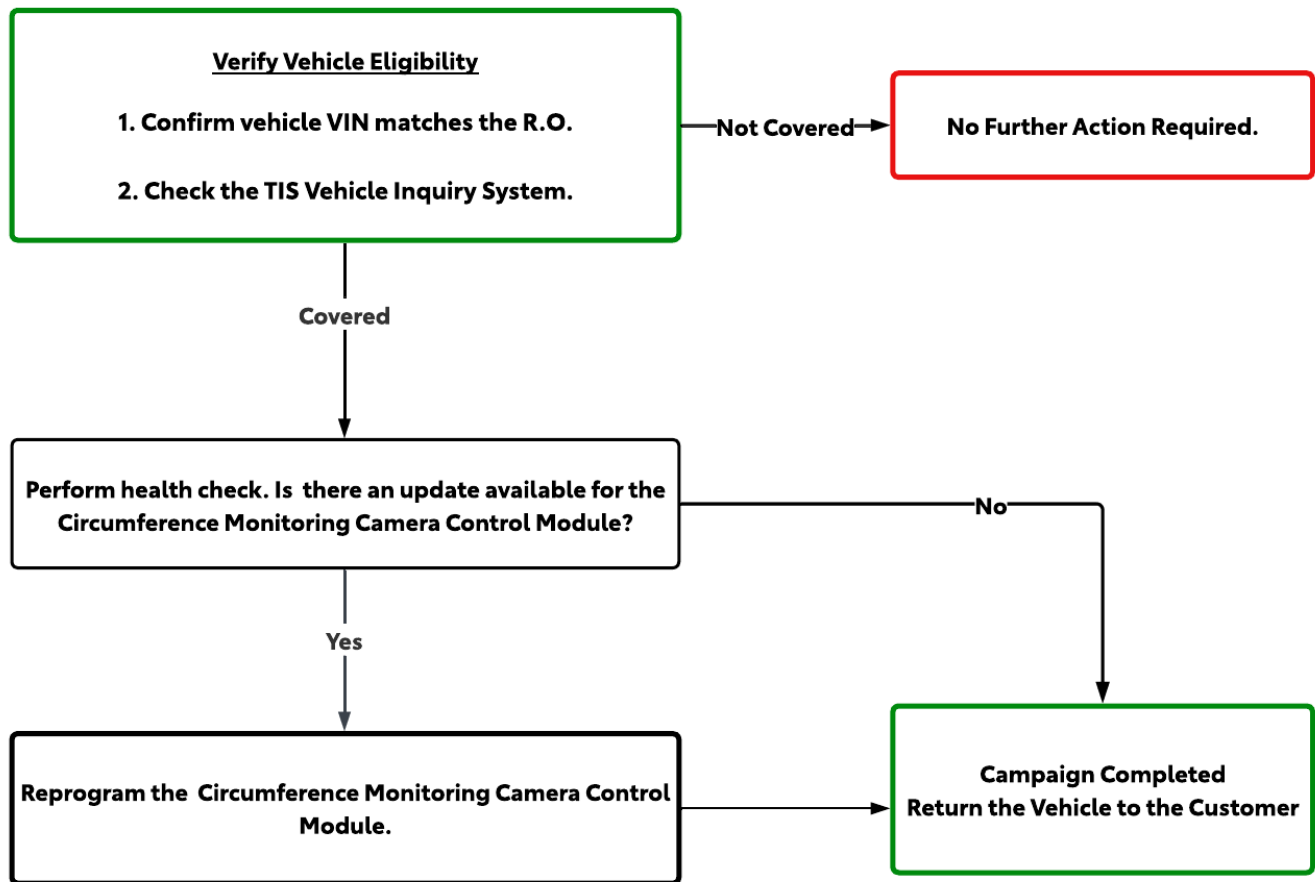
## I. OPERATION FLOW CHART

The flow chart is for reference only. **DO NOT** use it in place of the full technical instructions. Follow **ALL** steps as outlined in the full technical instructions to confirm the campaign is completed correctly.
