◀ IMPORTANT UPDATE ▶

**TECHNICAL INSTRUCTIONS
FOR
SAFETY RECALL 25LA06
REPROGRAMMING FOR
CIRCUMFERENCE MONITORING CAMERA CONTROL MODULE
CERTAIN
ES, GX, LC, LS, LX, RX, RZ & TX350**

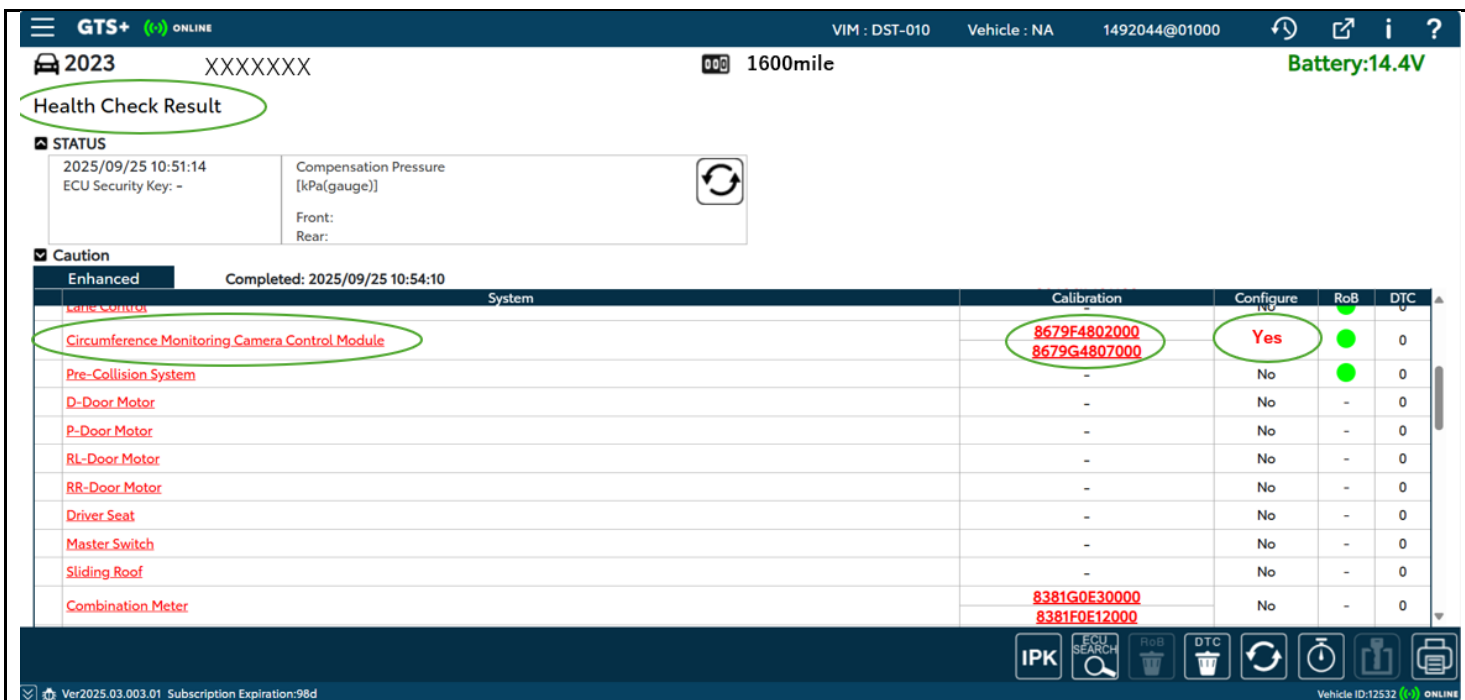
- a) Locate the "Update" column of the "Calibration Information" for the circumference monitoring camera control module system on the "Health Check Result" screen.
- b) Determine the status of an available update; indicated by a YES or NO.

If the CIDs indicate 'Yes', proceed with the update procedure.

The screenshot shows the GTS+ software interface with the following details:

- Vehicle: 2023 XXXXXXXX, 1600mile, Battery: 14.4V
- Health Check Result: STATUS 2025/09/25 10:51:14, ECU Security Key: -
- Table of Calibration Data:

System	Calibration	Configure	RoB	DTC
Circumference Monitoring Camera Control Module	8679F4802000 8679G4807000	Yes	●	0
Pre-Collision System	-	No	●	0
D-Door Motor	-	No	-	0
P-Door Motor	-	No	-	0
RL-Door Motor	-	No	-	0
RR-Door Motor	-	No	-	0
Driver Seat	-	No	-	0
Master Switch	-	No	-	0
Sliding Roof	-	No	-	0
Combination Meter	8381G0E30000 8381F0E12000	No	-	0

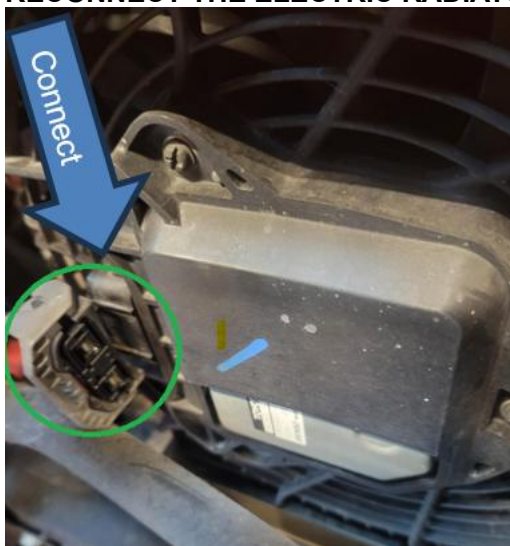
1. DISCONNECT THE DCA-8000
2. RECONNECT THE ELECTRIC RADIATOR FAN (HYBRID VEHICLES)
